DEMOLITION PROPOSAL. GROUND LEVEL VISUAL INSPECTION p. 1 of 2

JOB: Ground level inspection of two severely dilapidated stone buildings for possible demolition.

ADDRESS: No.33761, Victoria Location 720 Brand Highway, Greenough, City of Greater Geraldton

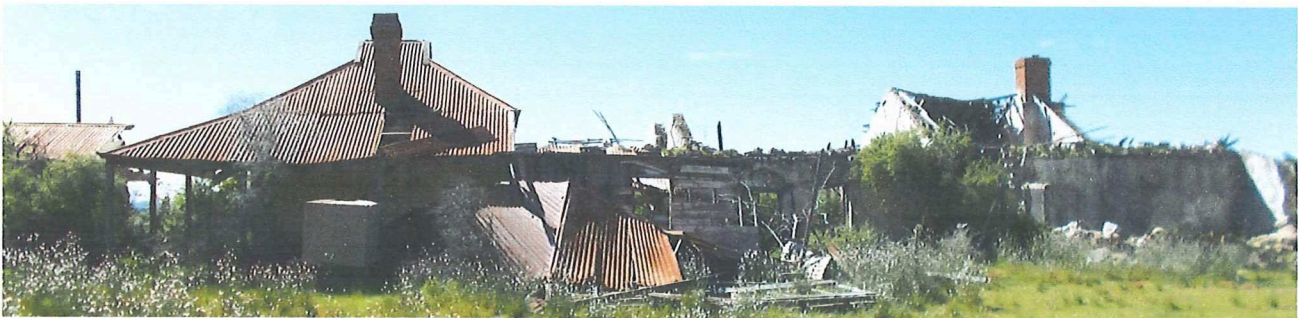
Above, we see the layout of the buildings. At far left there is the old stable & workshop from the 1920's. Then the building with the red corrugated steel roof is the 'new' homestead built in the 1920's. The right half of the photograph is the main heritage dwelling from the 1870's.

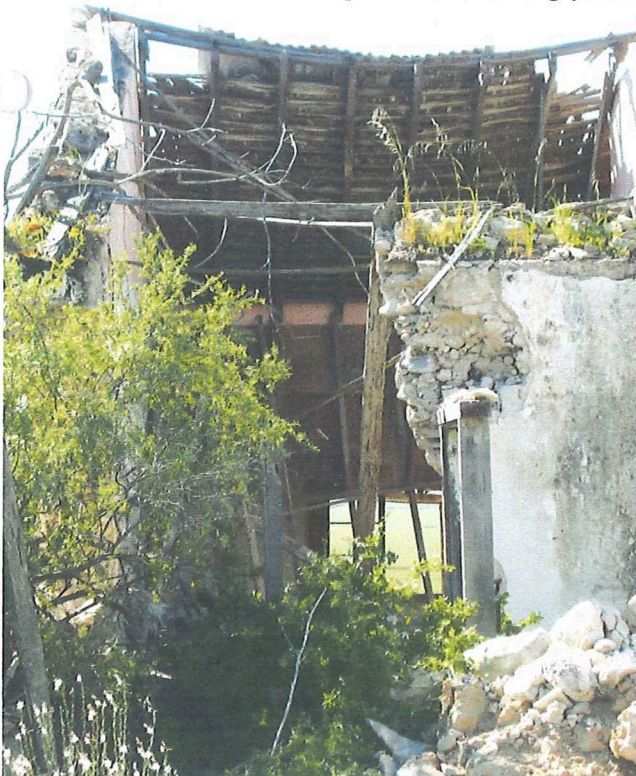
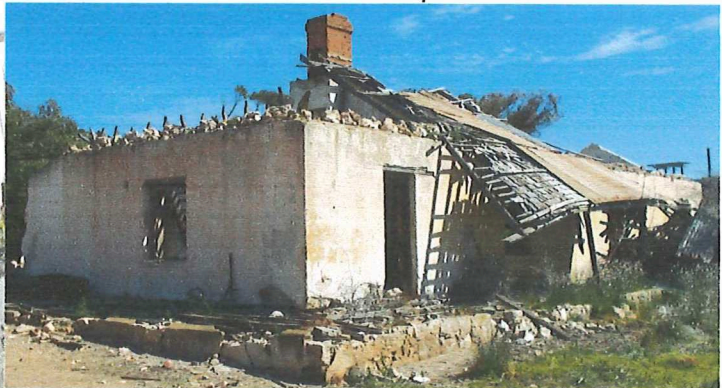
Above & to the left we see the extreme state of decay. The roof of 150 years ago had shingle cladding. But that was replaced a few decades later by corrugated iron when it became available. Inspection of the building shows nothing of historical value: The walls are standard poor stonework, and the roof is decayed typical jarrah framing, many, well preserved, examples of which exist today. So there is nothing remarkable or in preservable condition

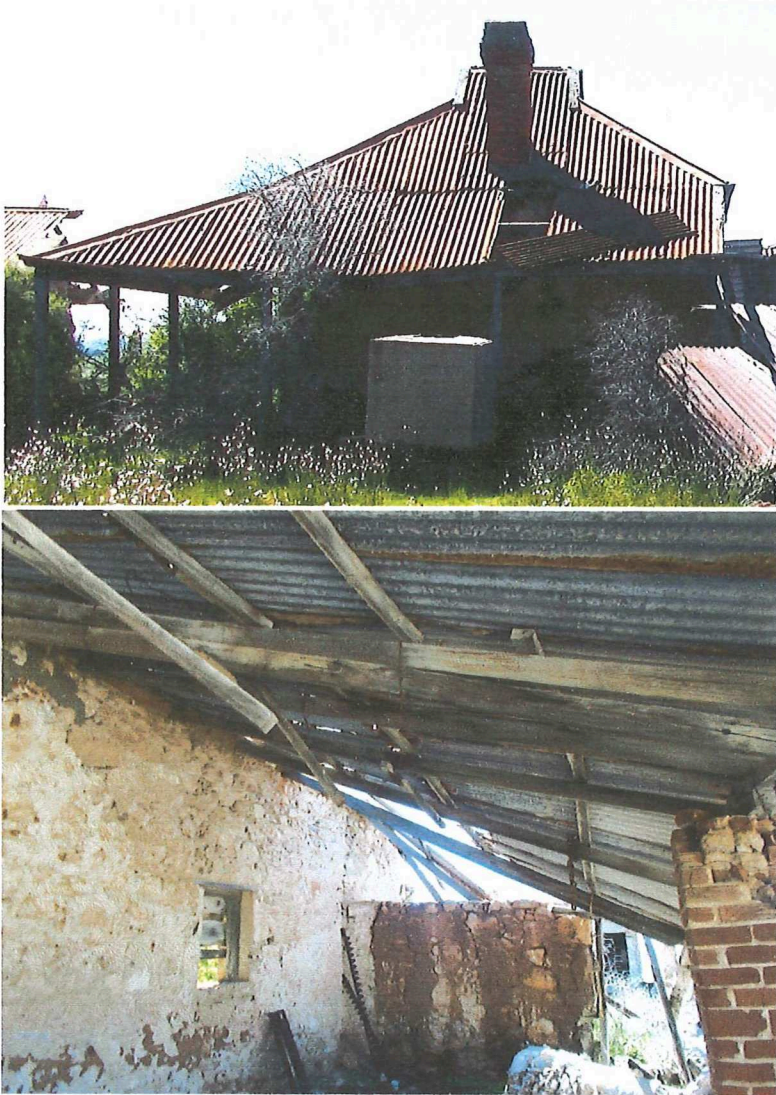
On the left, the replacement small house is from the same 1920's period as the stable & workshop.

It is totally gutted inside, and as can be seen by the collapsing roof profile, the roof frame is termite & water affected and fallen in several places.

The only recognizable feature is the chimney. But the mortar work is a home handyman effort, as seen next:
