Structerre reference number: S527512/AO

AQUARENA - PASS STREET WONTHELLA

The purpose of the visit was to inspect and comment upon the existing external male and female toilets/change rooms to determine if they are in a structurally acceptable state.

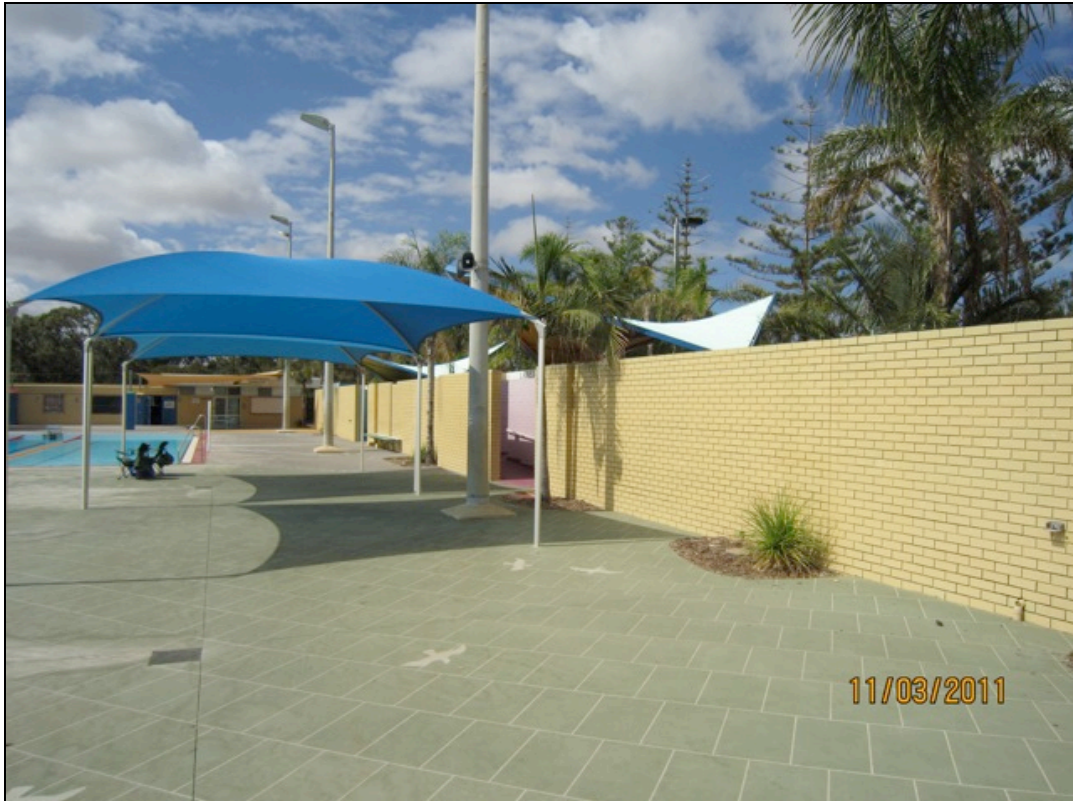
- Numerous cracks up to 10mm wide were observed throughout all leafs of brickwork in both toilet/change rooms.
- All brickwork is single leaf (110mm wide) up to 2100mm high with 230 x 470 buttresses located at approximately 3400mm c/c along the east and west facing walls. It was noted that a large portion of these piers are not built into to the single leaf perimeter brickwork.

- Both structures do not comply with Table 12.3 in AS3700 (Masonry Structures) which specifies no more than 2400 max centres between piers to an unreinforced single leaf wall.
- As youths are primary attendees of the Aquarena, there is a high likelihood of injury, due to youths jumping over the walls and the potential failure/collapse of the walls in the process.
- The level of compaction is currently at a low level as 8 blows per 300mm is an acceptable result.

Photograph 1 - Outside wall of existing toilets/change rooms

It is therefore the considered opinion of this Office that the structure has reached the end of its economic life, and it is our recommendation that the building be demolished and replaced as the extent of works required to restore the existing structures to a structurally acceptable level will require a large amount of reconstruction and ongoing maintenance in the future.

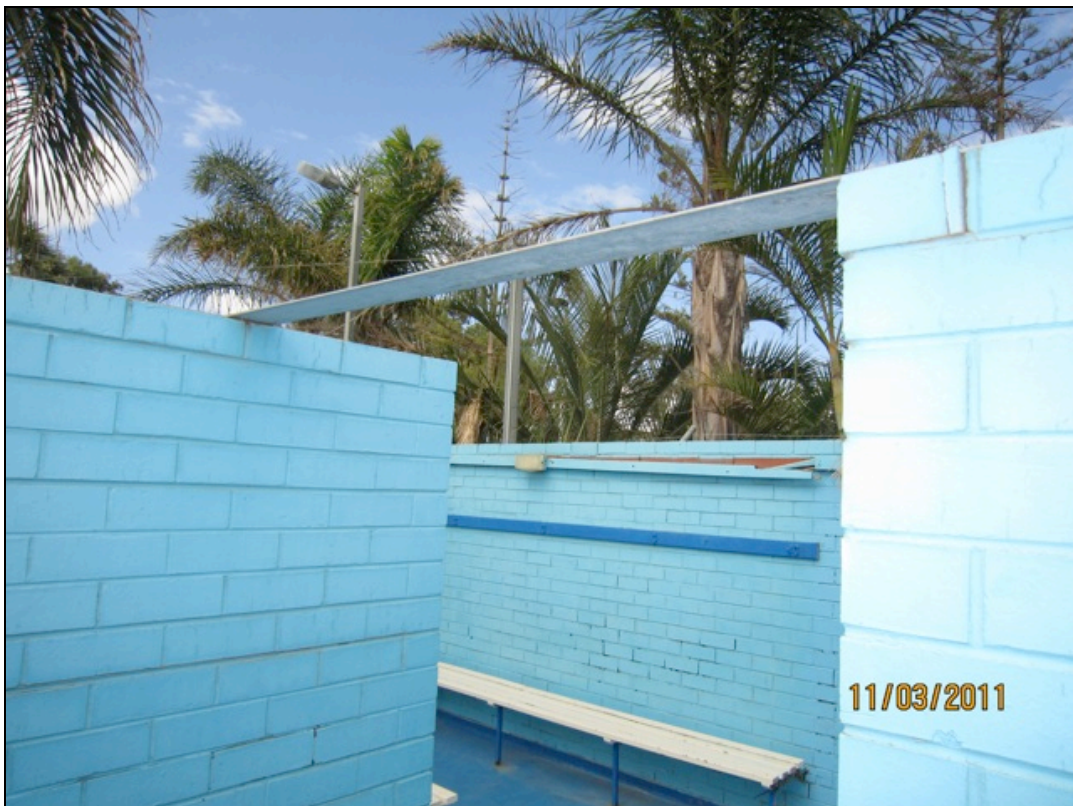
- Numerous locations where steel plates have been bolted into existing brickwork to try and possibly reduce cracking and potential failure.
- The curved awnings were constructed with 75mm 'C' section perimeter beams and curved 60 x 40 timber purlins at approximately 1200 c/c. It was noted that some areas of cladding and guttering appear to be in poor condition. One purlin has been repaired using a steel sleeve and bolts, but does not appear to be performing adequately.

Photograph 2 - Steel flat bar installed to temporarily restrain brickwork

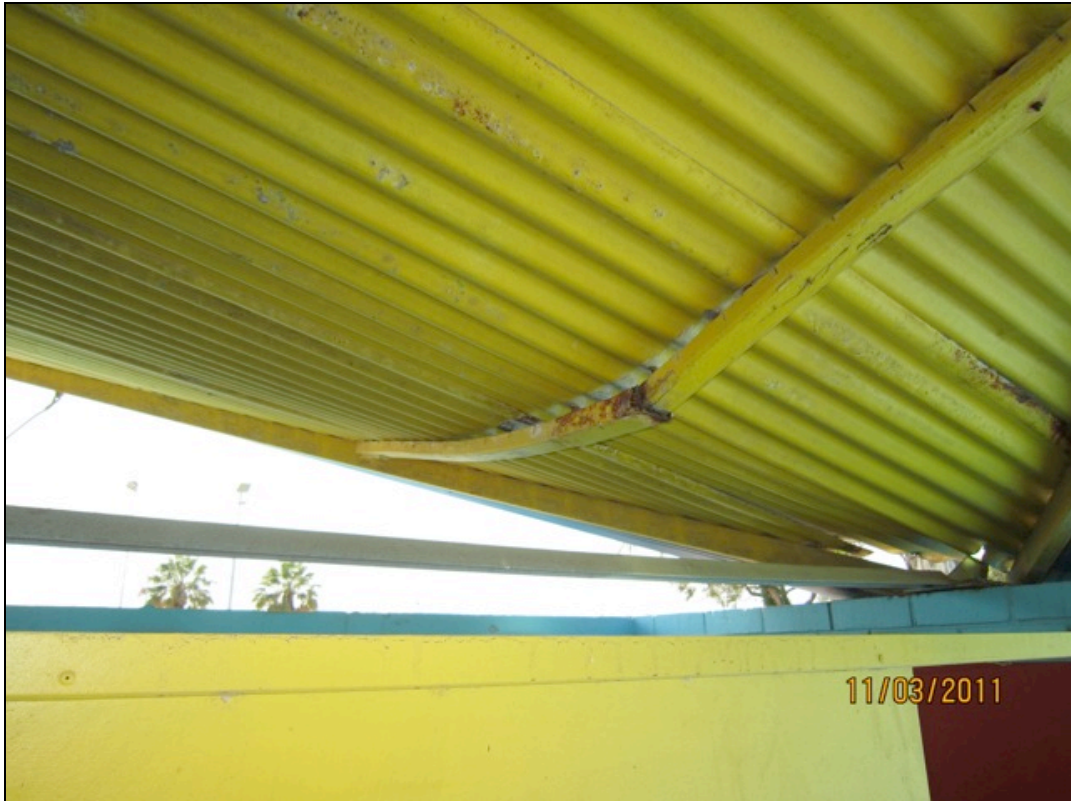
Photograph 3 - Failure to purlin

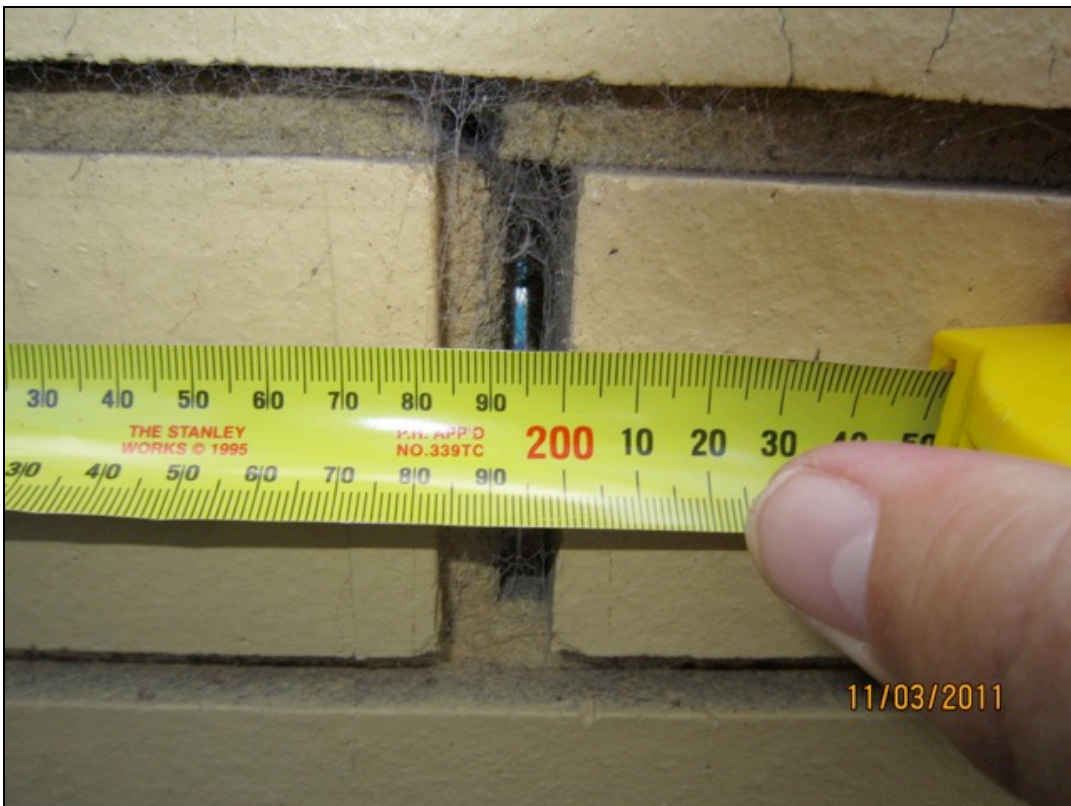
Photograph 4 - Cracking to brickwork

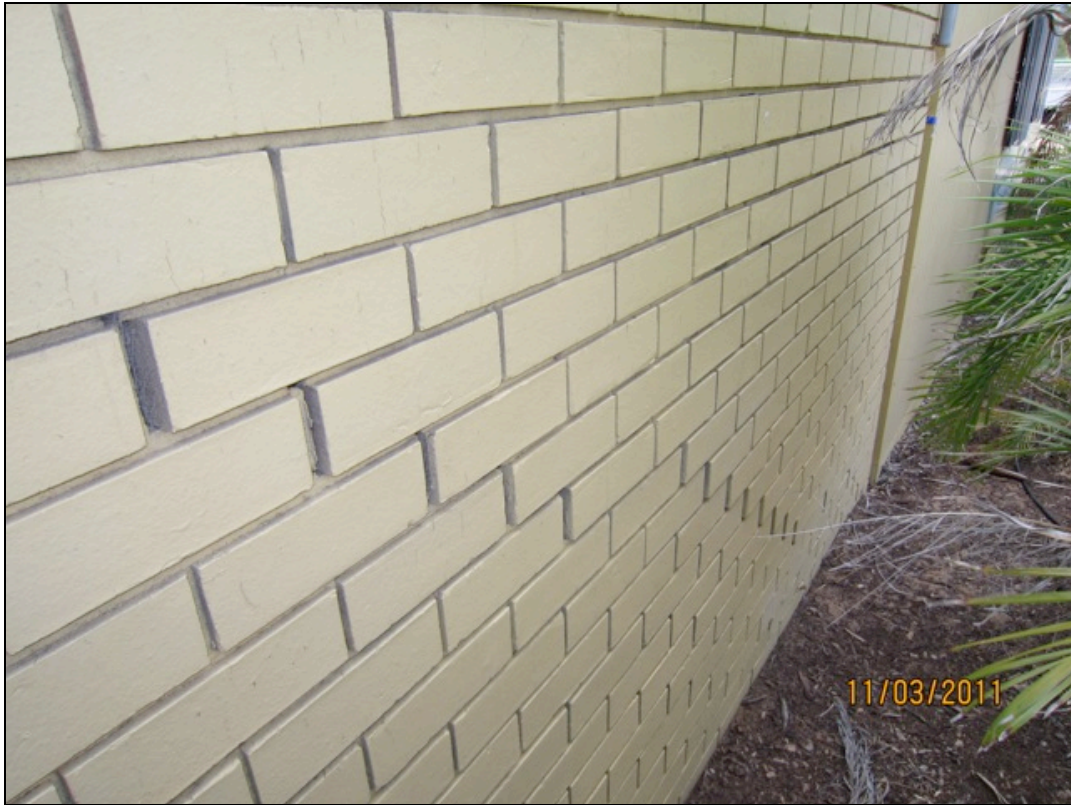
Photograph 5 – Cracking to brickwork

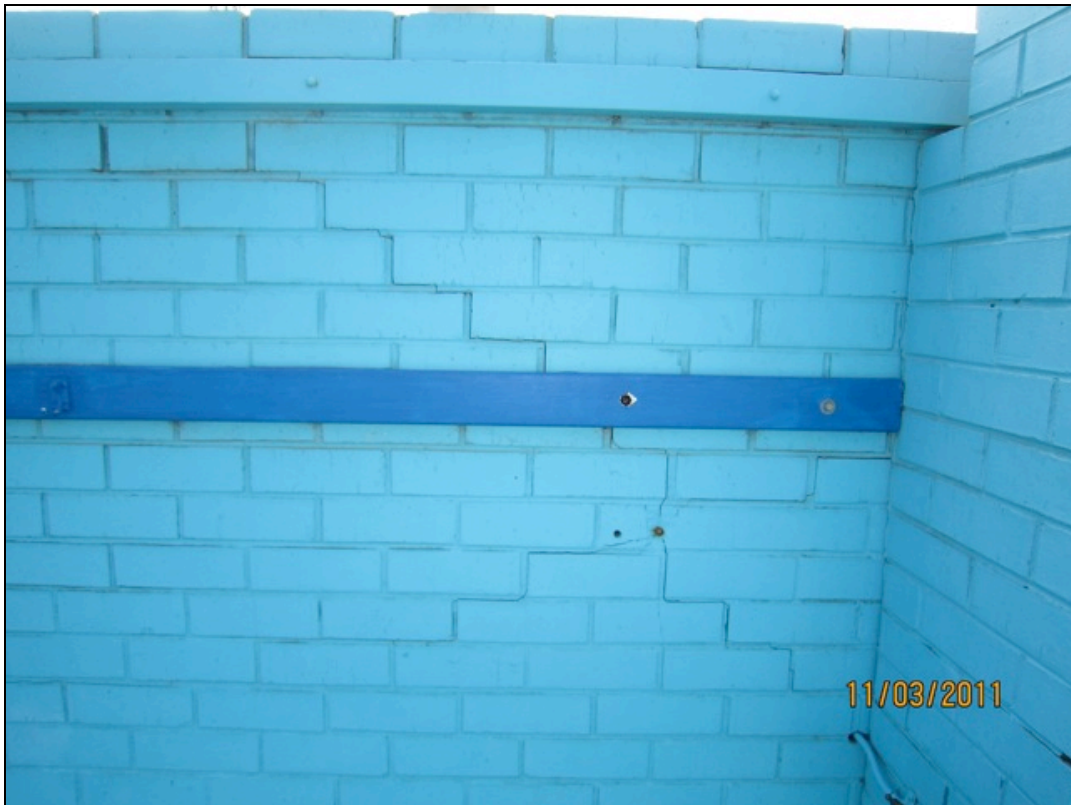
Photograph 6 - Cracking to brickwork
