BUILDING STRUCTURE REPORT

Structural Inspection and Report on Single Residence at 262 Chapman Road, Beresford, Geraldton WA.

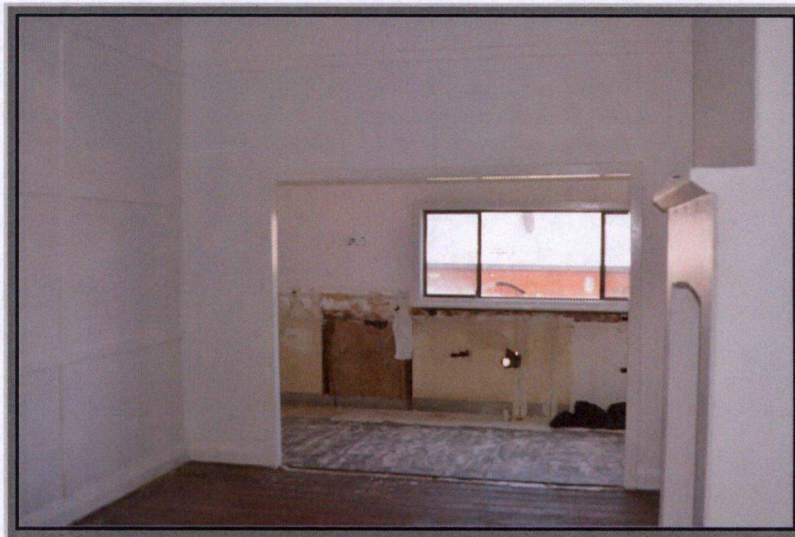
Plate 2 - Kitchen

The dwelling has no working kitchen and inoperable bathroom and toilet. As such, it cannot be legally occupied, either as a residence or a lettable unit.

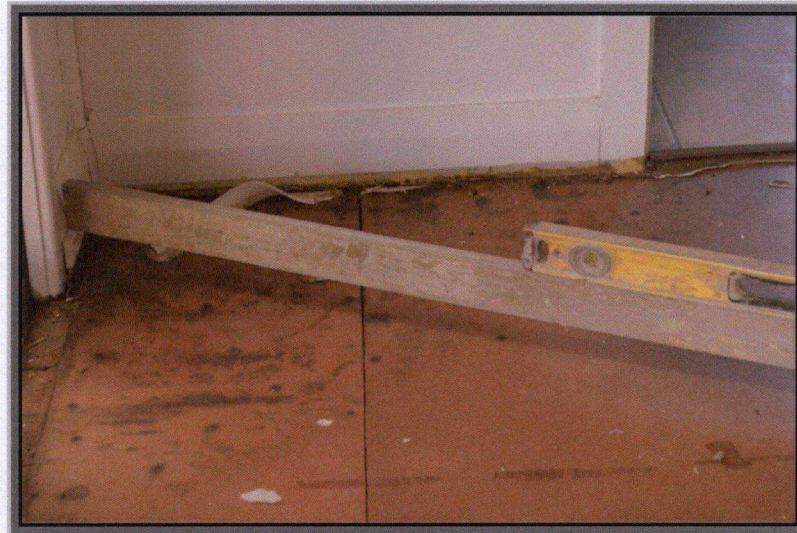
Plate 3 – Floor Subsidence

- The stumps and floor. These are timber and a considerable degree of subsidence has occurred in places that are beyond acceptable limits for floor construction.

Most of the floors have “domed” with some instances of settlement exceeding 100mm as shown in Plate 3. The stumps were not able to be closely examined, but those that were showed signs of rot and termite attack.

The **floors and stumps** require jacking, replacement, levelling and re-alignment. Due to limited headroom, this will only be achieved by removal of the floor in sections and systematic replacement of the structure. Most of the materials won't be able to be re-used and it is assessed that a 90% of this element's fabric will require demolition and replacement.

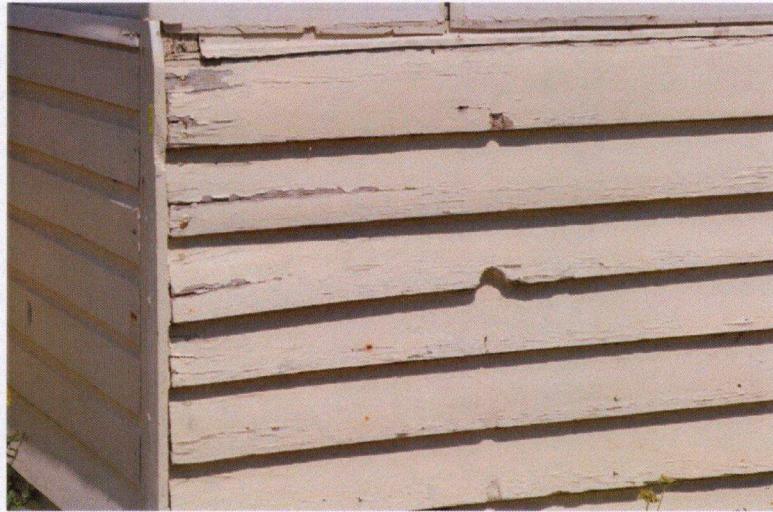
Plate 5 – Wall Cladding (weatherboard)

The weatherboard dado is in an aged condition demonstrating dry splitting, nail weariness and shrinkage. The type of weatherboard around the house varies and some is possibly not the original. The upper cladding is counter battened asbestos cement sheet which has eased in places and is in a generally weathered condition.

Internal cladding has been the subject of recent painting, however, there are signs of the sheeting easing or “letting go” of its attachments to the frame behind. There are also broken sheets.

The **walls and cladding** will require cladding removal and re-fixing of frame connections where nail weary or corroded beyond serviceable condition occurs. It is estimated that approximately 60% to 70% of this element's building fabric will be demolished and replaced.
