DATE: 10 February 2012. **Order/Ref No:**

JOB: Inspection of old timber frame house for structural adequacy.

ADDRESS: No. 18 Lewis Street, City of Greater Geraldton.

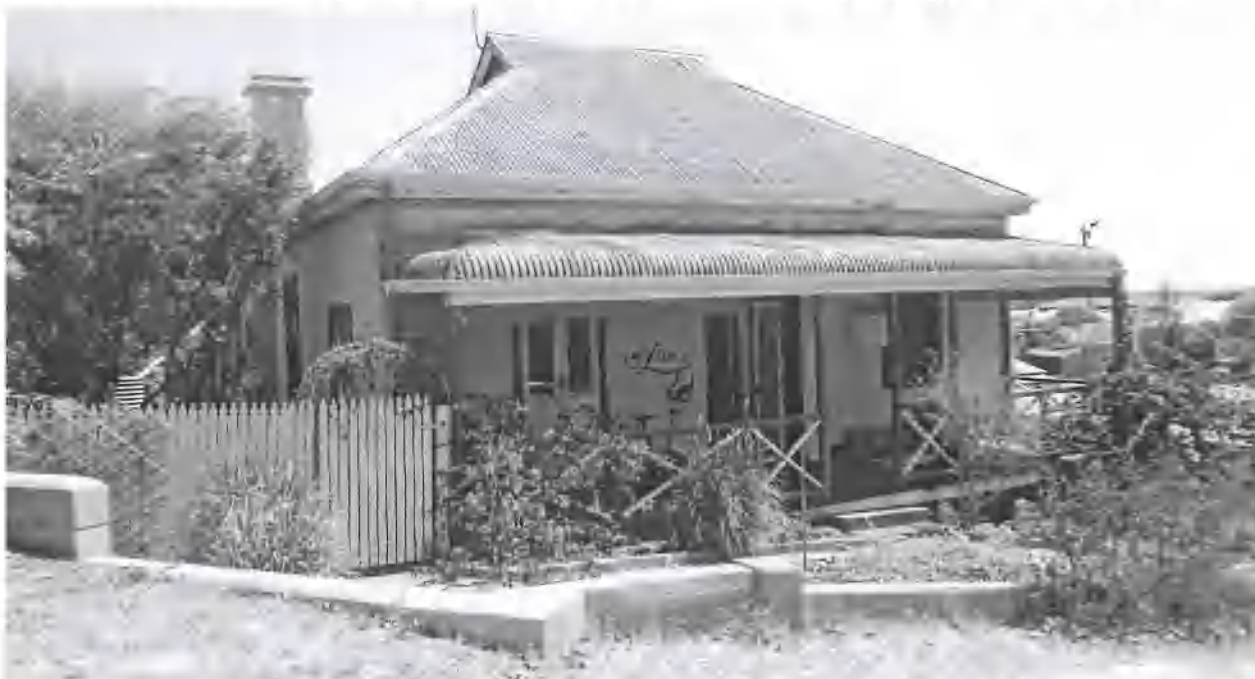
A termite report has already been done by 'Central West Pest Control' on 5 January 2012. It confirms my observations that there has been substantial termite damage. This is the North wall

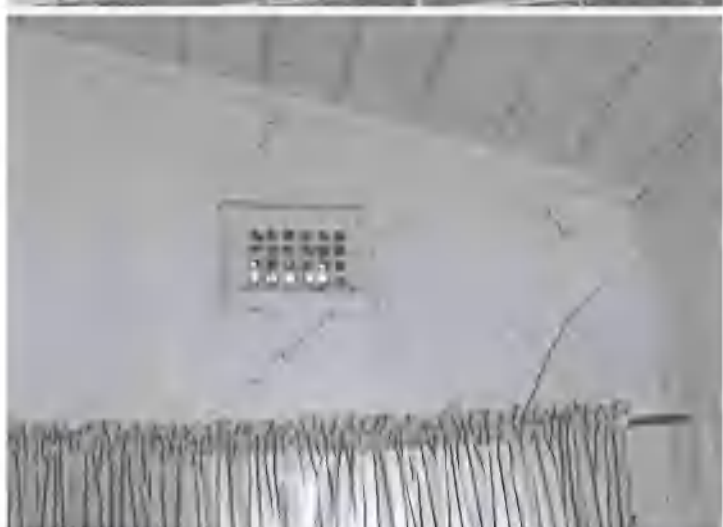
The next photo of cracks and eaves gap is a consequence of the tilting of the building, as the North side tries to resist the pull from the South.

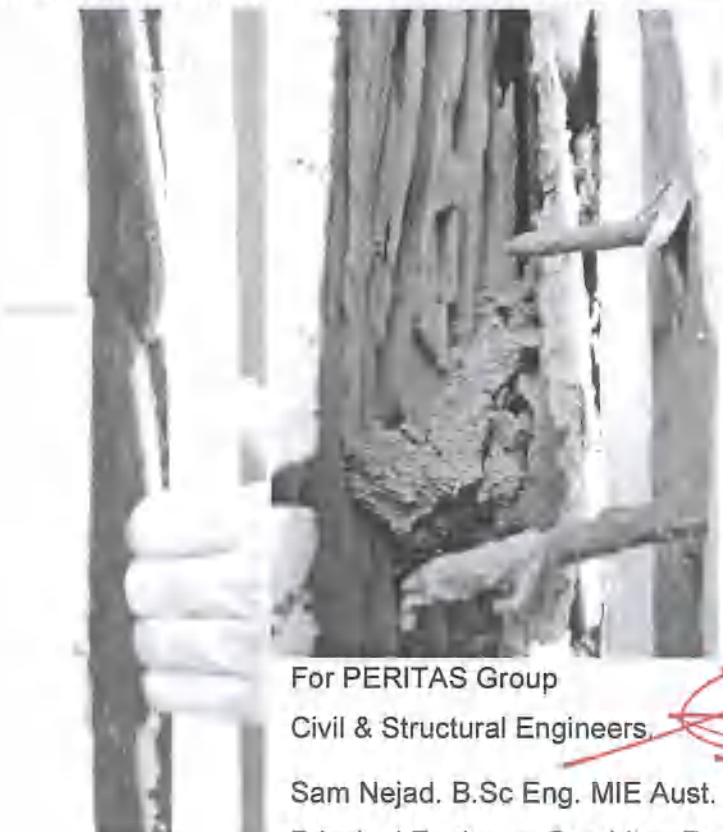
Finally, here is an example of the termite attack, the extent of which can only be determined by stripping the cladding. But it is evident that it is extensive and would be expensive and laborious to repair, leaving little of the original timber.

For satisfactory repairs there would have to be wide scale stripping of the cladding and floors, including joists and bearers.
