City of Greater Geraldton
The Rocks Building
Structural Condition Survey and
Concept Report

REP-001

Issue | 5 March 2018

Job number 259677

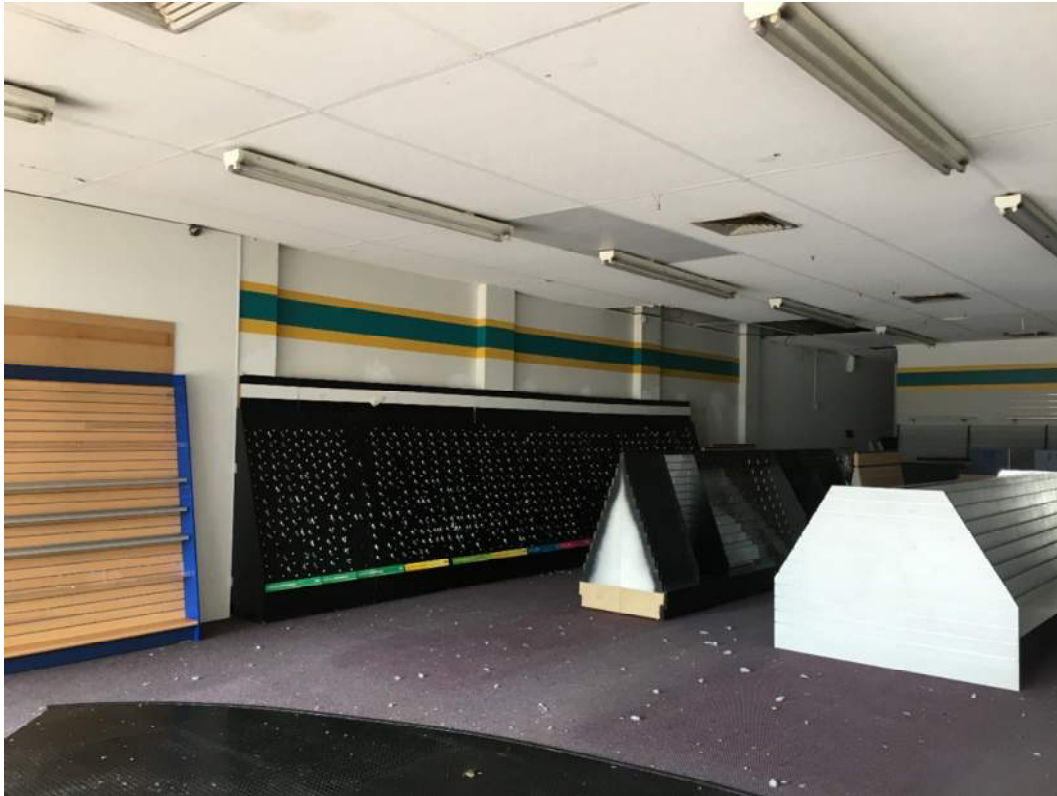
The building is supported by masonry walls along its long axis. It is understood that the wall on the south-west side of the wall is a party wall supporting both the building and the adjacent property at 110 Marine Terrace. Along the length of this wall are a number of masonry piers (approximately 500mm long) which coincide with the roof truss locations. It is therefore assumed that the loads from the roof trusses is transferred directly down these piers. These piers can be seen in Figure 2.

Figure 2: View of front space of building looking west

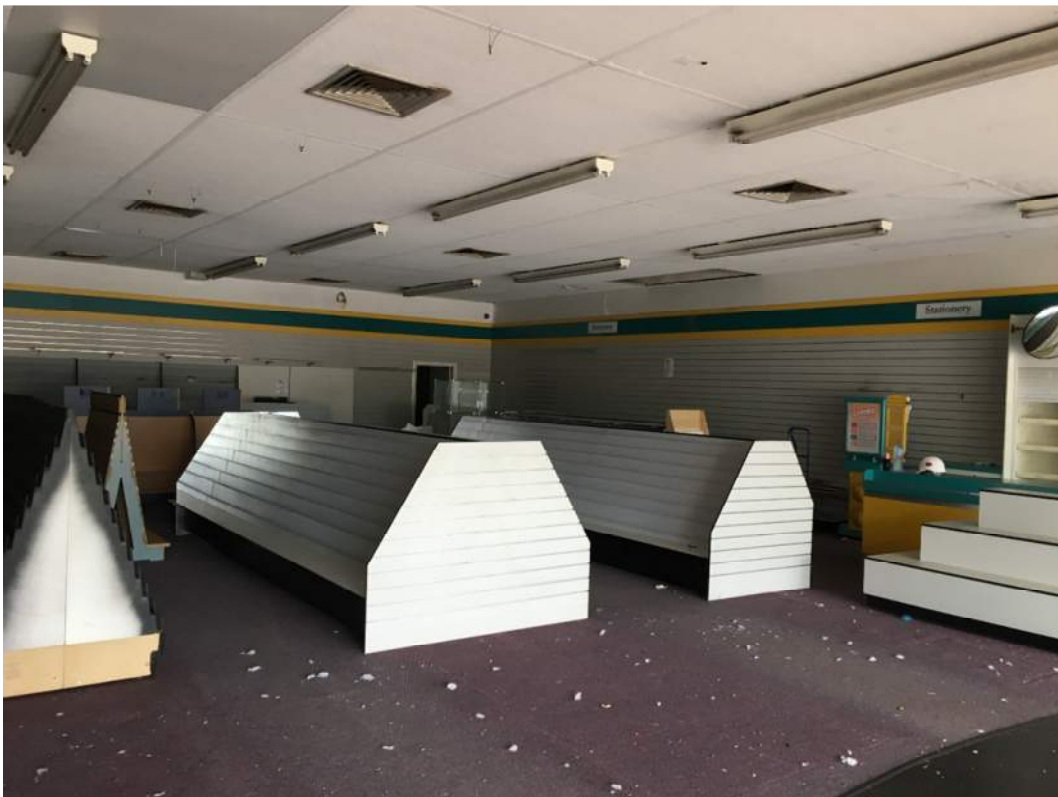
On the other side of the building, there is a gap between the building and the adjacent property at 106 Marine Terrace and therefore the masonry wall is only supporting the roof of the building. There are no masonry piers visible in the front section of the building (as seen in Figure 5), however there are two piers in the rear section of the building, once again at the locations of the roof trusses. It is assumed that the section of wall with piers is a later extension. One of the piers can be seen in Figure 11. Arup surmised that there are masonry piers on the outside of the building (in the gap between the building and adjacent property) which will be used to support the roof trusses.

Figure 5: View of front space of building looking north

2. Confirm that the masonry wall on the north-eastern side of the building (adjacent to 106 Marine Terrace) has masonry piers built in the gap between the two buildings.

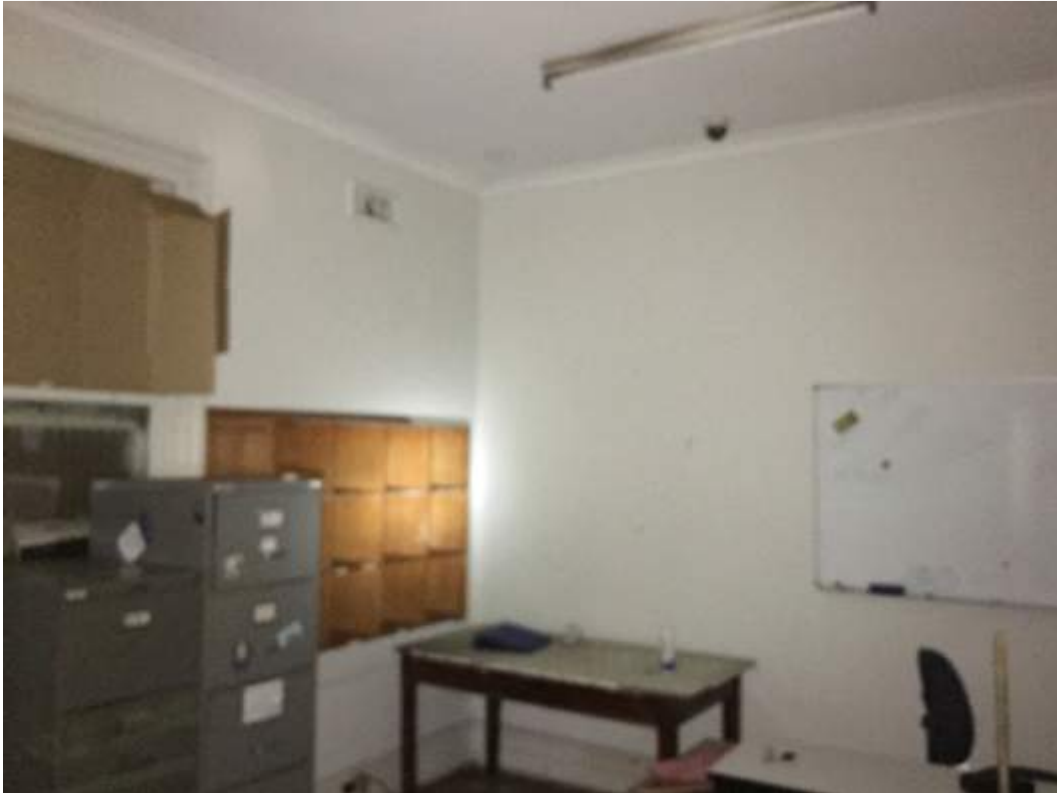
On the northern side of the building, there are a number of masonry walls which form a room. This area is seen in Figure 8. Finally, there is a masonry wall spanning across the width of the building, as seen in Figure 10 and Figure 11. This wall is located towards the rear of the building and is assumed to have once been the end of the building, prior to an extension. None of these walls extend up to the roof line, or support the roof structure and therefore can be removed.

Figure 8: View of central space of building looking north

The internal masonry walls that form the internal room and separate the back of house area and storage area are currently not supporting the roof of the building and therefore can also be demolished. Furthermore, the toilet block/kitchen area at the rear of the building can also be demolished, however the end masonry wall of the building is currently supporting the roof and can't be removed at this stage.

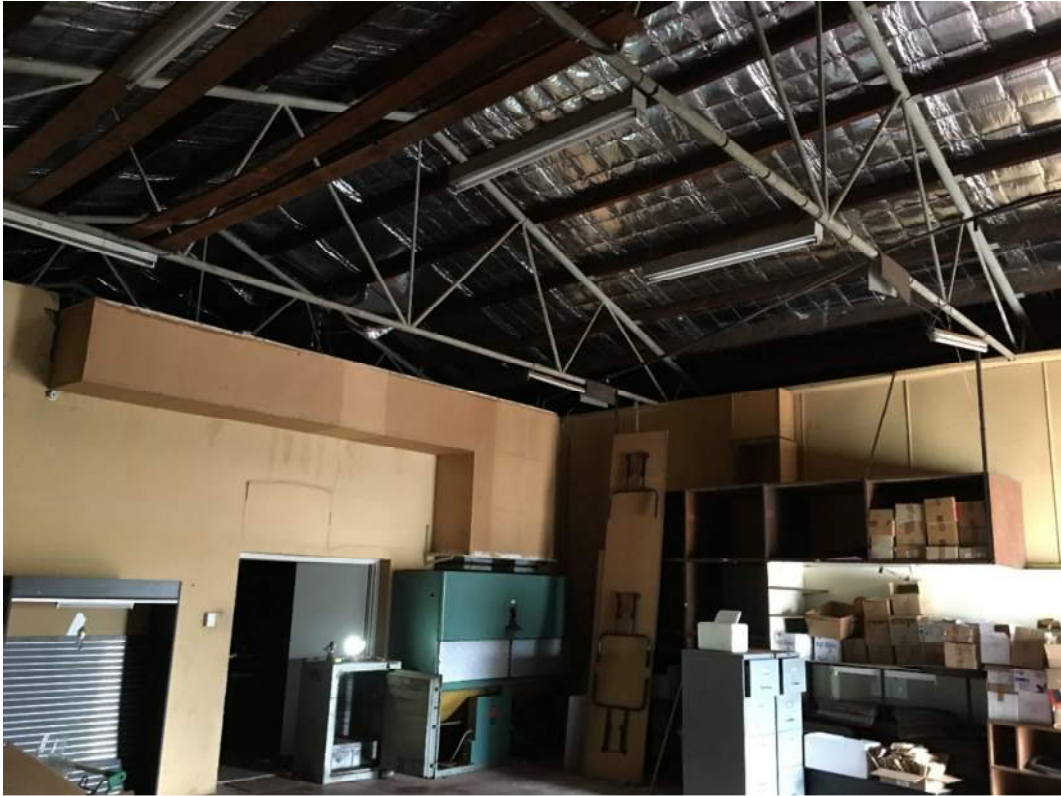
Figure 10: View of rear space of building looking south

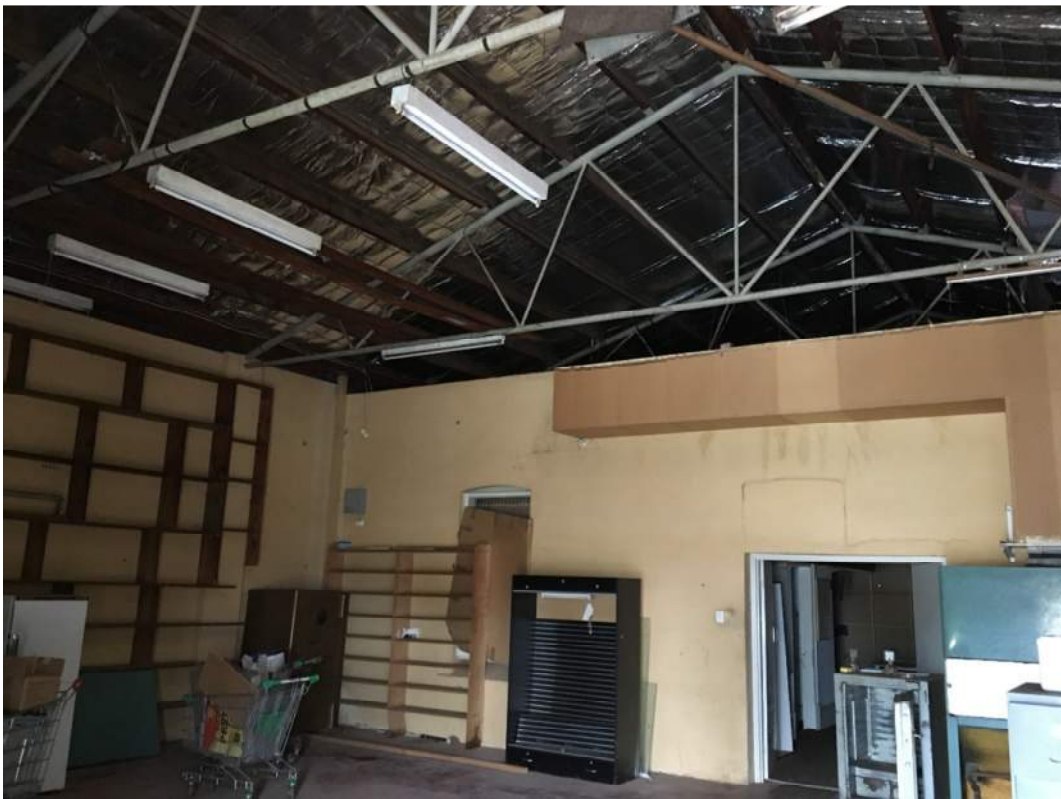
Figure 11: View of rear space of building looking east

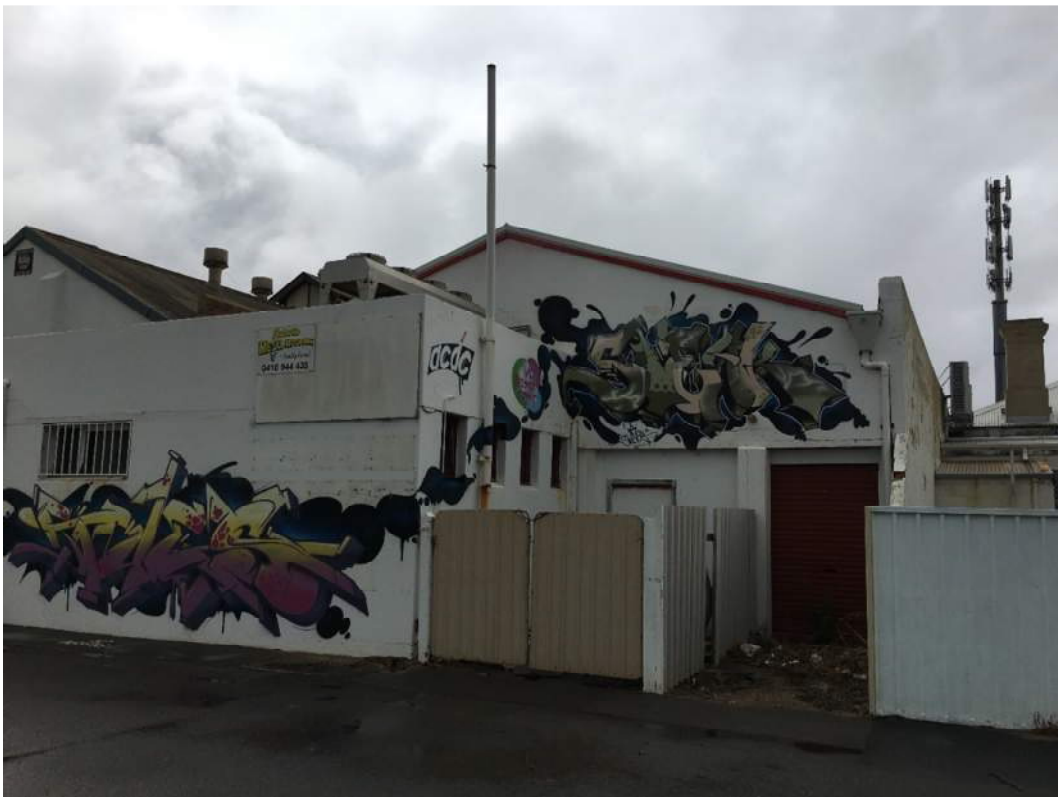
There is also a kitchen and toilet at the very rear of the building. These areas can be seen in Figure 13. It is understood that this area will be demolished as part of the modifications of the building.

Figure 13: View of rear of building

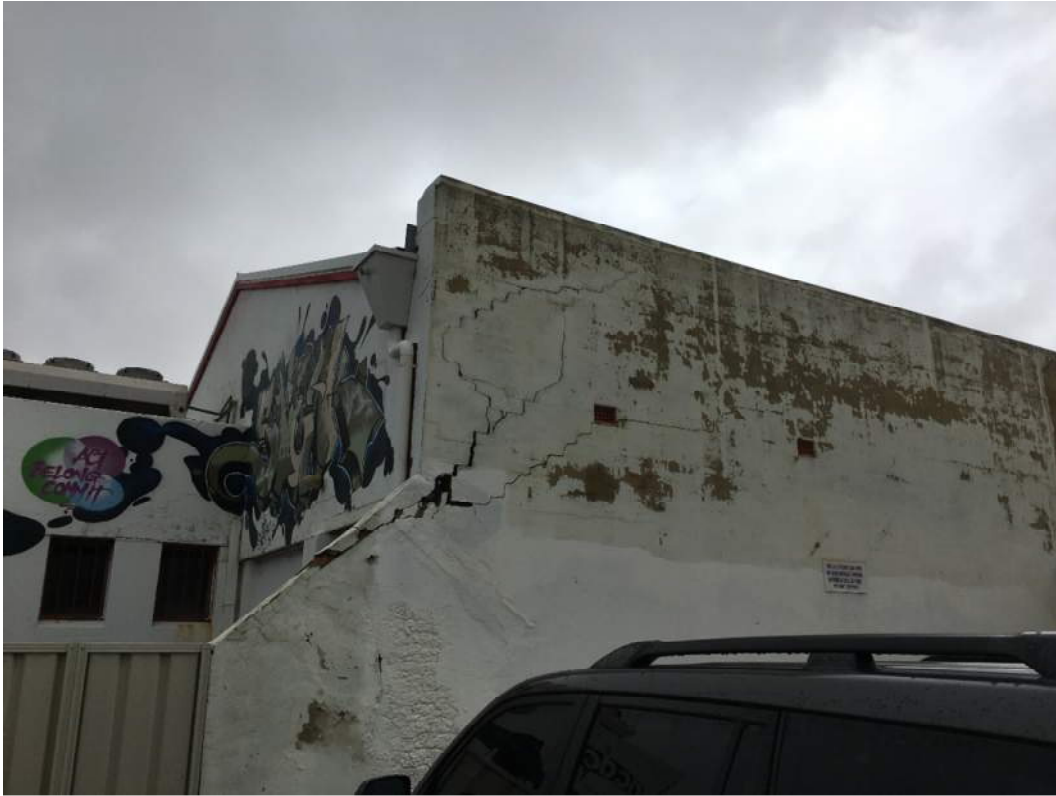
Typically, where visible, the masonry walls appear to be in good condition. The one exception to this is at the rear of the building. On the south-west corner, there is significant cracking of the masonry wall. This can be seen in Figure 14 and

Figure 14: Extent of cracking of masonry wall on western corner of building

Figure 15. Depending on the proposed modifications to the building, these cracks may need to be repaired as part of the works.

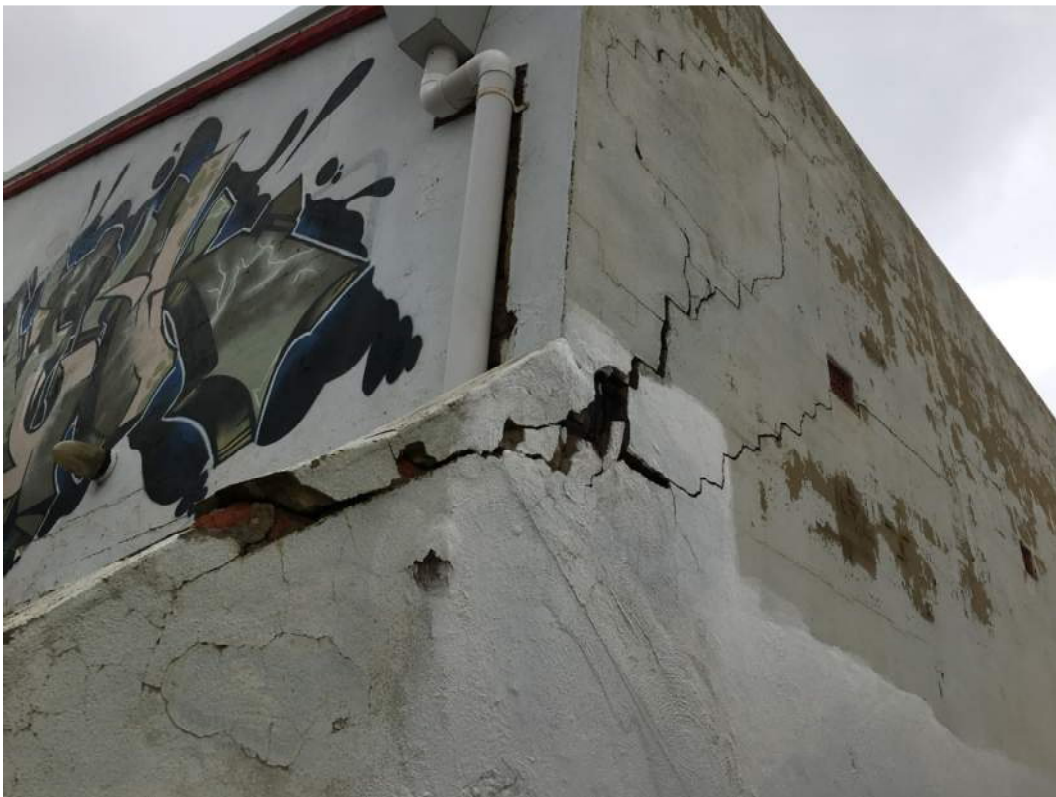
Figure 15: Closeup of cracking of masonry wall on western corner of building

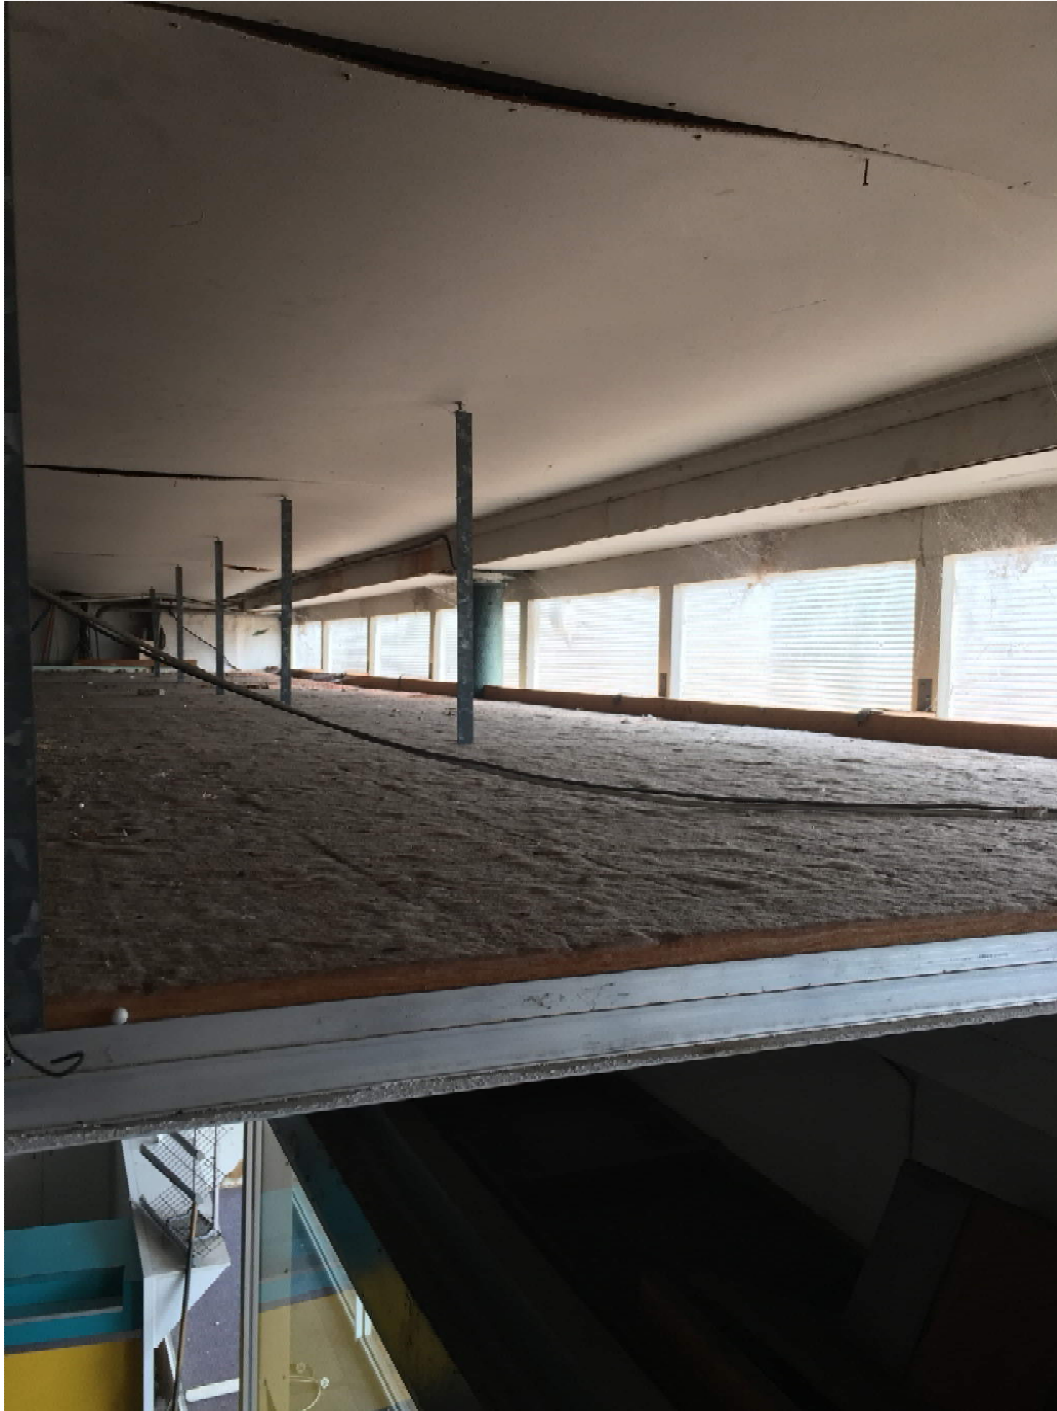
The Marine Terrace Shop Front consists of a glazed shop front with a lightweight canopy and masonry parapet, which can be seen in Figure 1. The condition of the masonry parapet is unknown as this area in the roof space was not safely accessible, however the area below the tin ceiling can be seen in Figure 16.

Figure 16: Shop front between plasterboard ceiling and tin ceiling

3. Further investigation should be made into how the building parapet and canopy is supported. This can be done by removing a section of the pressed tin ceiling to allow access into the roof space adjacent to the shop front. Further investigation will determine if any strengthening works is required to the parapet or canopy.

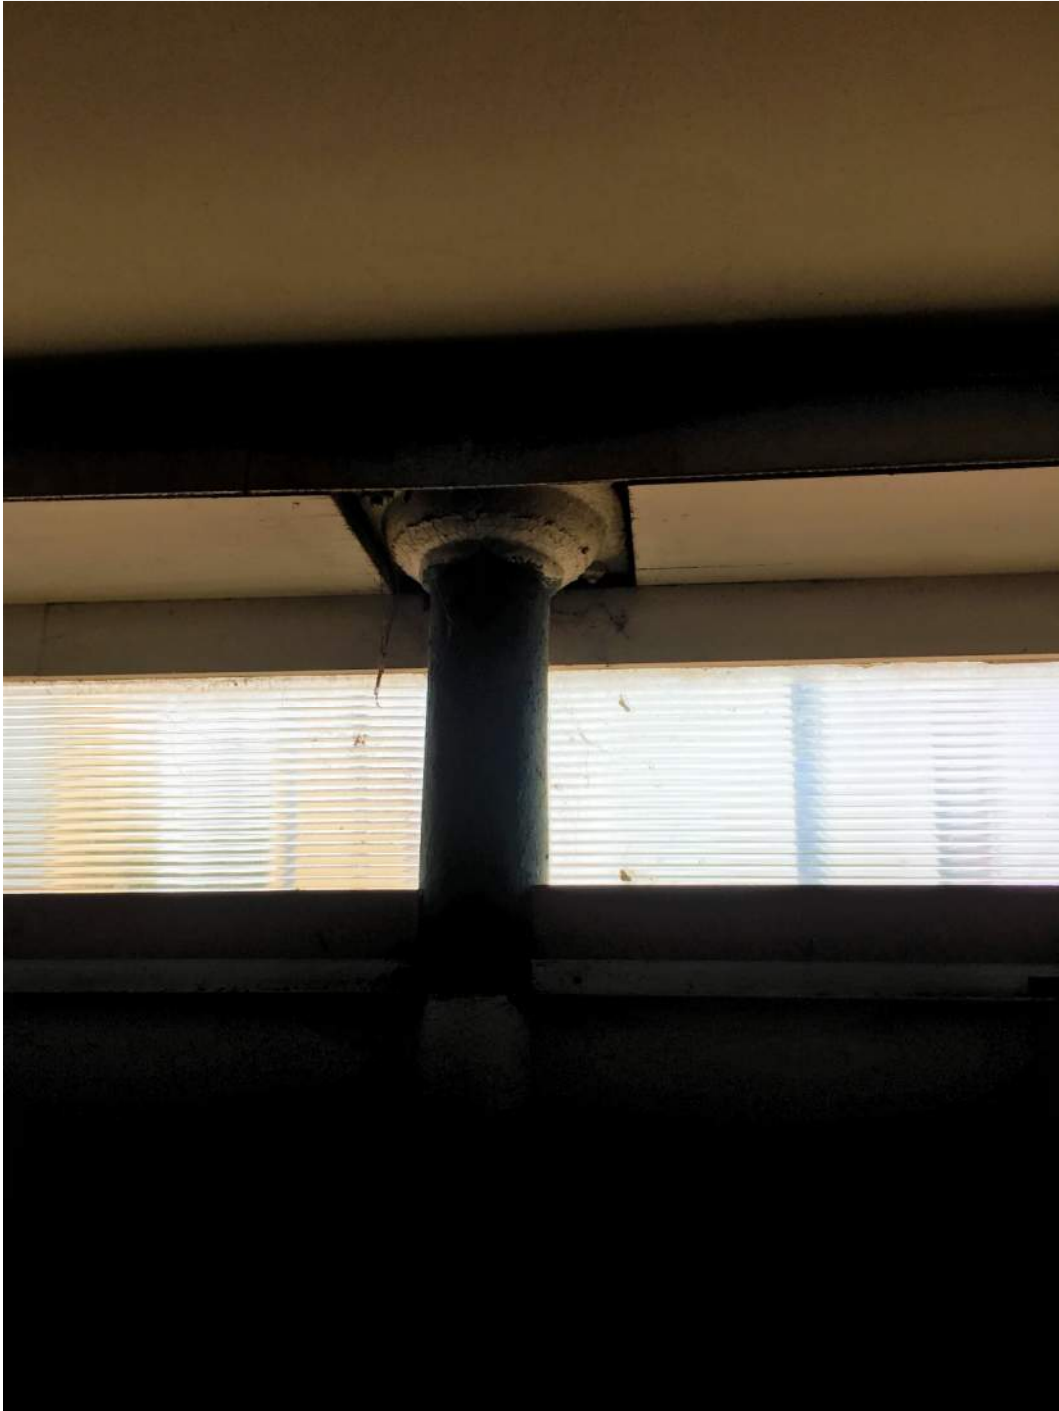
The parapet and canopy are supported on two steel columns, which are currently located on either side of the entrance doorways. One of the column heads can be seen in Figure 17.

Figure 17: Column head supporting shop front

The glazing of the shop front and the masonry below the glazing can be removed to open up the Marine Terrace entrance way to the thoroughfare provided the investigation into how the parapet and canopy are supported are undertaken. Furthermore, the steel columns, currently on either side of the shop front entrance way are to remain.

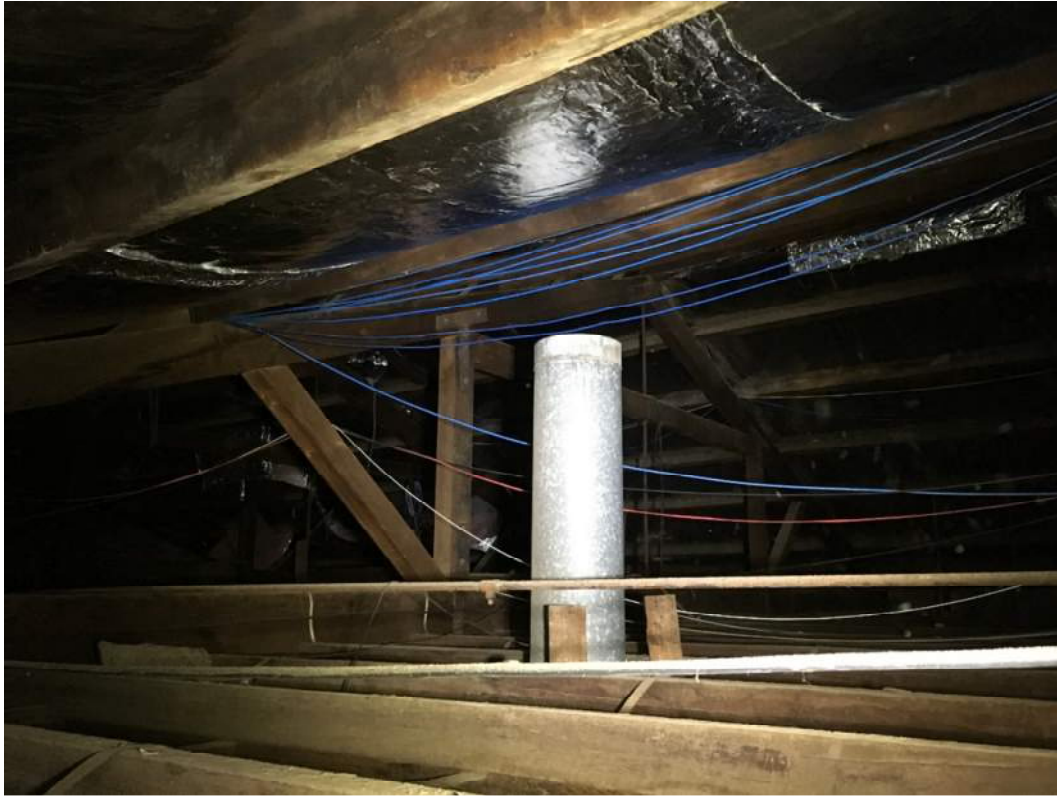
There are five timber trusses in the front of the building. These are constructed from 190x90mm timber sections in the top chords of the truss and 290x90mm timber sections of the bottom chords of the truss. The internal elements could not be measured as safe access to these elements could not be made. The timber trusses can be seen in Figure 18 and Figure 19.

Figure 18: Overall view of timber roof truss

4. The full dimensions of both the steel and timber roof trusses should be determined so that a complete structural review can be undertaken of the trusses to determine their structural adequacy for the new wind loads. This would include full measurements of the section sizes and geometry of both steel and timber trusses, and determination of the wall thicknesses of the steel truss elements.

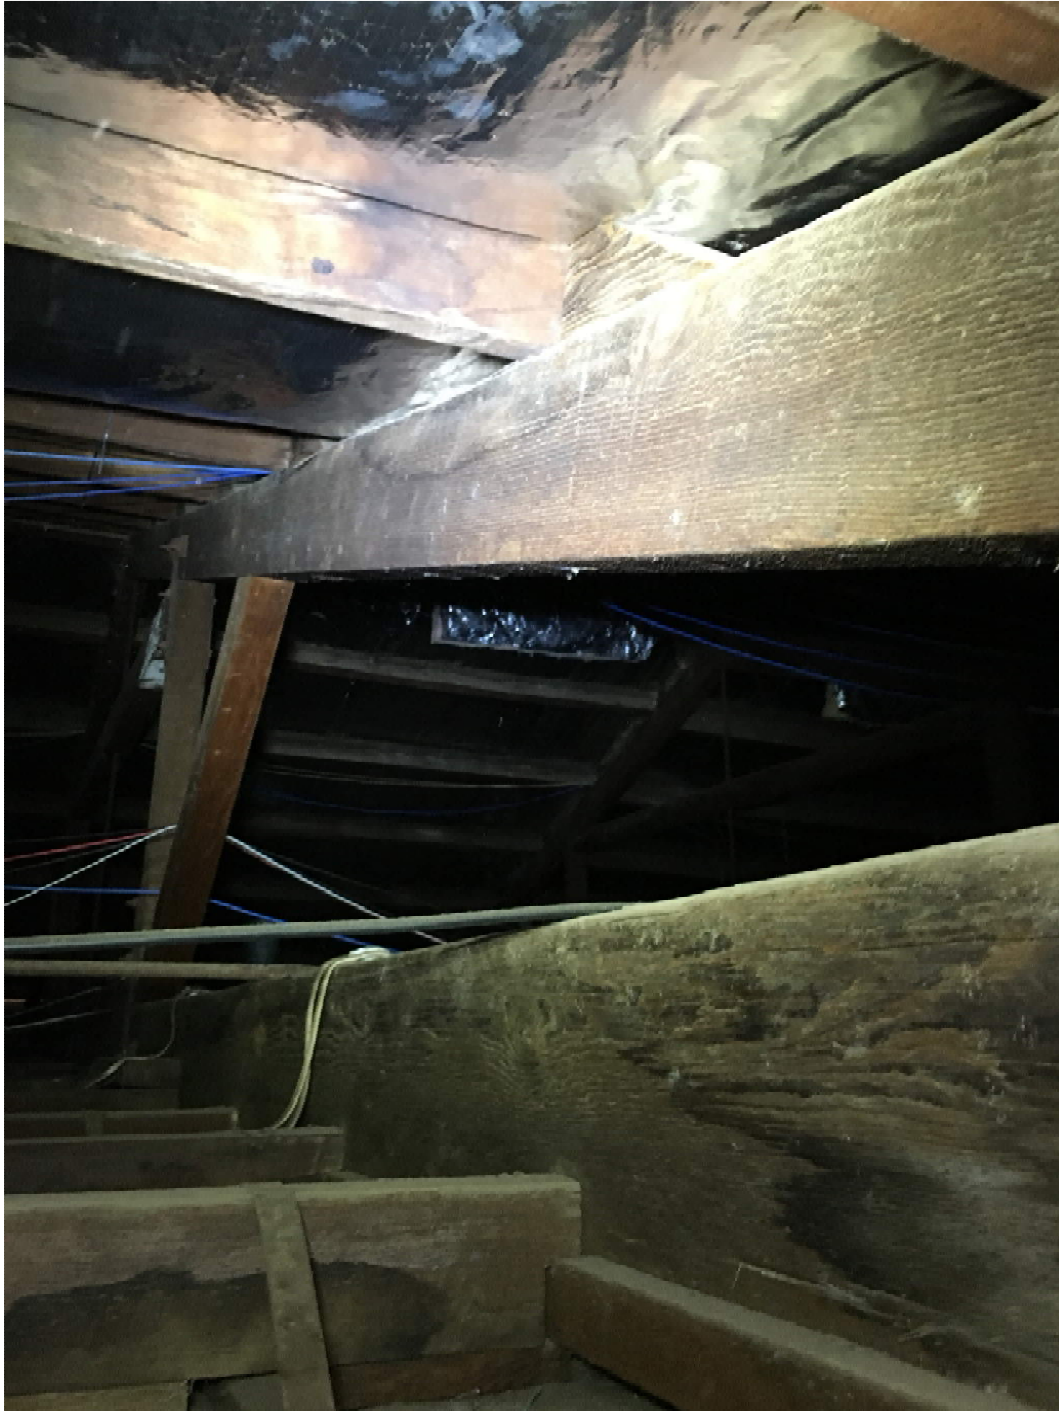
Figure 19: Close-up of Timber Truss

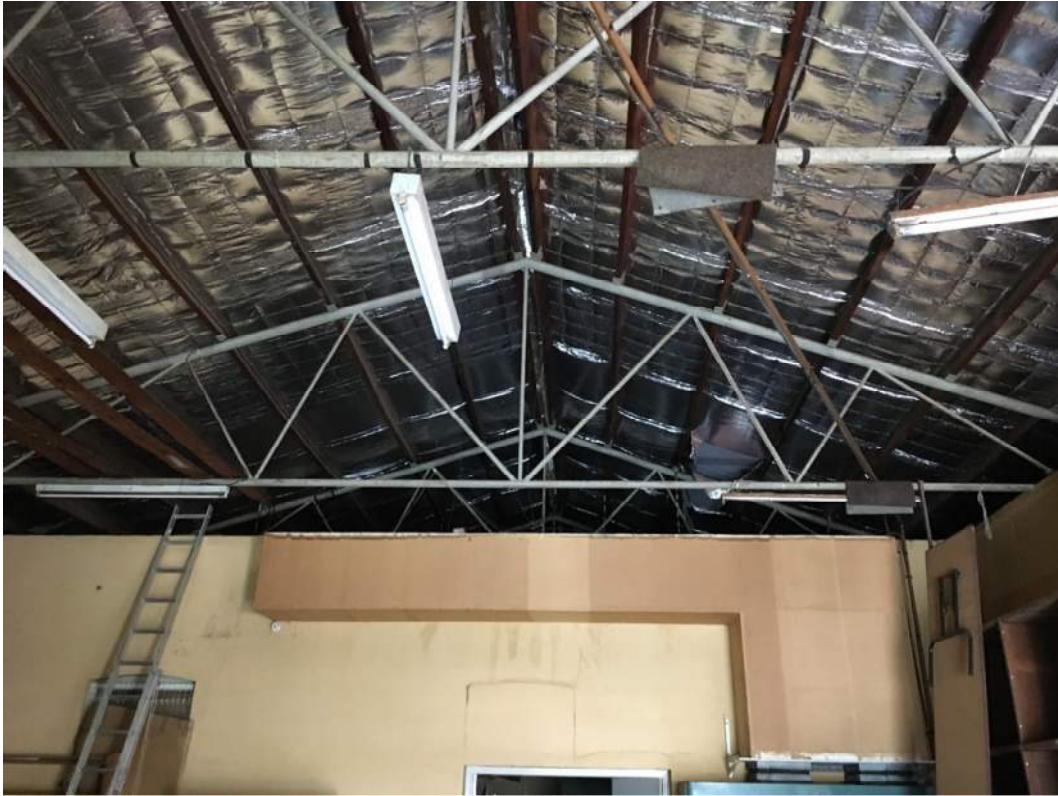
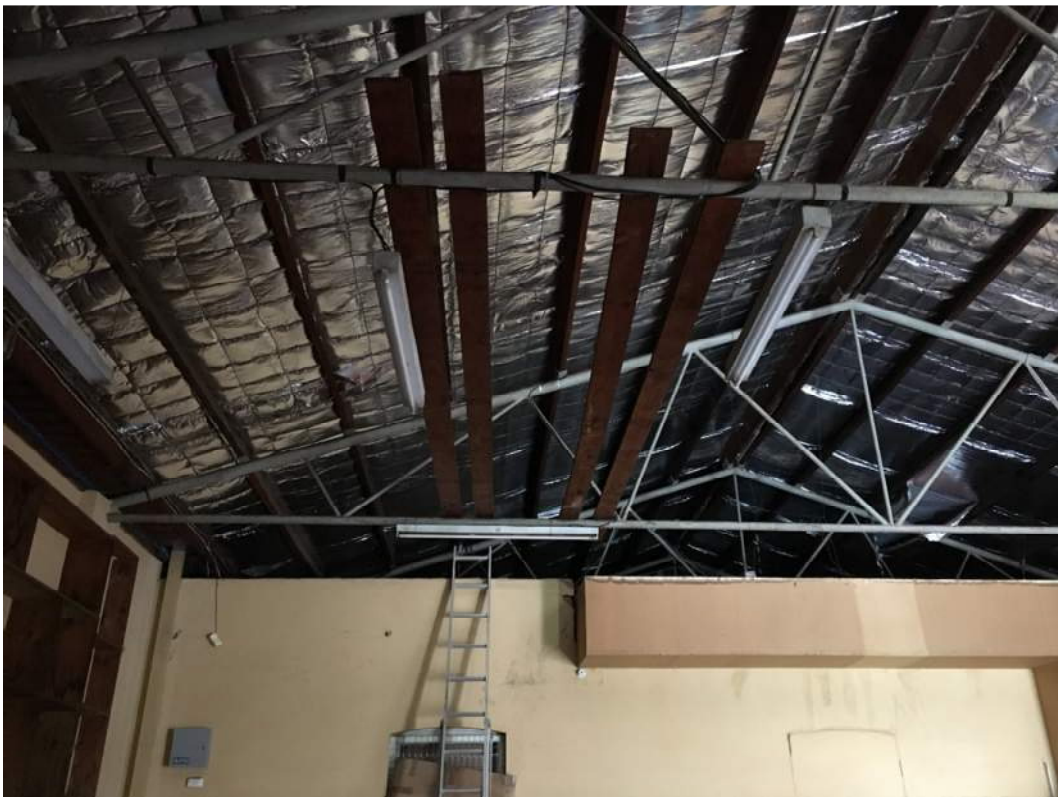
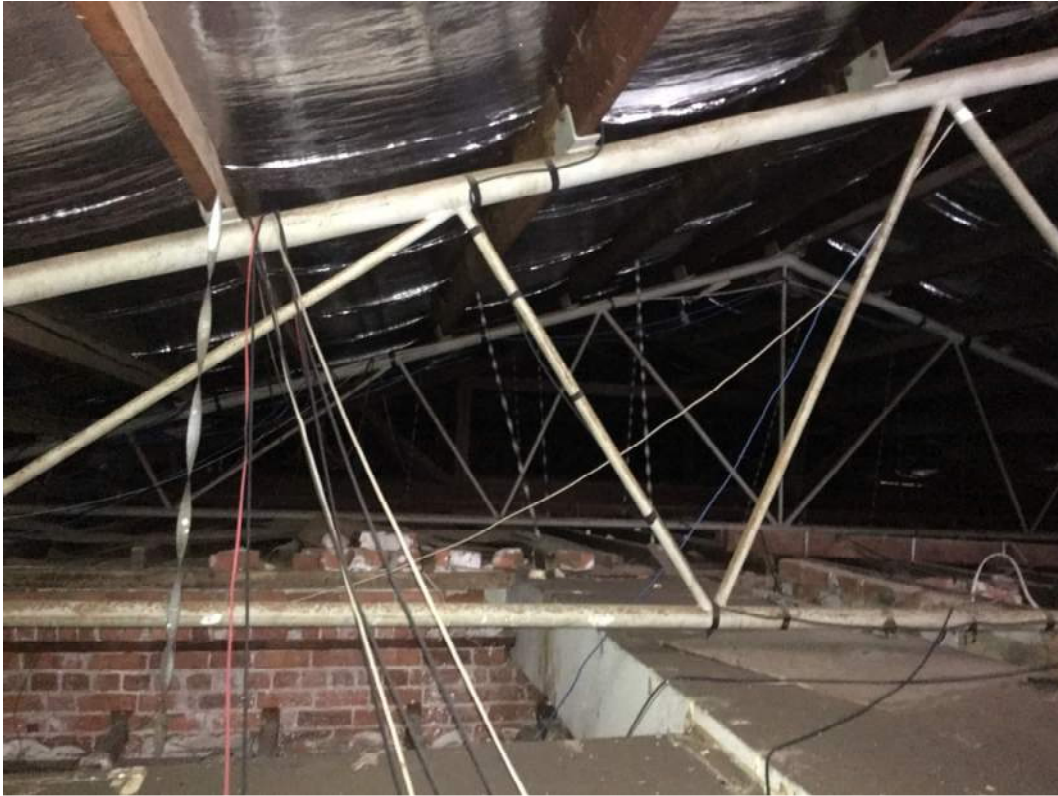
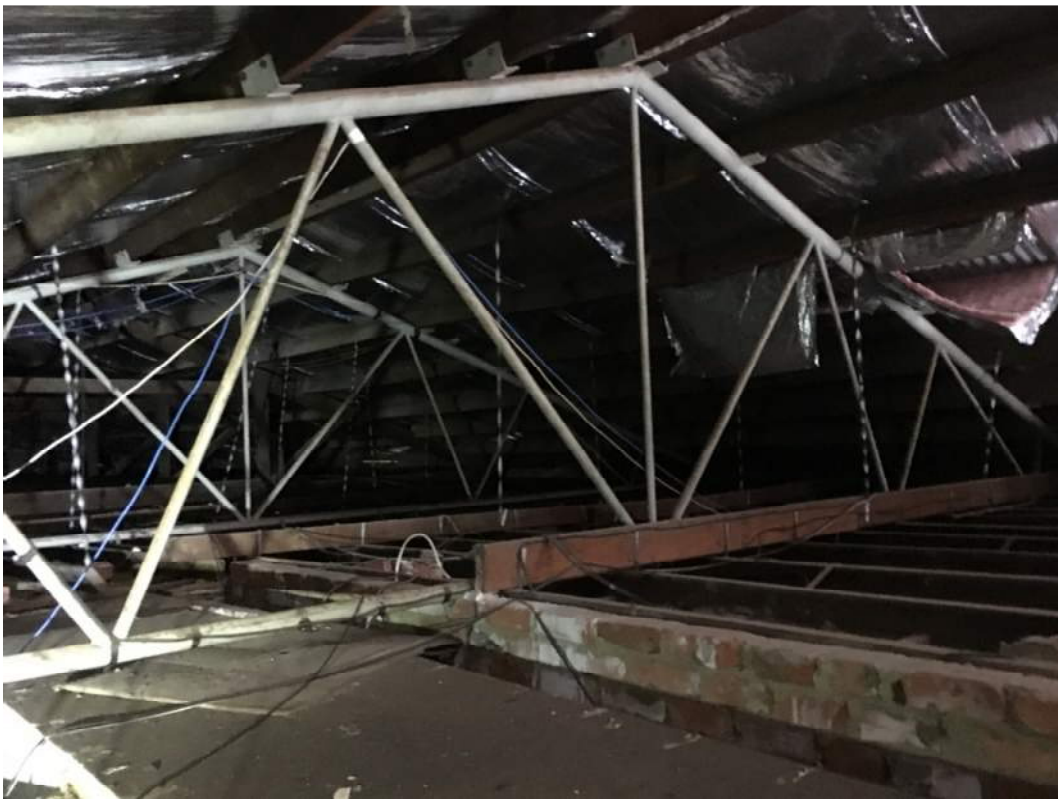
There are an additional four steel trusses in the rear of the building. These are constructed from steel circular hollow sections welded together to form the truss. The top chords of the truss are constructed from 89mm diameter tubes, the bottom chords are constructed from 60mm diameter tubes and the diagonals within the truss are constructed from 33mm diameter tubes. The wall thicknesses of these tubes could not be determined during the inspection. The steel trusses can be seen in Figure 20 to Figure 23.

Figure 20: Steel truss from ground level

Figure 21: Steel truss from ground level

Figure 22: Closeout of steel truss

Figure 23: Closeout of steel truss

Due to the proximity of the building to the ocean, there is a high risk of corrosion of steel elements due to salt spray. This is further increased as the building will be opened up and therefore salt spray will be able to directly settle on the steel elements. It is likely that all structural steel elements including, but not limited to, the steel trusses, front columns, tie-downs and any steel connection plates within the truss will need to be re-painted in a suitable corrosion protection paint.

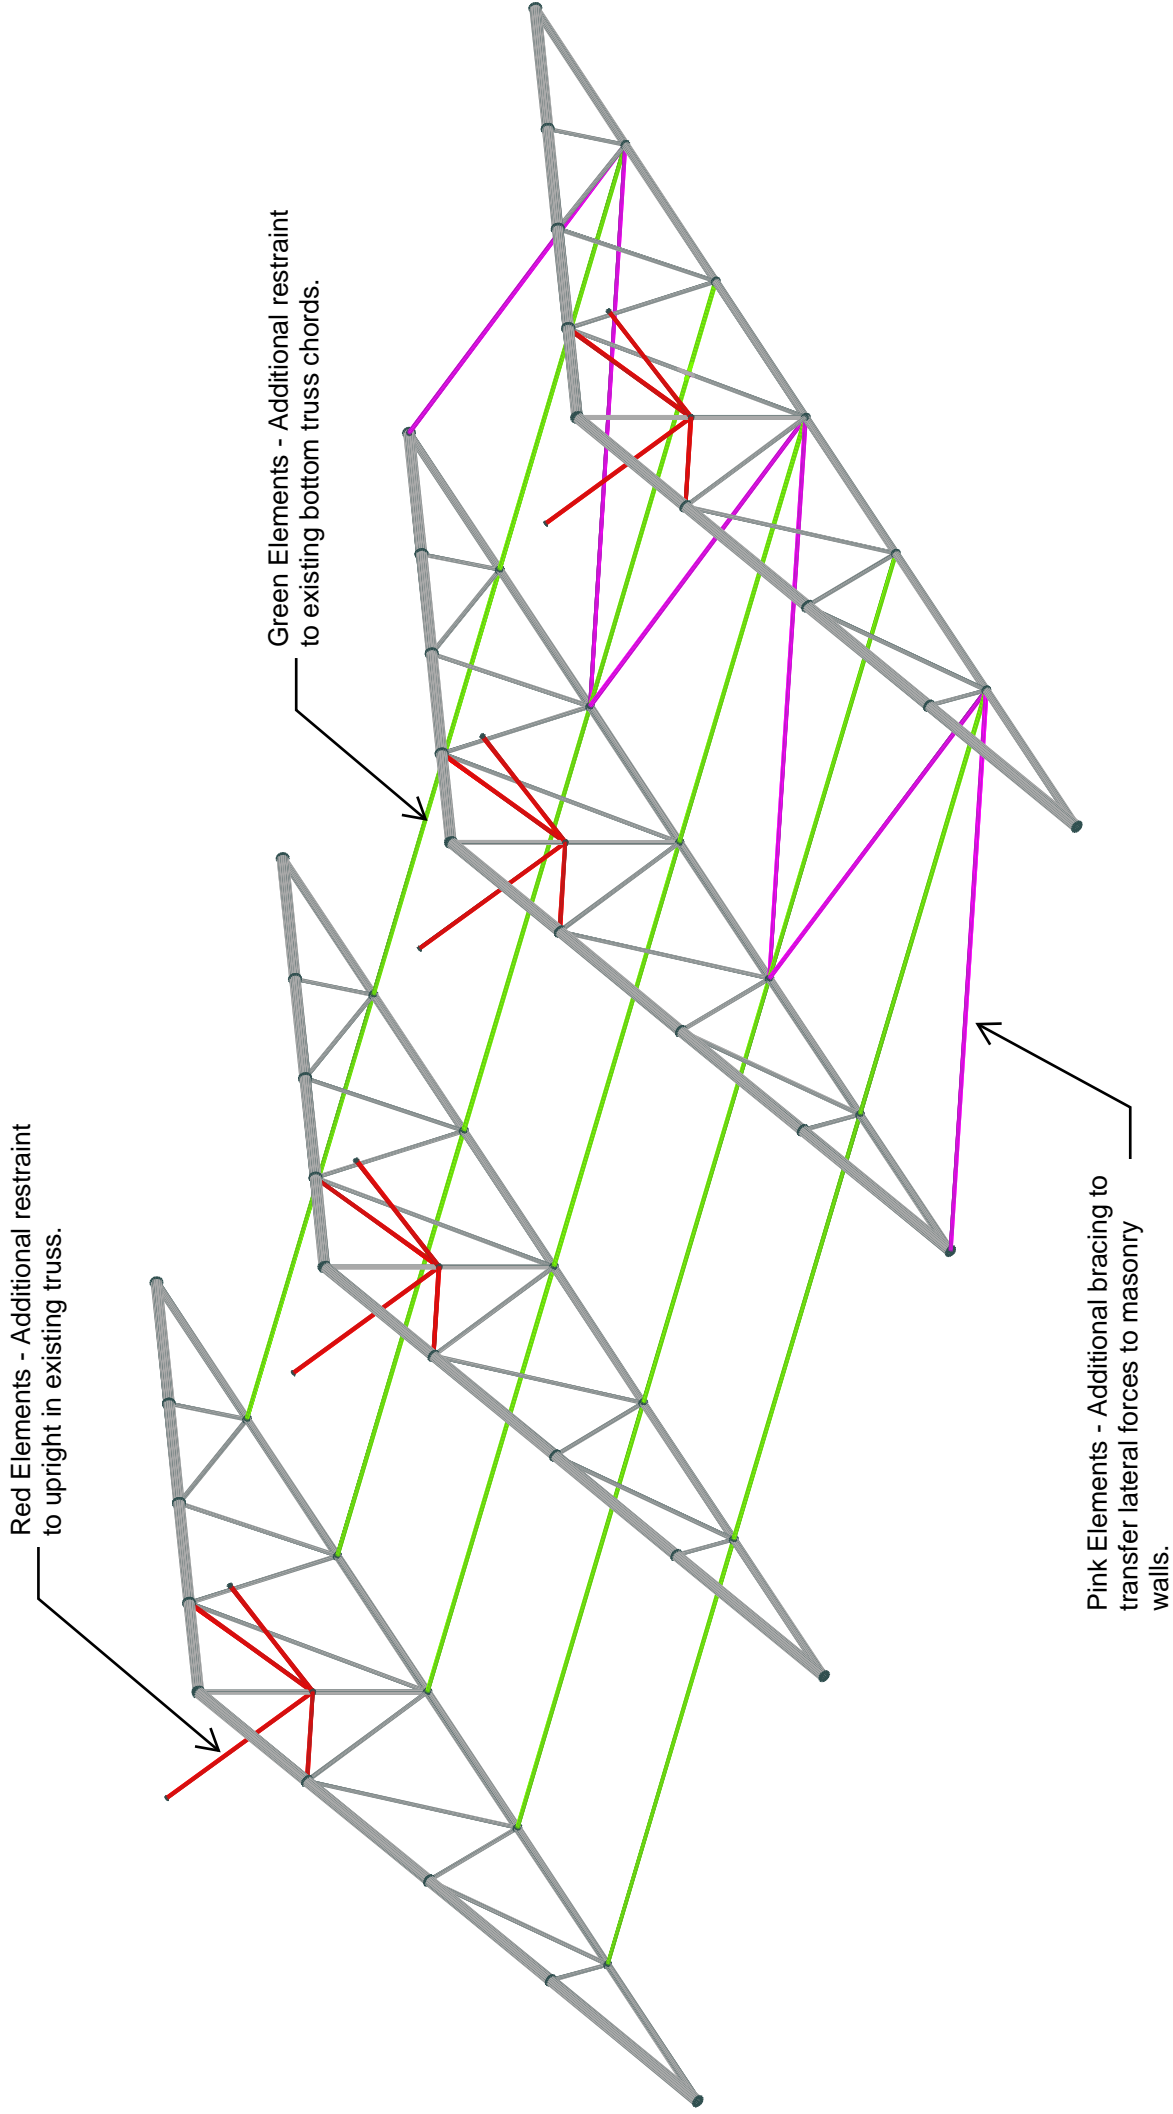
Possible Strengthening Works to Steel Trusses

The bottom truss chord is constructed from a steel 48mm diameter circular hollow section. The wall thickness is unknown. There is no 48mm diameter circular hollow section which has sufficient capacity to resist the increased loads on the truss without additional restraint being provided to the bottom chord for buckling. This could be achieved by tying the bottom chords of the steel trusses together horizontally and providing lateral bracing to the longitudinal masonry walls. This can be seen as the green and pink elements in the markup in Appendix C.

The exception to this is the central upright, which spans between the bottom truss chord and the highest point to the top truss chord. This section does not have enough capacity for the increased wind loads without strengthening works. This could be achieved by bracing the centre of the upright in both directions to the primary structure. This can be seen as the red elements in the markup in Appendix C.
