REMOVAL OF HERITAGE LISTED PLACE – 140 FLORES ROAD, WEBBERTON

REPORT

ATTACHMENT 3

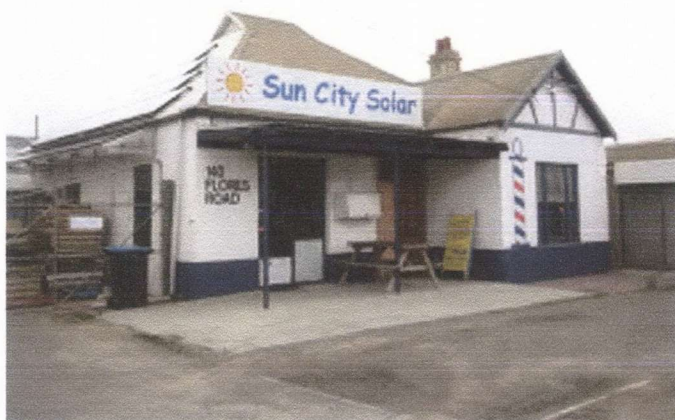
26/06/2009
Tanya Henkel
Verandah posts replaced and solar panels mounted to northern roof.

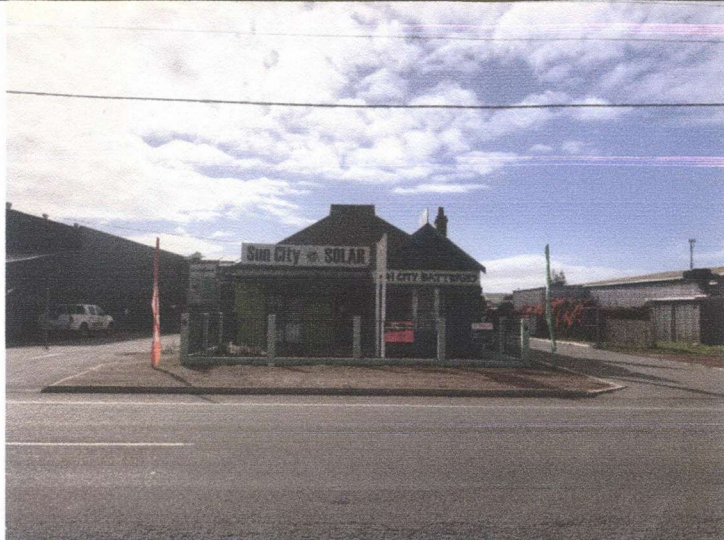
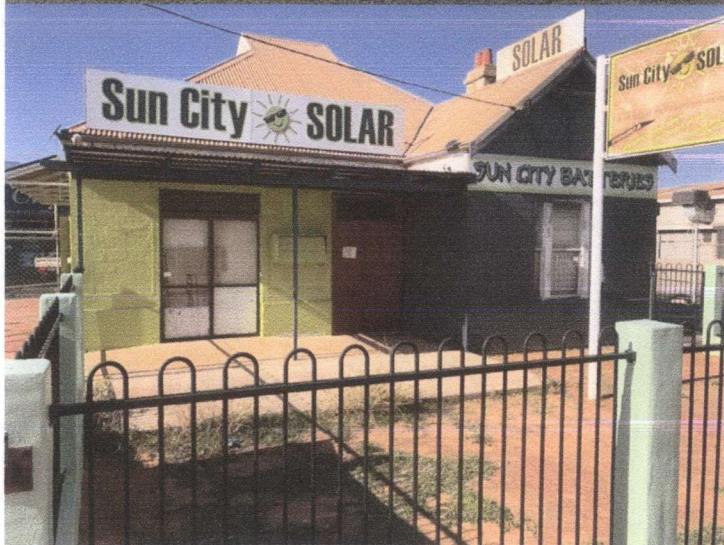
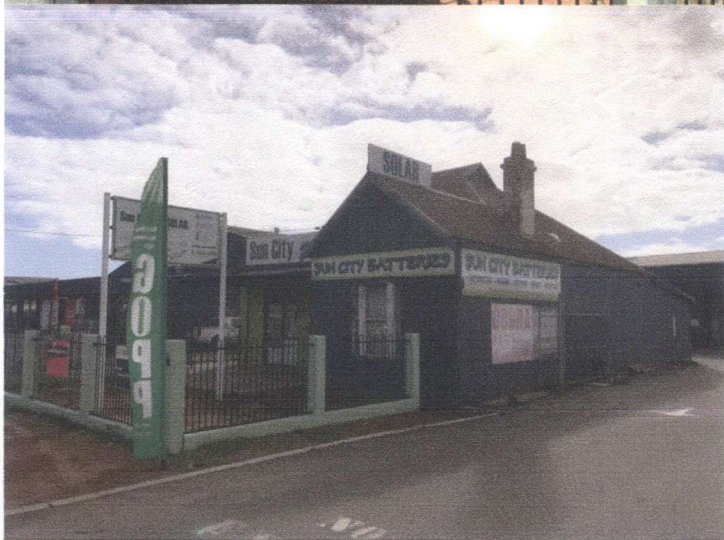
WESTERN (FRONT) ELEVATION

- Front elevation as viewed from front of the property on the eastern side of Flores Road
- Original roof line and chimney still maintained
- Addition of signage to advertise the presence of the business upon the lot.
- Façade has been painted in colours that match with the colour theme of the business

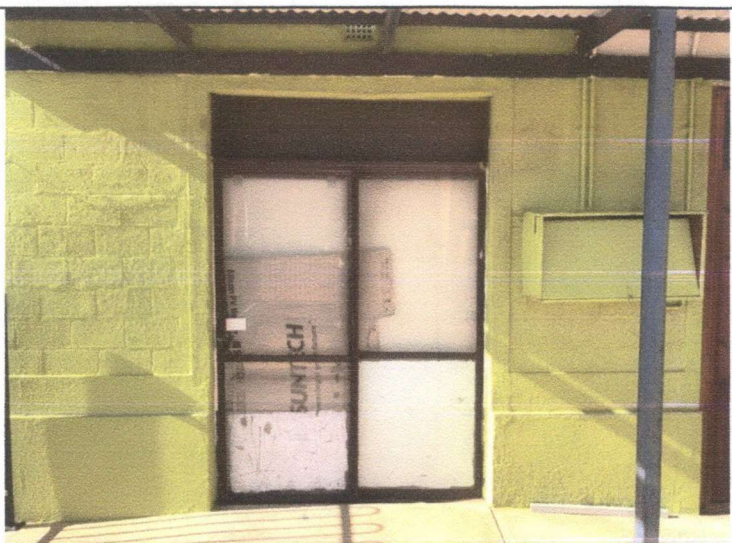
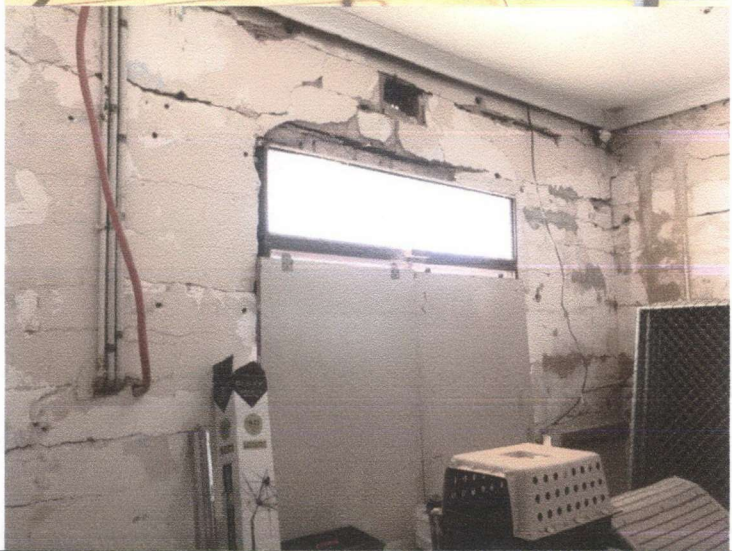
- Northern side of front elevation
- Front elevation has been modified with a large front window
- Lintel above window is visibly bowing
- Electrical box can be seen attached to the front of the building although no electrical wiring is still functional within the building with the electricity turned off to this building and the fixtures and wiring mostly removed
- Bottom photo is the view of the window from the inside of the building to demonstrate the extensive deterioration and risk of collapse of this wall over the opening

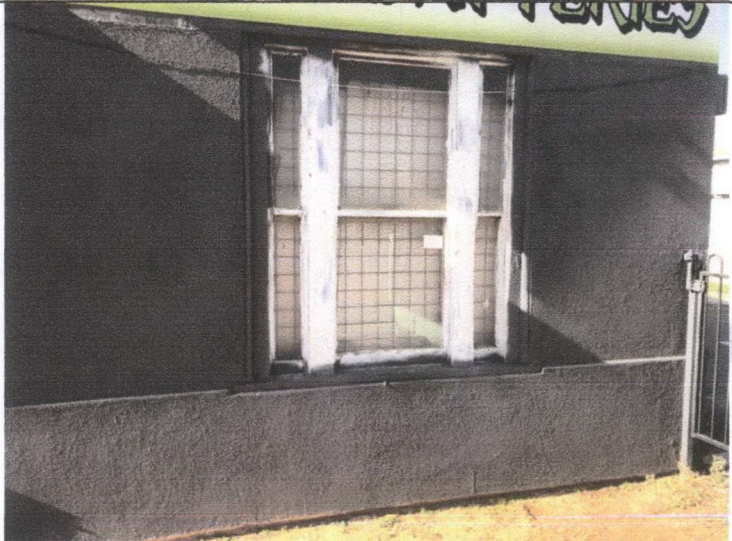
- Southern side of front elevation
- Window facing Flores Road

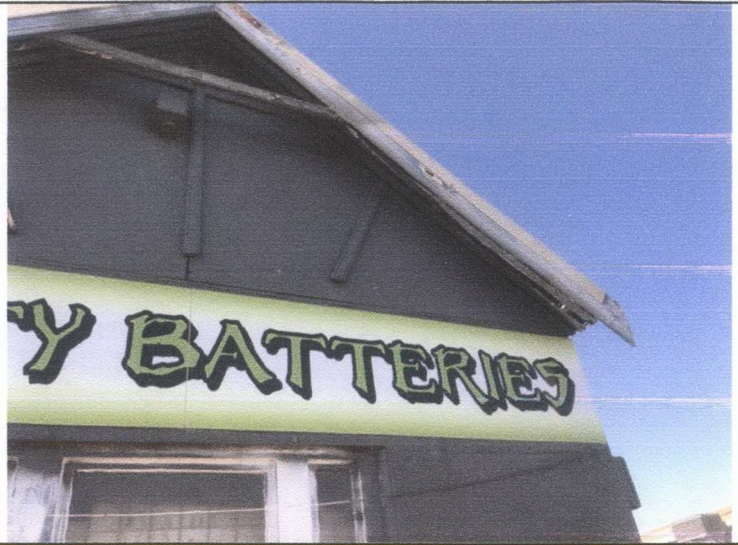
- Southern side of front elevation showing gable end
- Modified signage
- Damaged eaves and barge

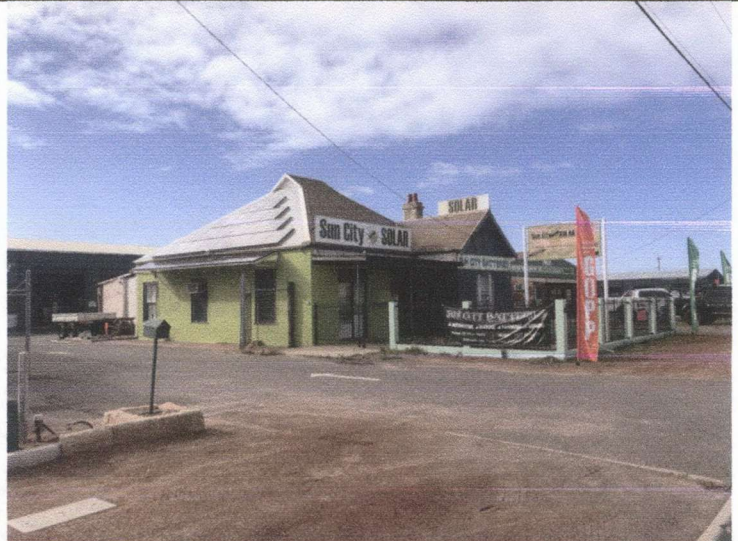
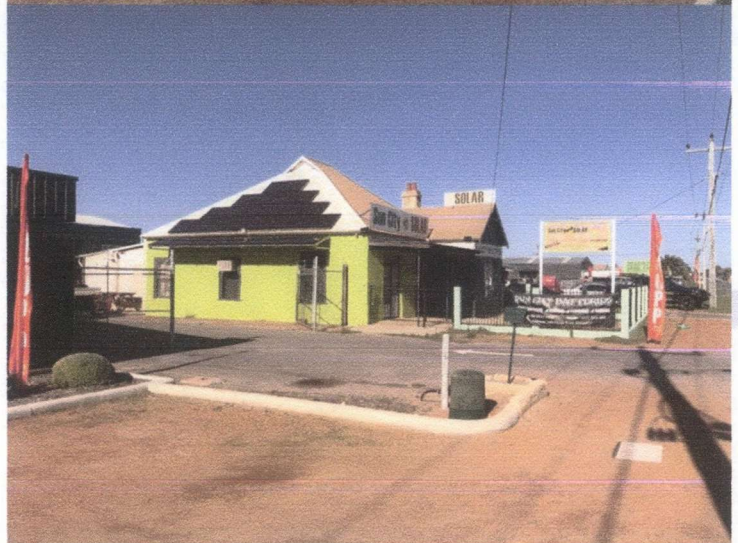
NORTHERN (SIDE) ELEVATION

- Extended view of front elevation as seen driving from the north on Flores road.
- Solar panelling has been added to the North facing roofline
- North facing roof cladding has been painted white

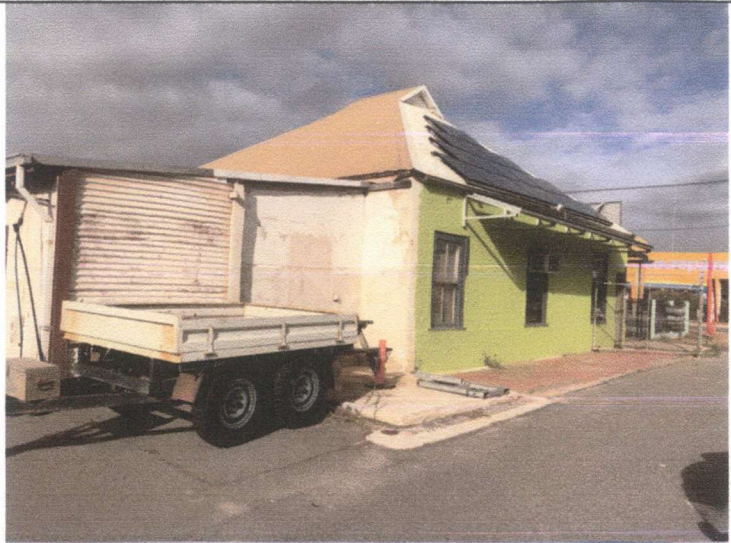
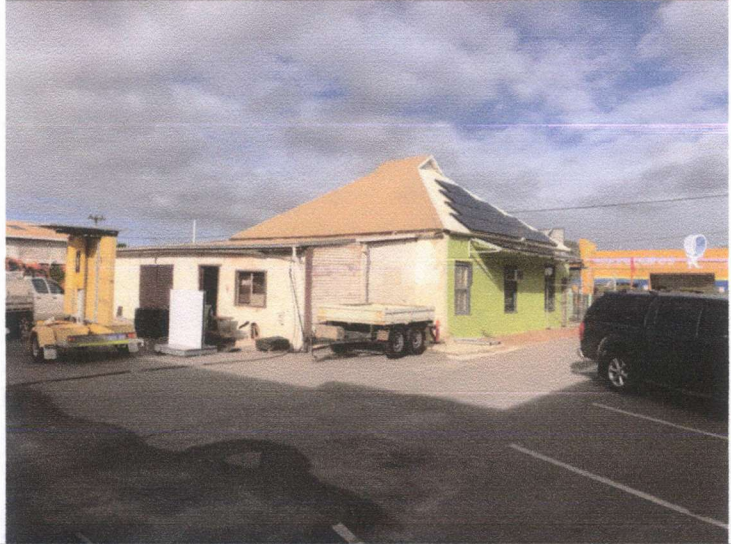
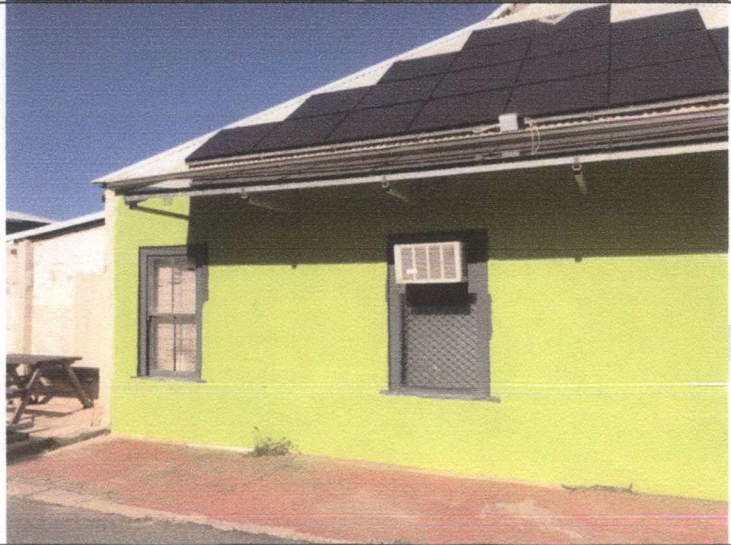
- Closer images of northern elevation
- Modified windows to aluminium frame with security screening
- Addition of air-conditioning within window frame
- Cracks showing through render of compromised mortar joints

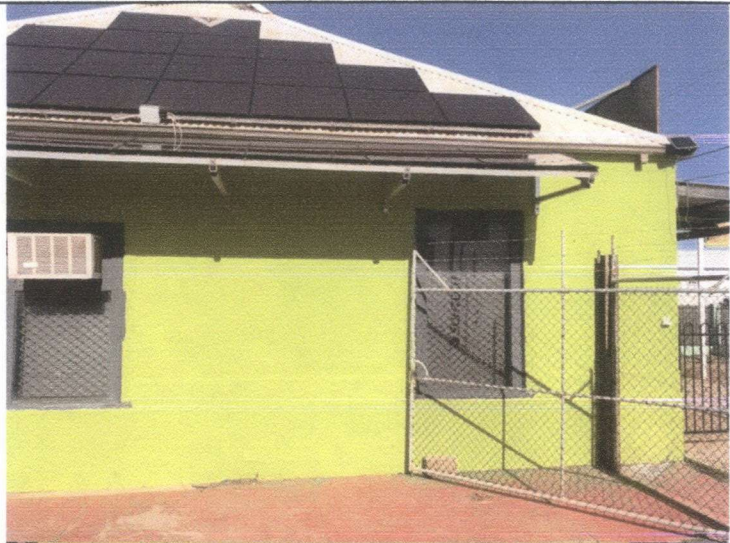
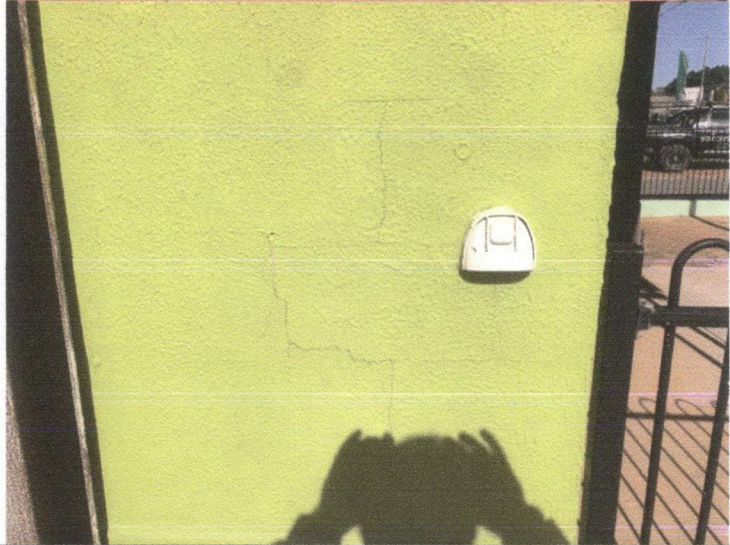
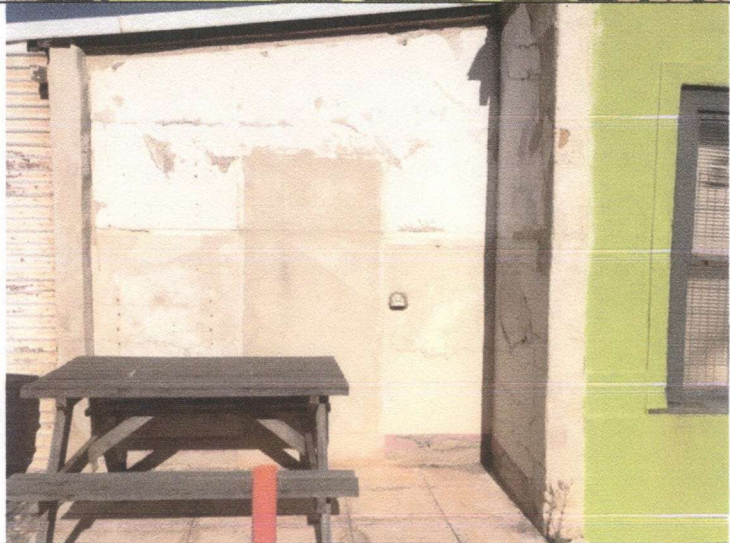
- North side elevation to the rear of the building
- There had previously been a lean-to kitchen which fell down and was not replaced. The old doorway to this lean-to has been filled in
- Extensive cracking to brickwork is present

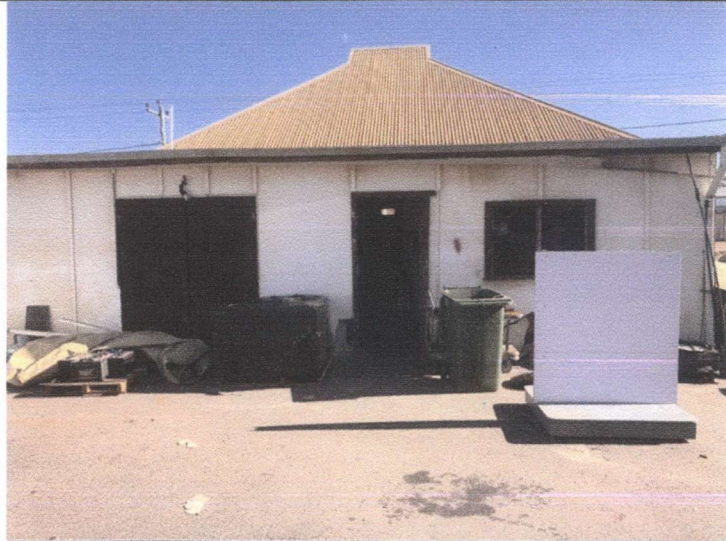
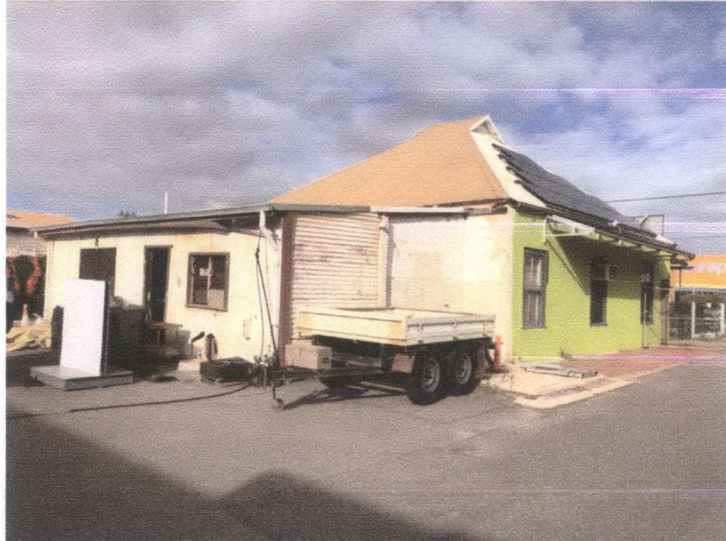
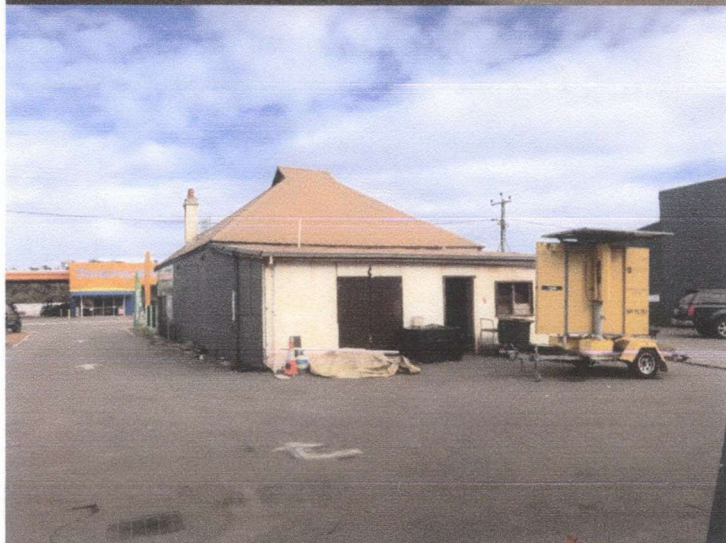
EASTERN (REAR) ELEVATION

- Rear elevation as viewed from the front of the additional building to the rear of the property
- Asbestos extension with flat roofline
- Condition of rear of building is poor

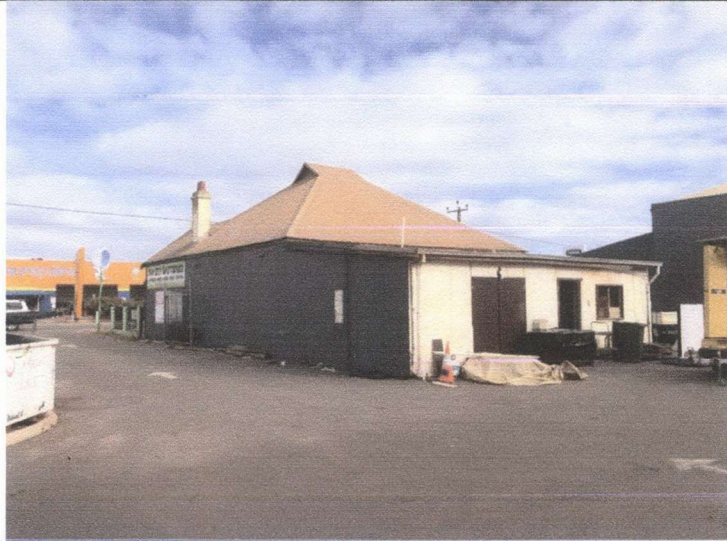
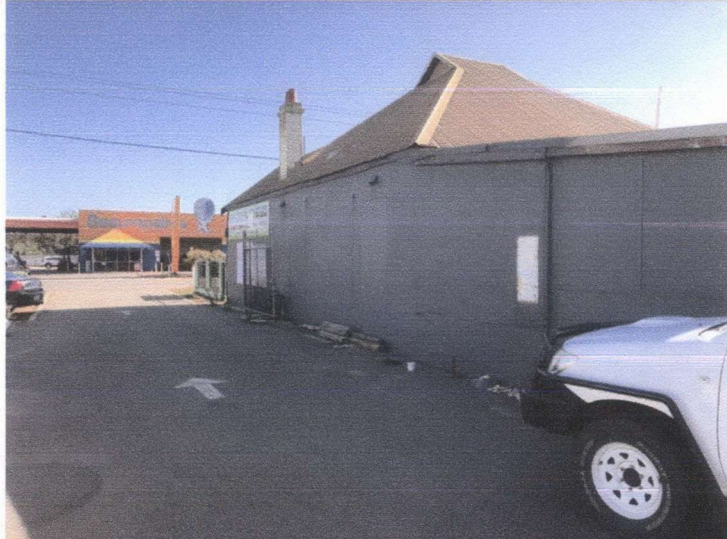
SOUTHERN (SIDE) ELEVATION

- Southern side elevation as viewed from rear of the property
- Original roof line and chimney still maintained to the front of the property.
- Asbestos extension and flat roofline present to the rear of the building.
- Addition of signage to advertise the presence of the business upon the lot.
- Façade has been painted in colours that match with the colour theme of the business

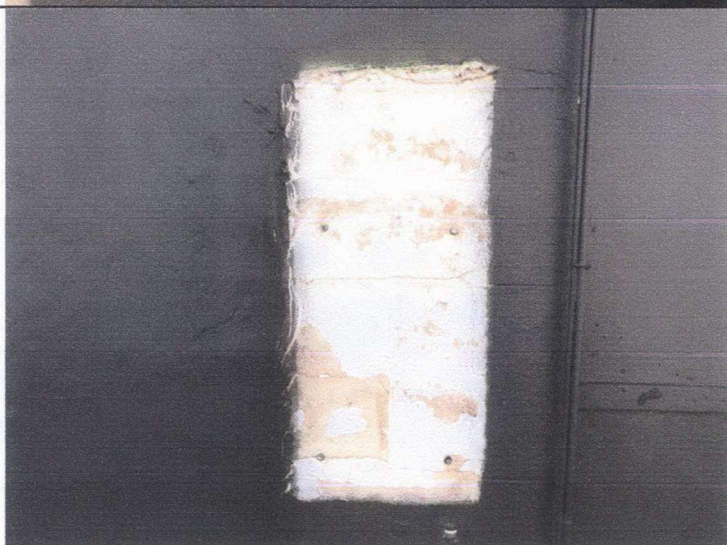
- Southern side elevation to rear of building
- Portion of brickwork has been exposed to allow for an assessment of the extensive cracking present

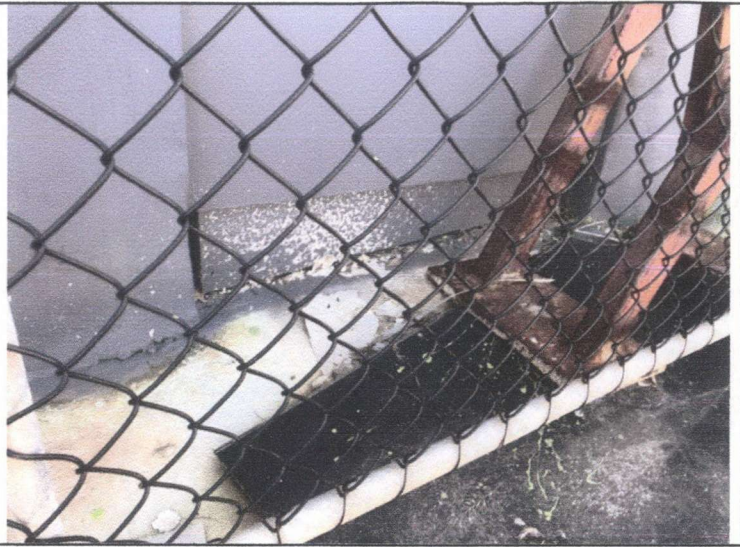
- Southern side elevation to front of building
- Damage to base of building joining footings

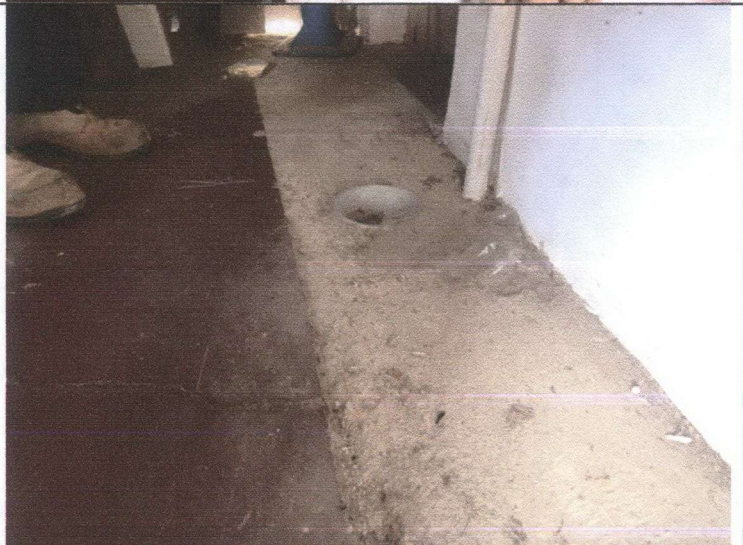
- Modified concrete work
- Drainage for the roof is still directed into the rear extension

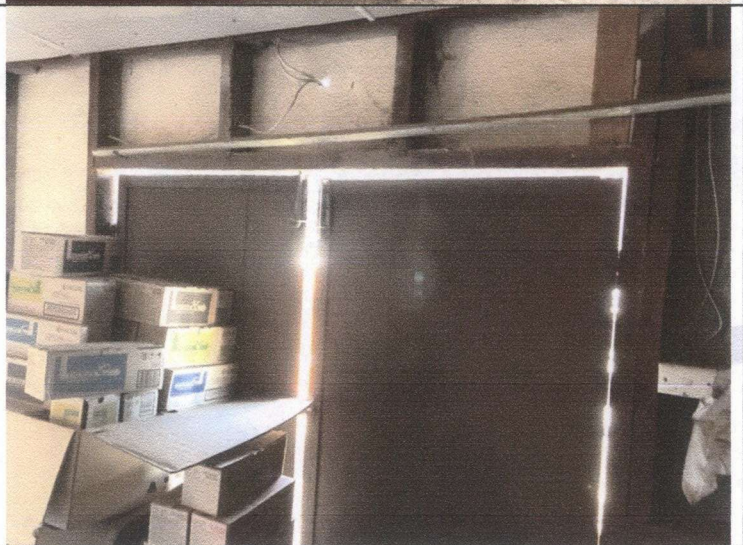
- Poor sealing
- Missing wall panelling
- Exposed wires (no longer live as power has been restricted to building)

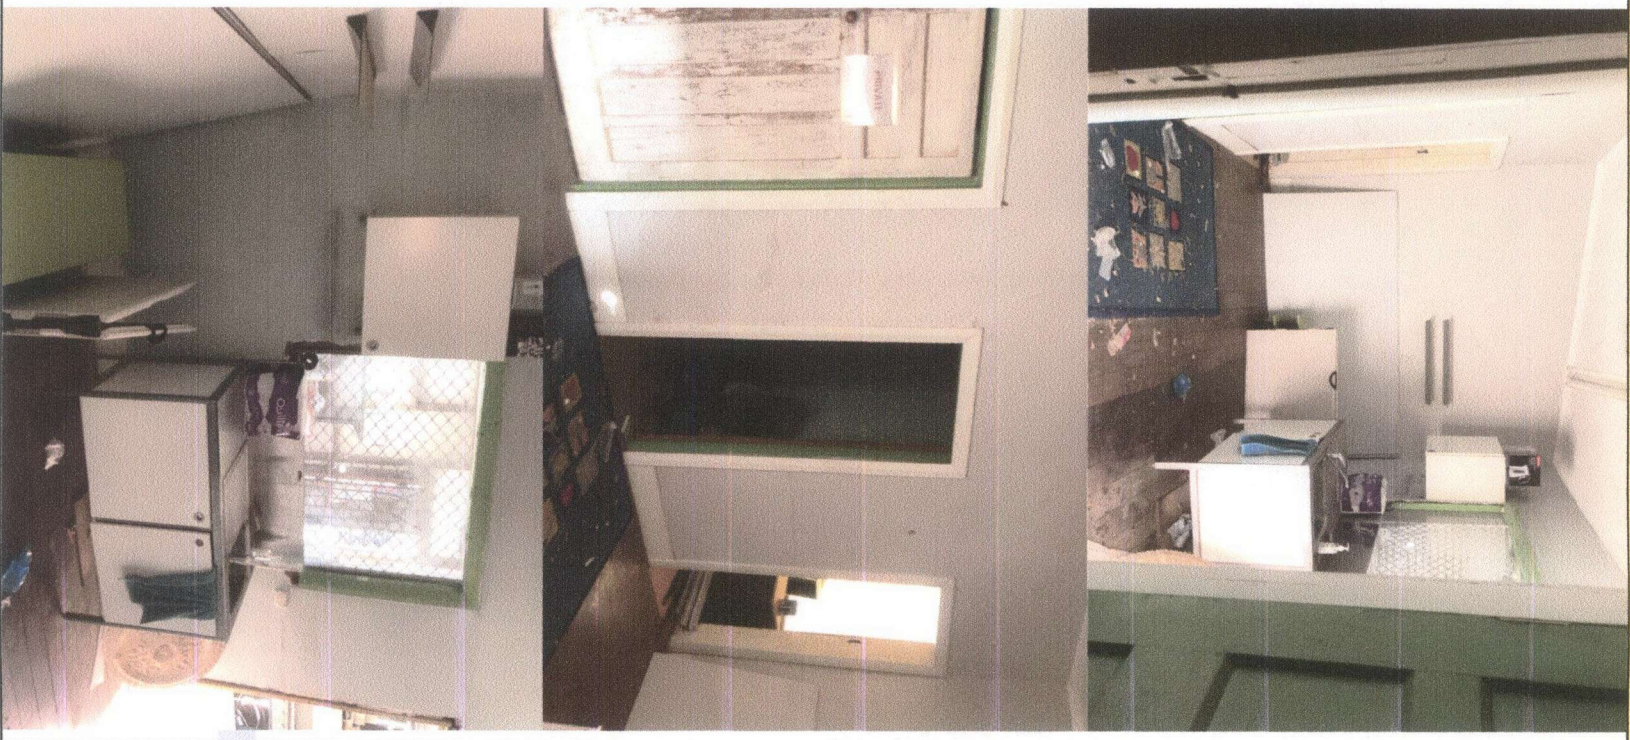
KITCHEN

- Damaged brezeway

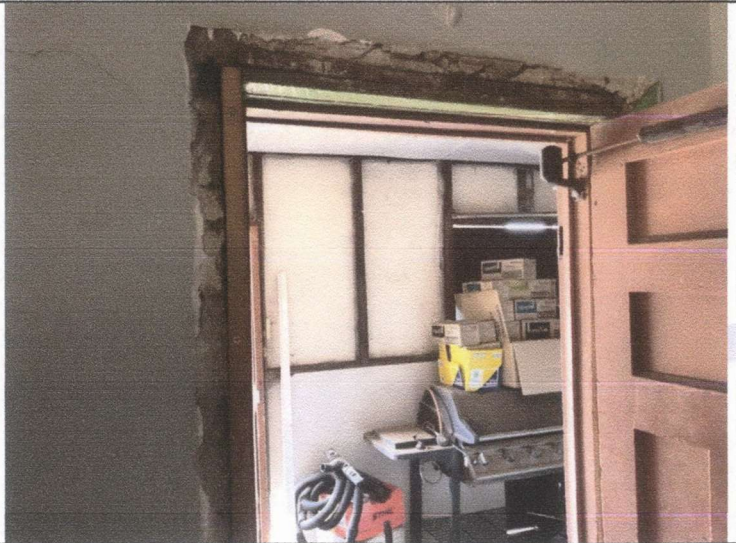
- No architraves around door, damaged mortar and brickwork

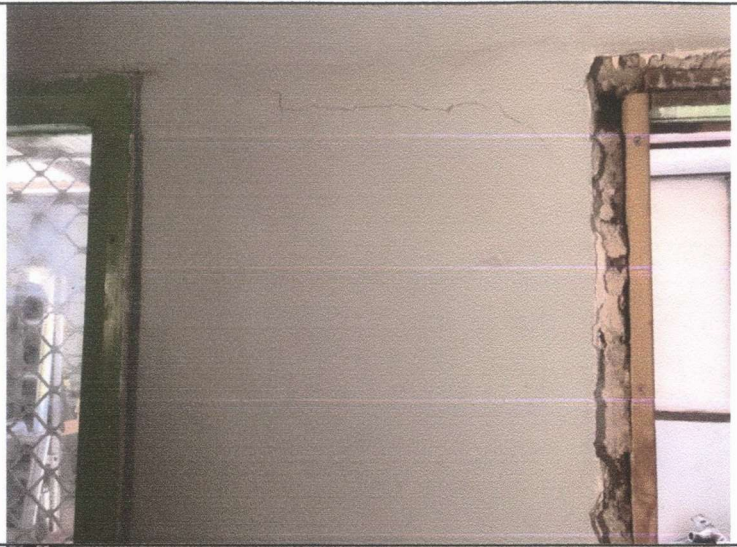
- Cracking to brickwork
- Missing architraves

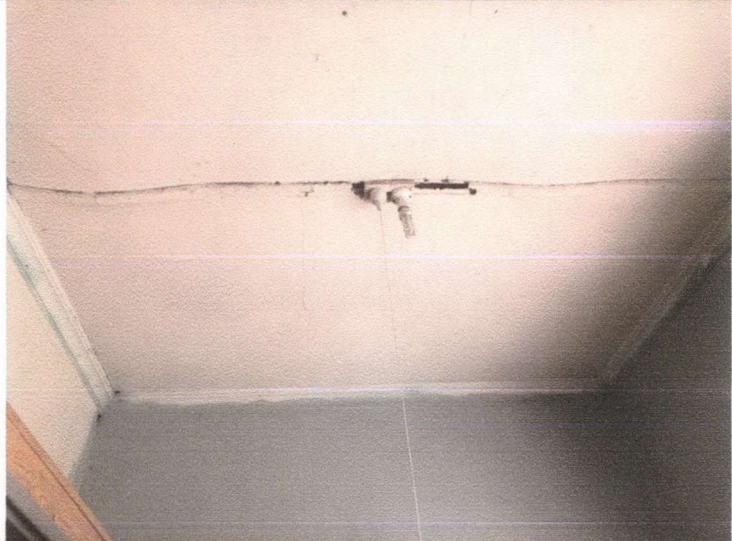
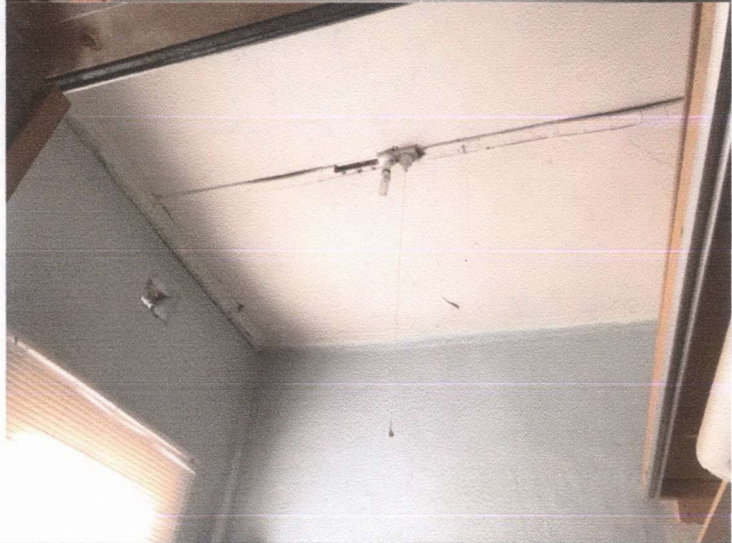
- Ceiling bowing and cracked

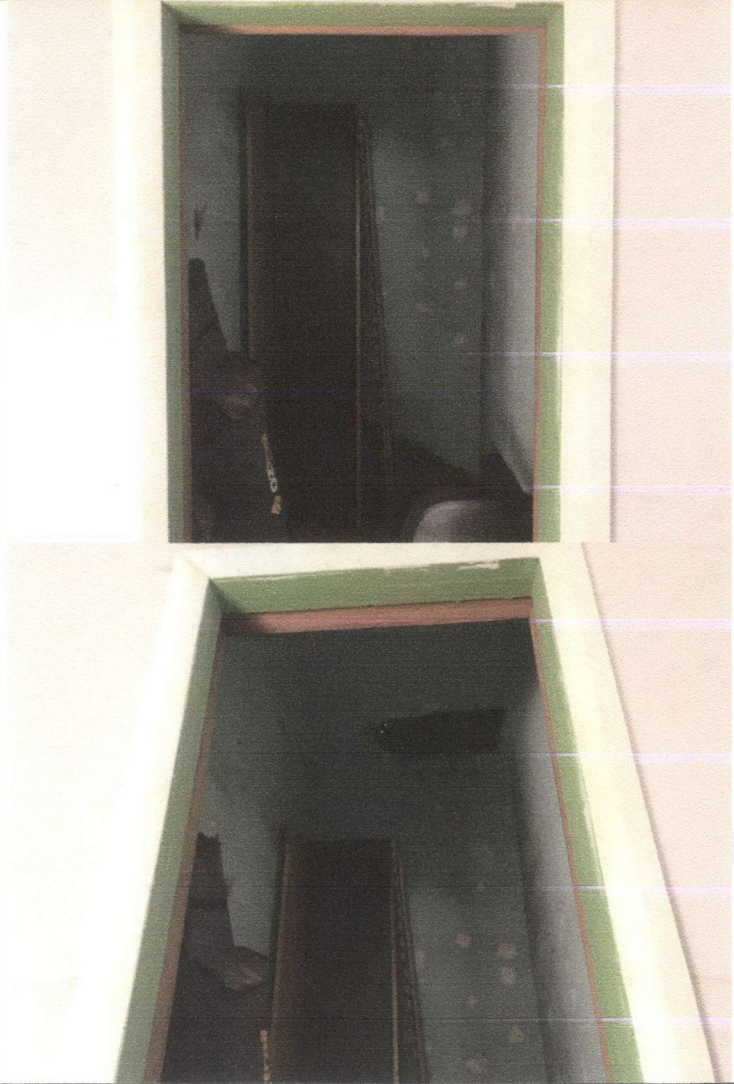
PANTRY

- Internal room to northern side of building
- Modified brickwork to doorway
- Modified sliding door

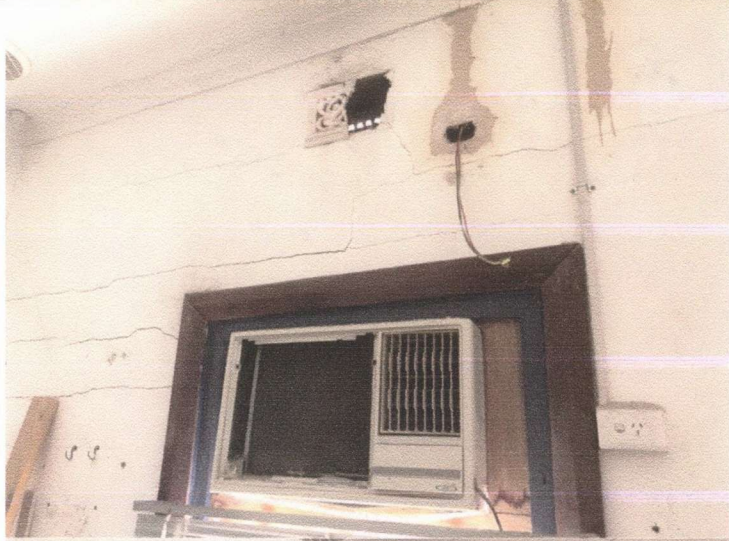
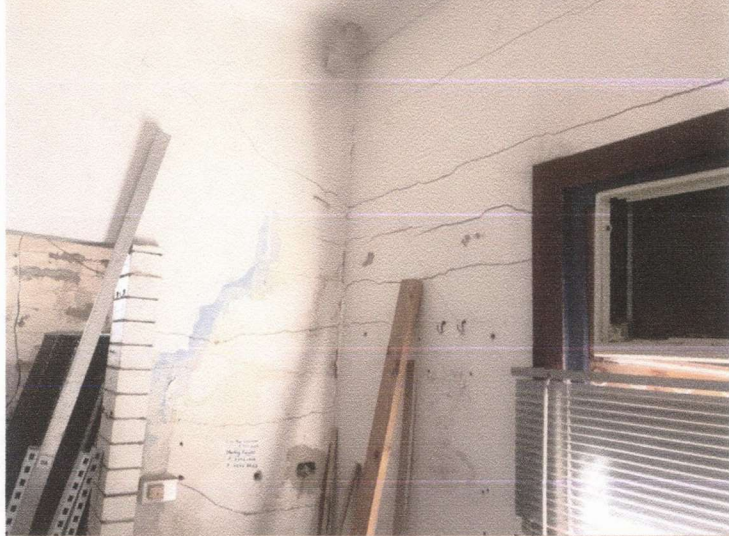
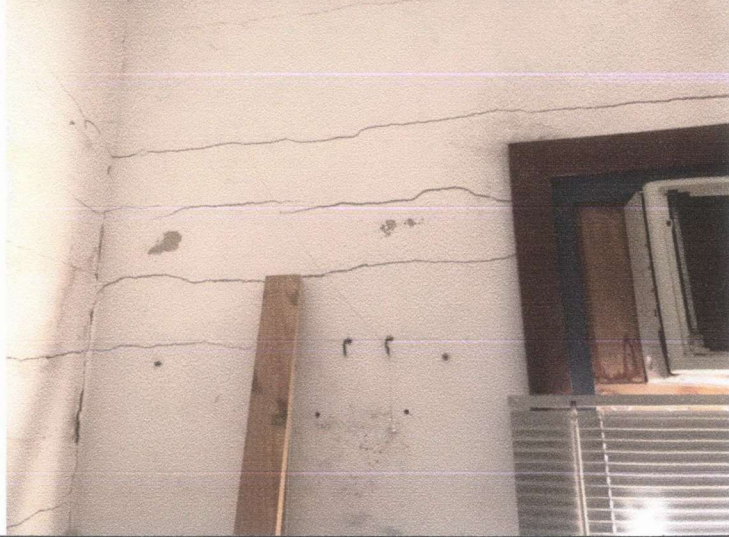
LOUNGE

- Internal room to northern side of building
- Large amount of cracking to brickwork present
- Modified brickwork around doorway

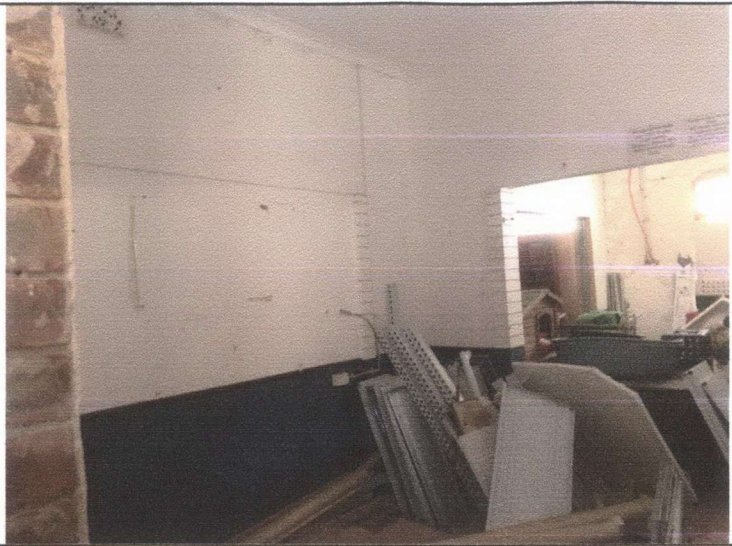
- Internal room to northern side of building
- Modified brickwork to window entrance
- Window entrance enclosed

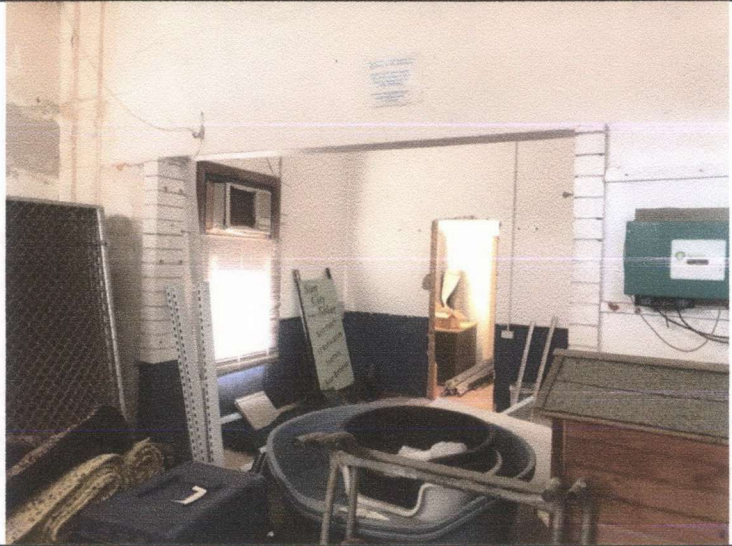
- Internal room to front of building
- Extensive cracking to brickwork
- Modified brickwork to entrances

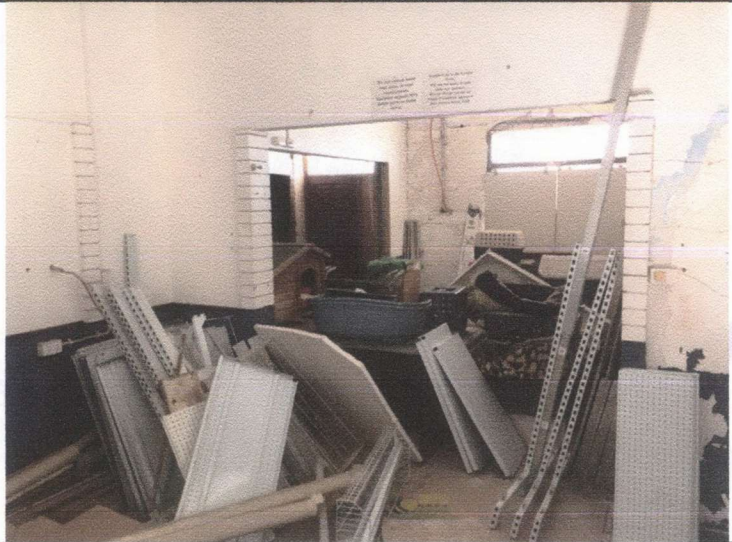
- Internal room to front of building
- Modified brickwork to entrances
- Cracking to brickwork

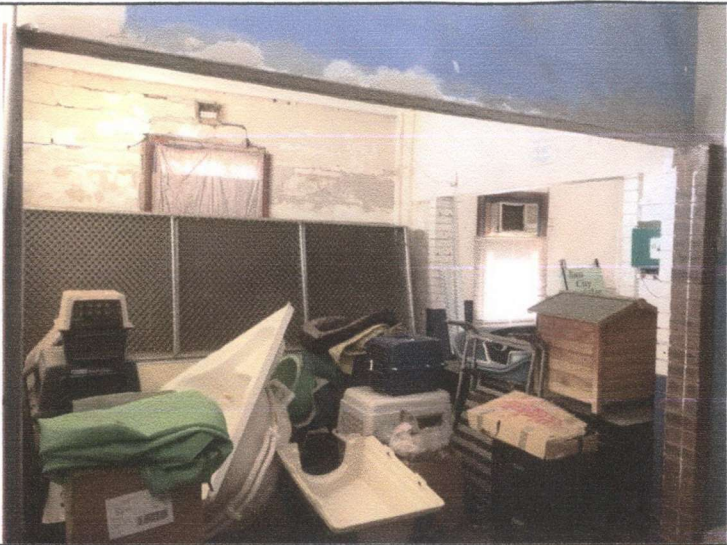
- Internal room to front of building
- Missing breezeway
- Extensive cracking to brickwork
- Modified brickwork to entrances

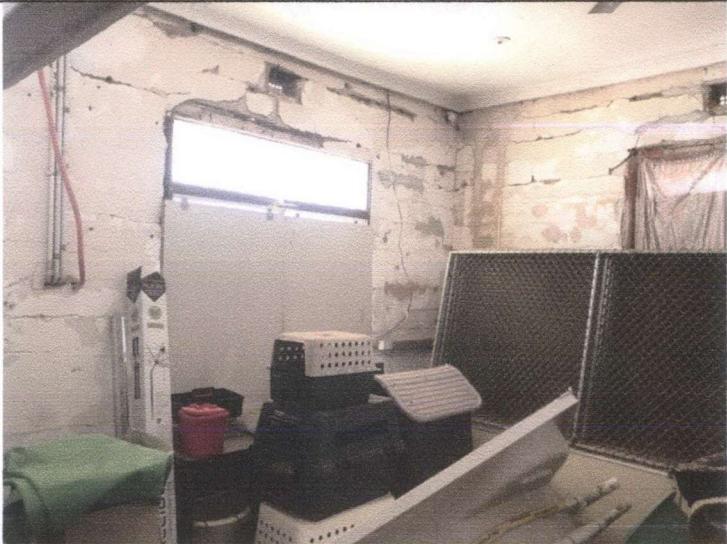
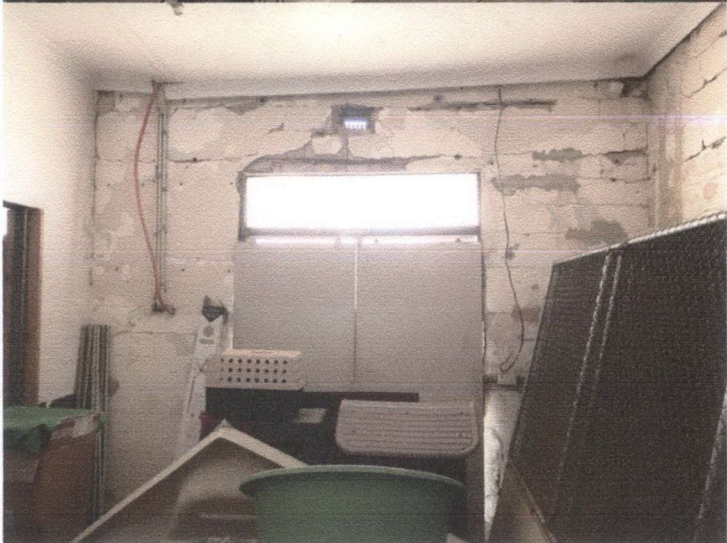
- Internal room to front of building
- Missing breezeways
- Extensive cracking to brickwork
- Car springs used for lintels
- Bowing of brickwork above windows

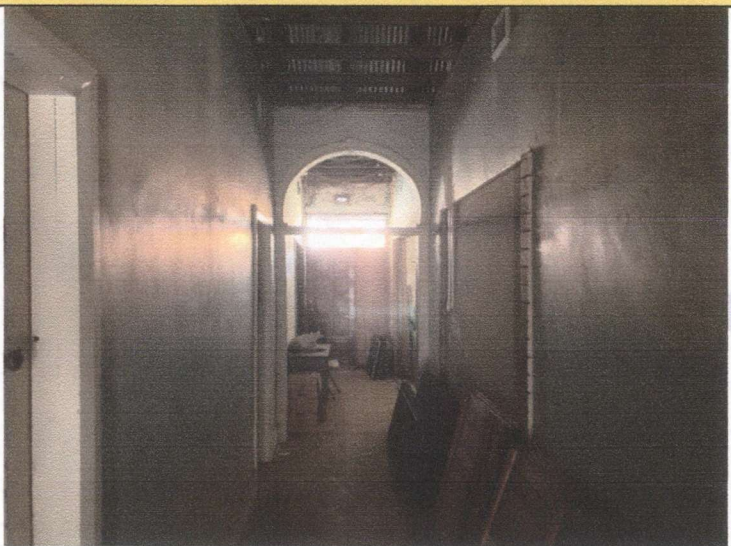
HALLWAY / ENTRY

- Internal hallway facing front door
- Missing ceiling
- Extensive deterioration to blockwork above entry

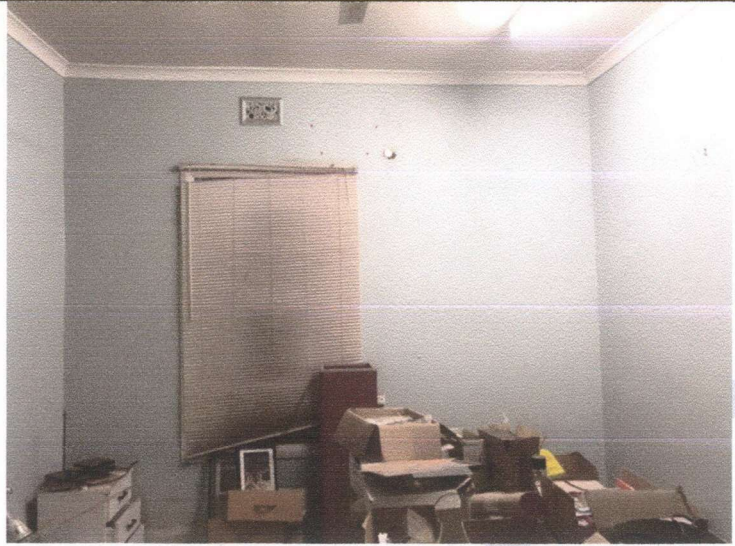
BEDROOM (EAST)

- Internal room to southern side of building
- Damage to breezeway

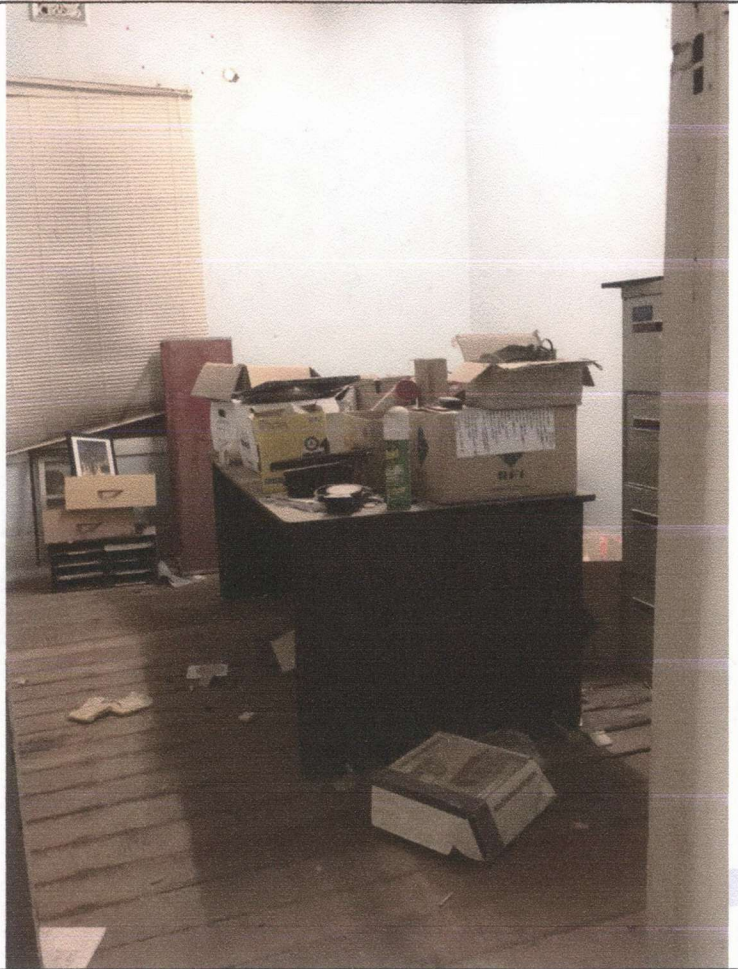
- Internal room to southern side of building
- Damage to breezeway
- Damage to floor boards

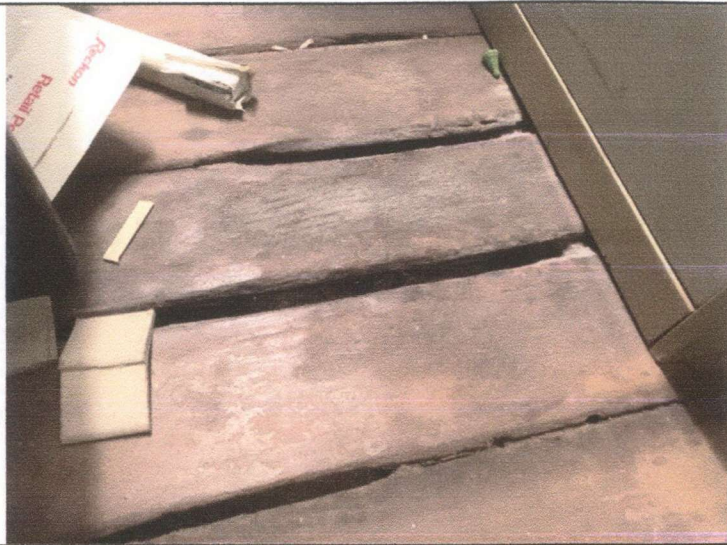
- Internal room to southern side of building
- Damage to floor boards
- Rumoured that the damage to the floor was caused by an occupant who died in the room and was not found for sometime and the body had begun to rot away the flooring. It was said that the body was brought out by removing a large section of the wall to this room

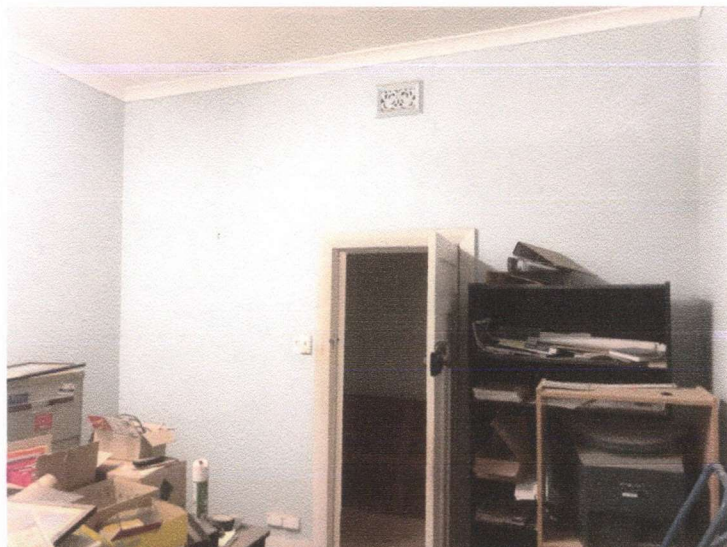
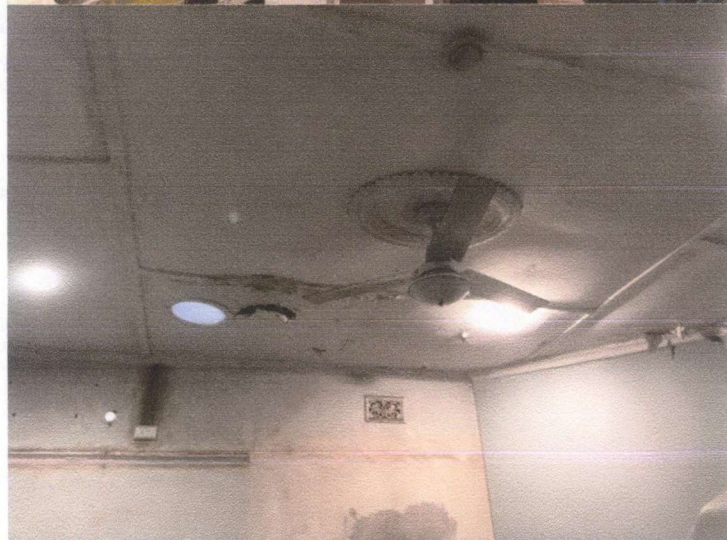
BEDROOM WEST

- Internal room to southern side of building
- Roof bowing and in poor repair

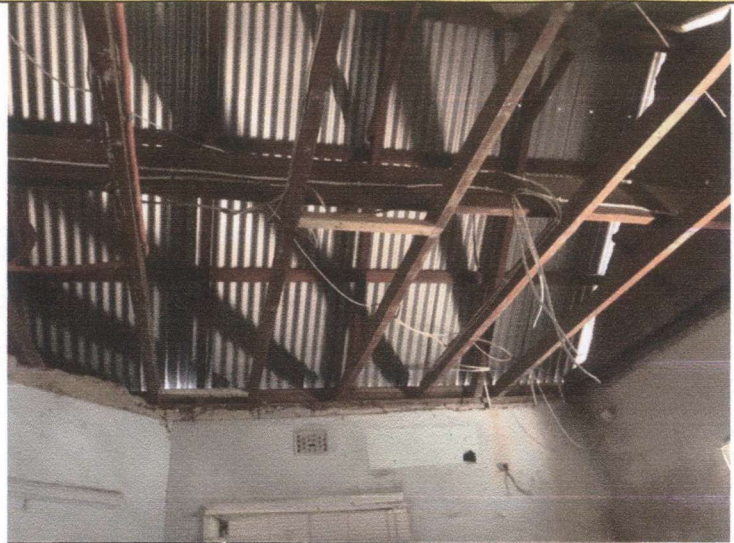
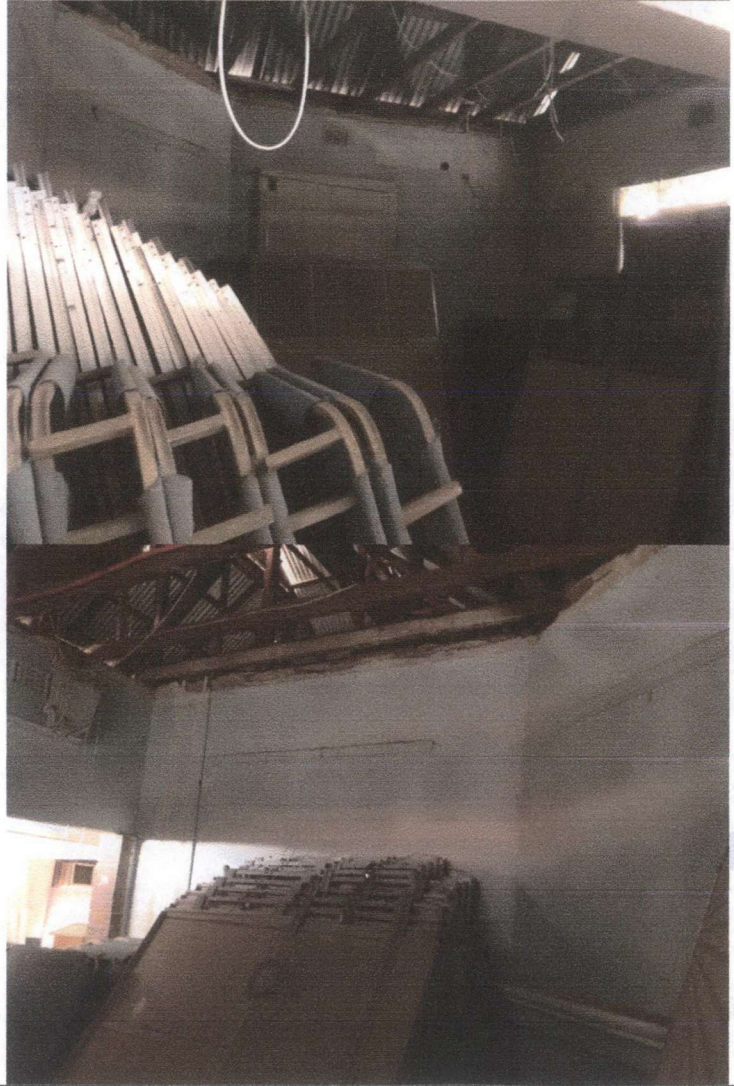
OFFICE

- Internal room to southern side of building
- Missing ceiling

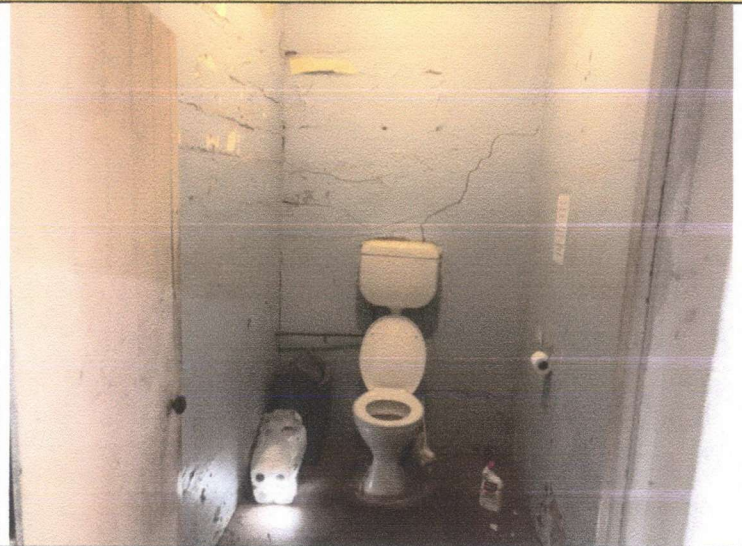
TOILET

- Internal room
- Modified tiled flooring
