REMOVAL OF HERITAGE LISTED PLACE – 140 FLORES ROAD, WEBBERTON

REPORT

ATTACHMENT 3

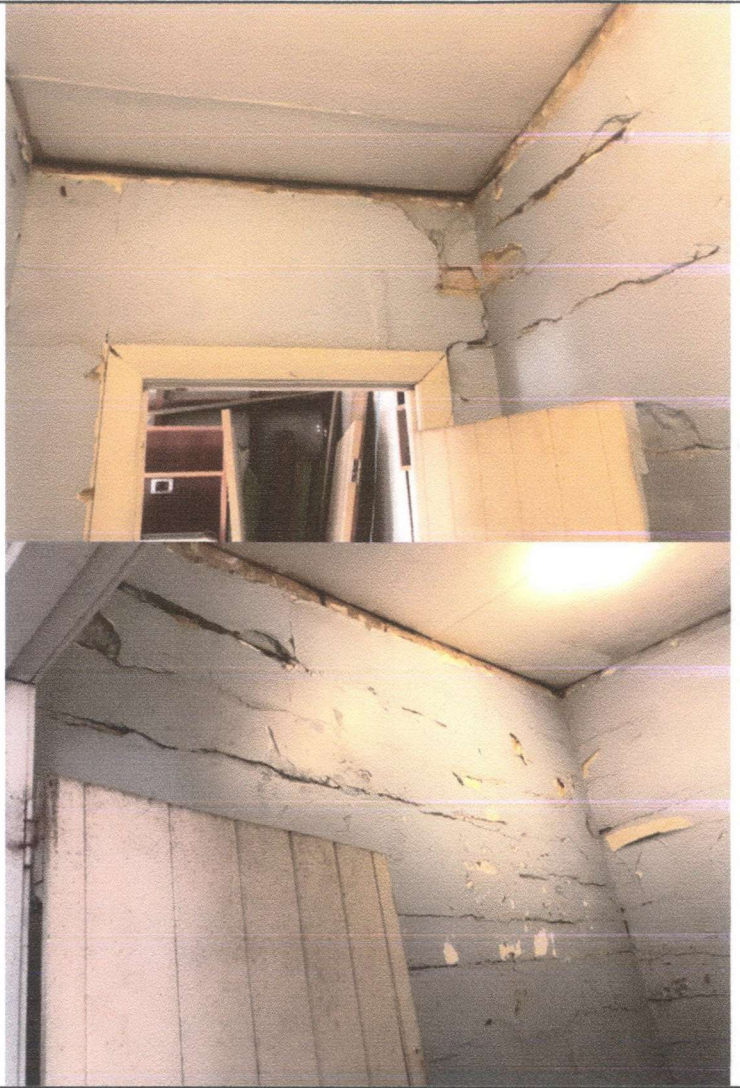
- Cracking to brickwork
- Wall in poor repair
- Large gap between wall and roof
- Door incorrect size for doorway
