## GROUND LEVEL VISUAL STRUCTURAL INSPECTION

**JOB:** Inspection of dilapidated old house, circa 1935, with view for demolition.

**ADDRESS:** No. 140 Flores Road, Webberton, City of Greater Geraldton.

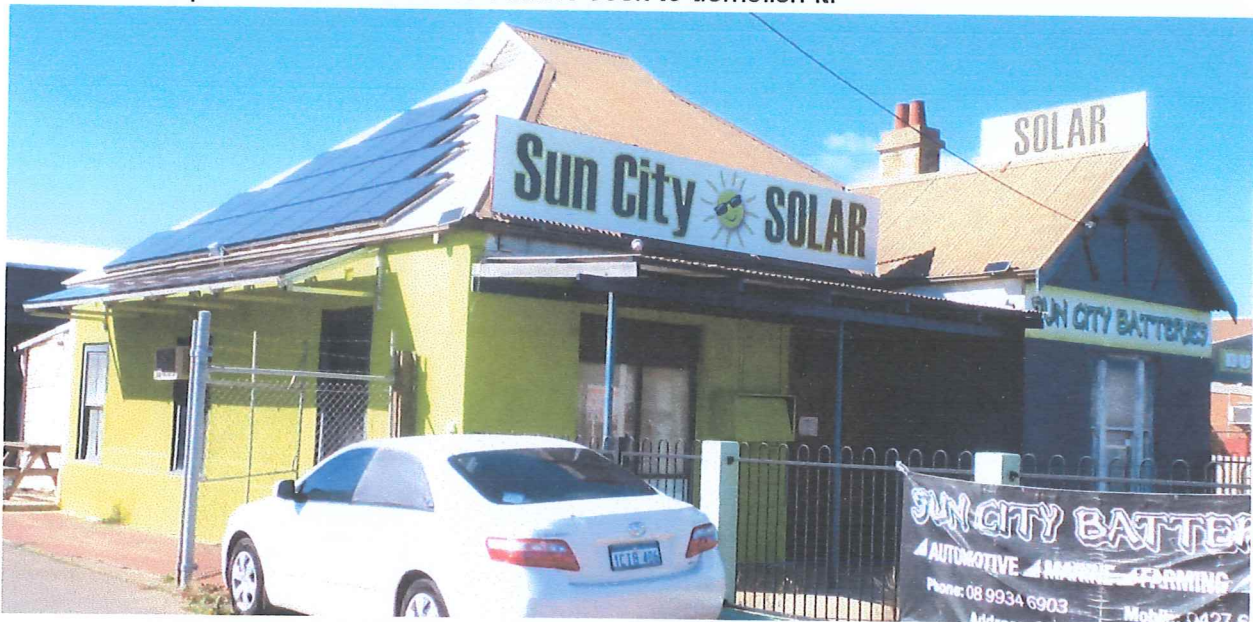
Above is the frontage of the old house. Below is the rear and current entrance.

As can be seen, there is nothing of structural interest to the exterior of the house. It has not been well designed or built. There is little original material left that is in acceptable condition. There are many more interesting and historical houses within and around Geraldton.

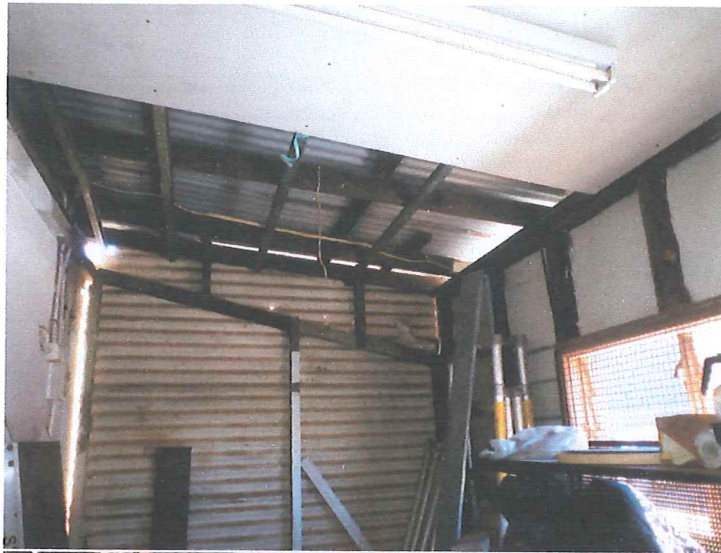
On the left we see the interior of the lean-to timber framed addition at the rear of the main brick building.

It is not remarkable, and lacks sufficient framing, for example at the wall facing us. Parts of the ceiling are missing, as in the next photograph.

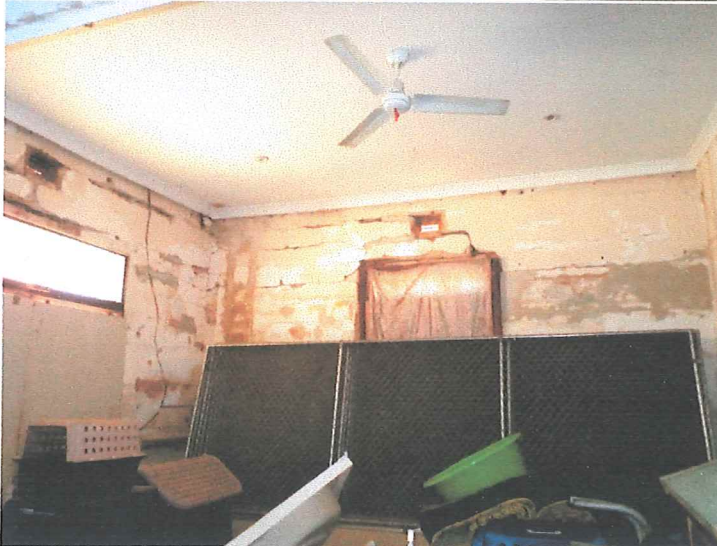
On the last photo we can see the long horizontal cracks in the mortar bed of the two walls. Also notice the previous repair work.
