# **CITY OF GERALDTON – GREENOUGH**

## **REPORT ON WONTHELLA OVAL**

**JANUARY 2010**

**SPORTS TURF  
TECHNOLOGY**

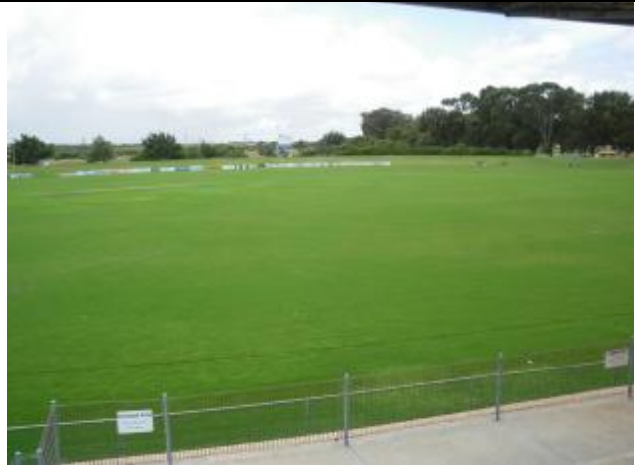
The oval was in excellent condition, with a full cover of healthy and actively growing turf.

The turf type was predominantly saltene, mixed with couch and some patches of kikuyu around the wicket block.

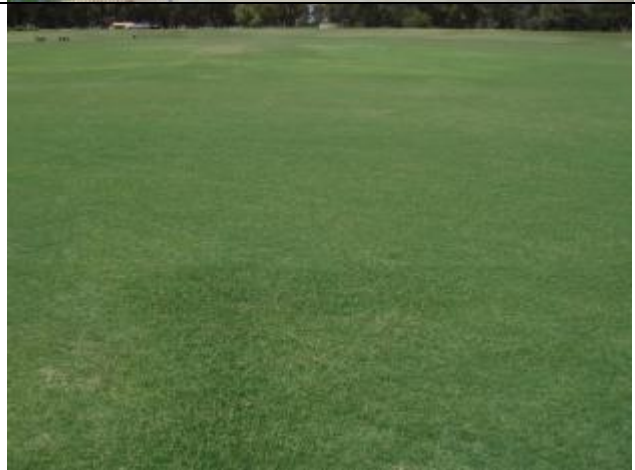
The oval had a smooth playing surface with no potholes or obvious undulations. There was an even turf cover with no bare patches.

Re-turfing was not required after the football season, as the turf had fully recovered from wear damage.

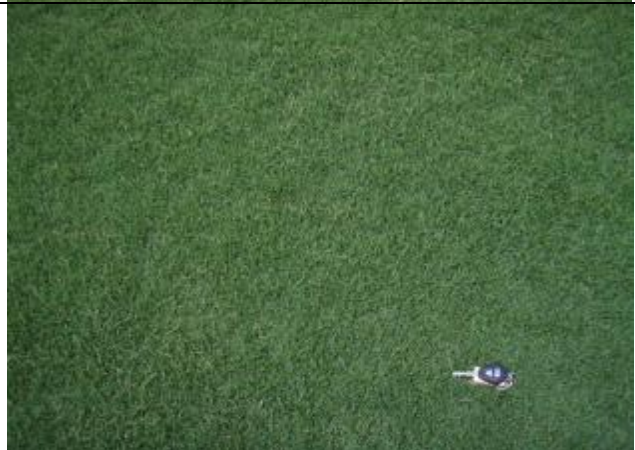
The turf density was generally very good, having recovered rapidly from scarifying approximately three weeks before the inspection.

The high growth rate of turf is the response to the high concentration of nitrogen in the bore water.

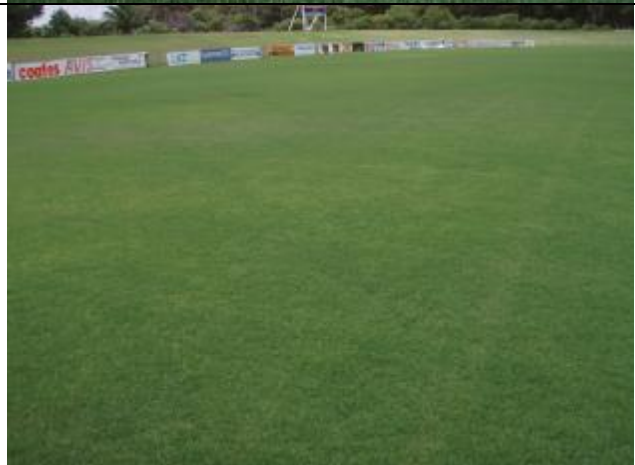
There was slight yellowing in the saltene on the eastern side of the oval, indicating symptoms of iron and manganese deficiency.

This was not a concern at the time of inspection, but may cause a decline in turf condition during winter.

- § Apply iron and manganese as a foliar spray, such as Ferrous Sulphate and Manganese Sulphate at 25kg/Ha, every two months between April and September.
- § Apply granular nitrogen fertiliser, such as Sulphate of Ammonia at 200kg/Ha, every two months between April and September, alternating with the foliar iron and manganese.
- § Monitor turf nutrient requirements with leaf tissue analysis three times per year, in autumn, winter and spring.

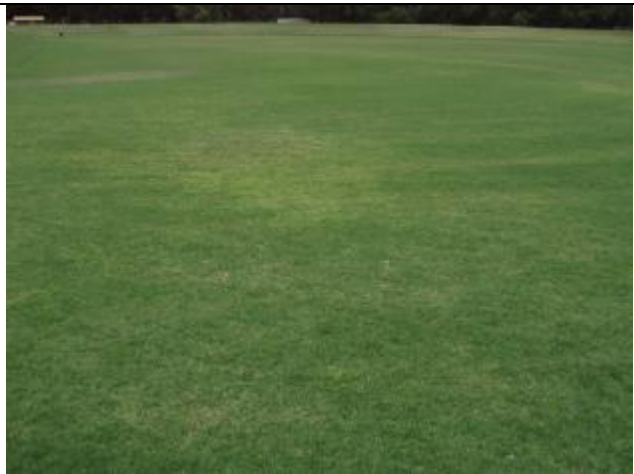
The yellowing was more pronounced in the patches of kikuyu, indicating that kikuyu is more prone to iron and manganese deficiency than couch and saltene.

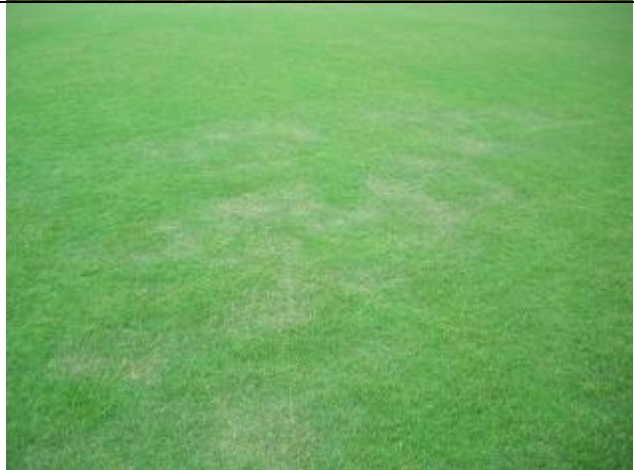
There were symptoms of localized dry patch on the northwest side of the oval, with turf wilting from moisture stress.

Soil wetting agent had been applied in the previous week, however the soil was found to have very severe water repellence.

- § The soil is prone to developing dry patch. Soil water repellence was still very severe after the wetting agent application prior to the inspection.

- § Apply soil wetting agent, such as Stamina 90 at 25 L/Ha, every two months during the irrigation season.

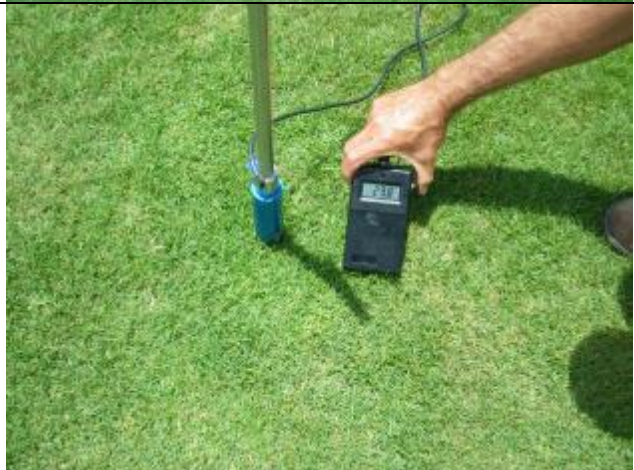
There was high soil moisture content in the good areas (29.8%).

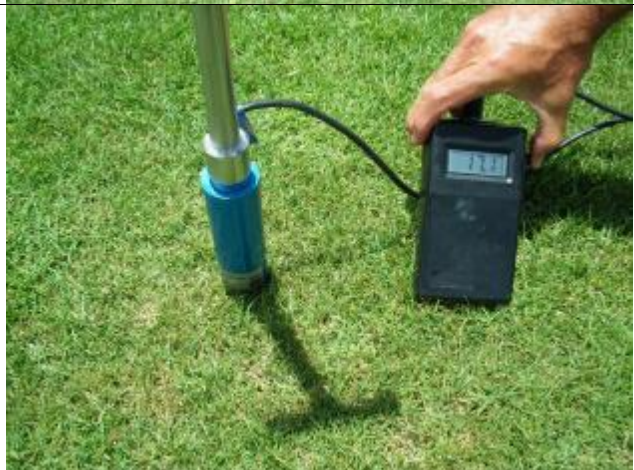
The wilted areas had lower soil moisture content (17.1%).

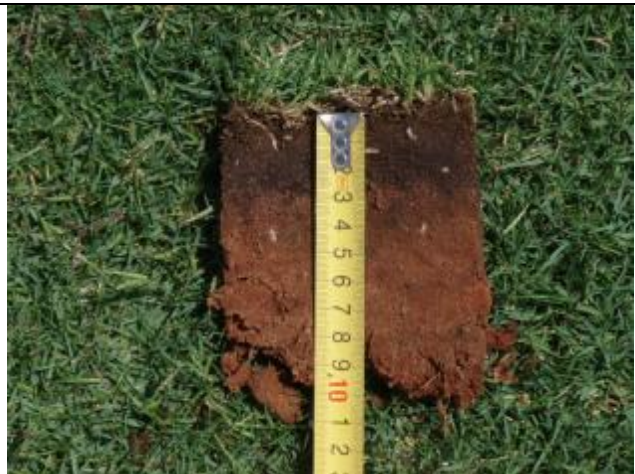
The most limiting factor for drainage at the time of inspection was the mat layer on the surface of the root zone. The proportion of fine organic matter to sand in the mat layer is excessive. As sand is no longer the primary medium on the surface of the root zone, it will not perform like a typical free draining sand profile. The surface infiltration rate at the time of inspection was found to be below the acceptable rate for a playing field.

Excessive mat layer development is most detrimental when the surface is exposed to heavy traffic in wet conditions. The mat layer becomes compacted or sealed, which impedes water movement and causes the surface to stay wet for extended periods, increasing the risk of the ground becoming excessively soft and muddy.

The turf root zone has developed a defined layer of highly concentrated fine organic matter (mat layer) on the surface.

The mat layer has the potential to impede water movement into the soil and create soft and muddy surface conditions in wet weather.

To assist the winter performance of the oval with the proposed increase in usage, the existing mat layer needs to be alleviated. This is done most effectively through renovation activities, including scarifying, shallow coring with hollow tines, and applying sand top dressing. It is essential to break through the restrictive layer to improve water movement into the profile, and incorporate sand to dilute the organic matter.

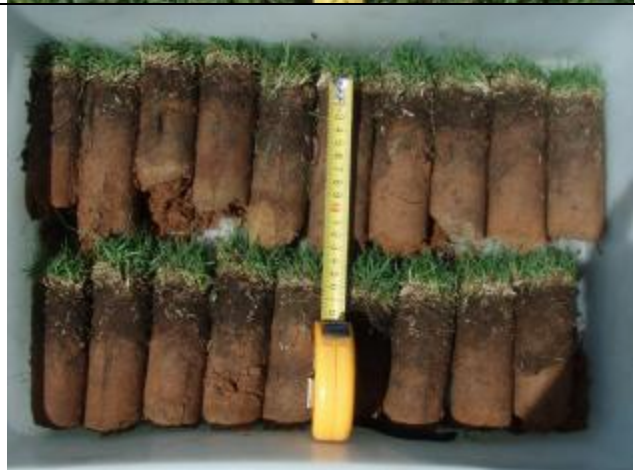
The depth of mat layer was typically 20-30mm, with up to 50mm in some areas. There was generally clean sand below the mat layer.

Additional renovation activities are required to treat the mat layer, such as hollow-tine coring and sand top dressing. A coring depth of approximately 75mm would be sufficient to target the mat layer.

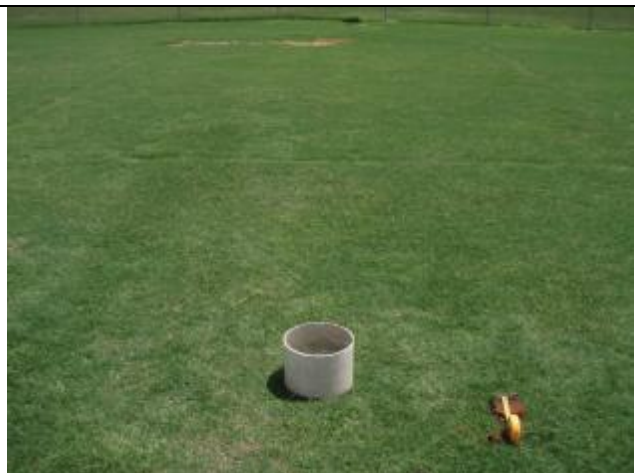
The surface infiltration rate was measured at 50mm/hr in front of the northern goal square. This is below the acceptable level of 100mm/hr.

The infiltration rate would be expected to decline in high wear areas during the football season, due to the mat layer becoming compacted.

- § The high wear areas are prone to developing drainage problems caused by low surface infiltration during rainfall periods in winter.

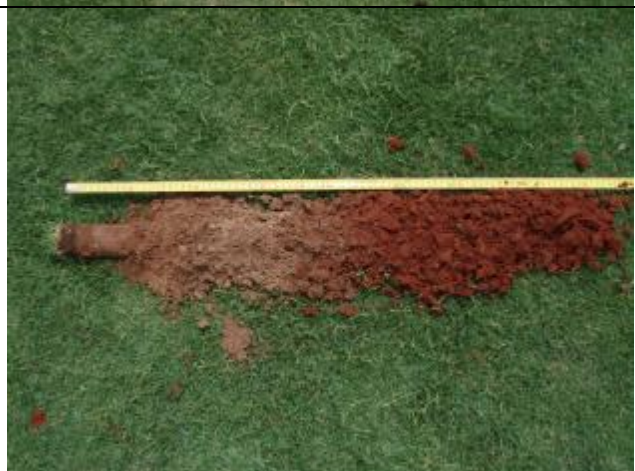
Soil profile - northern end

The depth of sand is approximately 45cm over clay loam sub-soil.

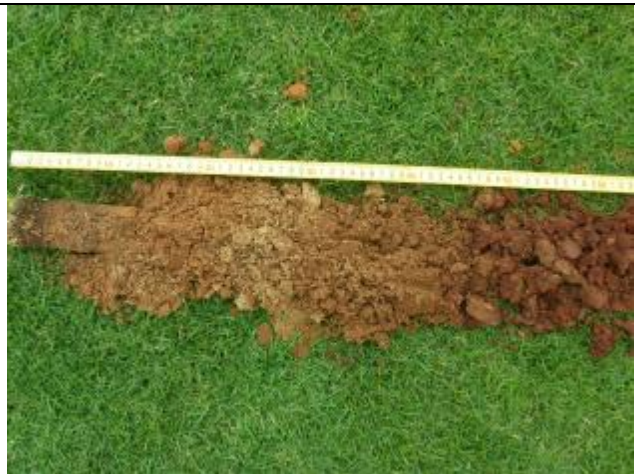
Soil profile - eastern wing

The depth of sand is also approximately 45cm over clay loam sub-soil.

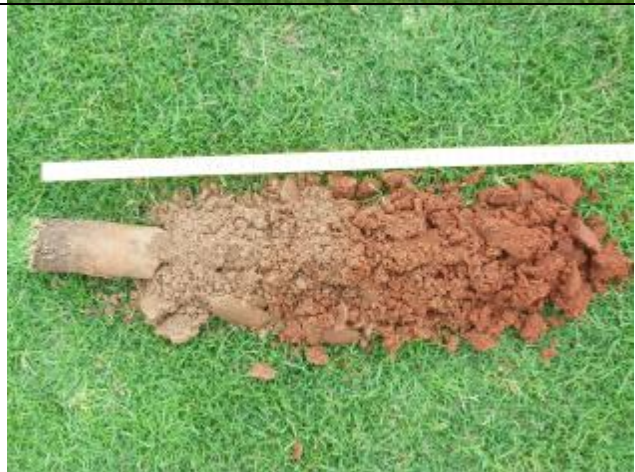
Soil profile - southern end

The sand depth is shallower, with approximately 25cm of sand over clay loam subsoil.

There have been drainage problems in the past on the southeastern side of the oval, which could possibly be related to the shallower depth of sand.

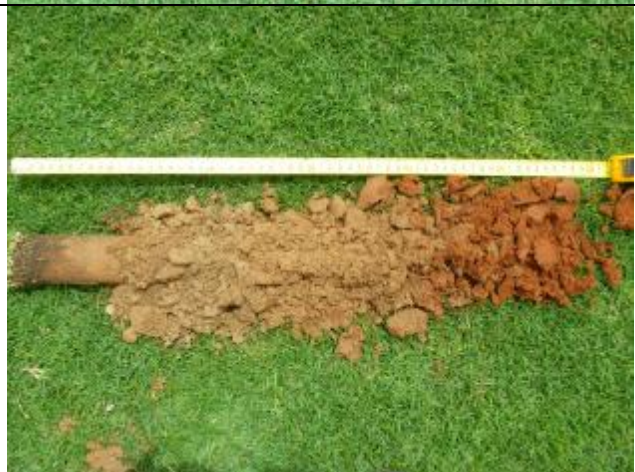
Soil profile - western wing

The depth of sand is approximately 40cm over clay loam sub-soil.
