<b>Area:</b> Geraldton	<b>Place Number:</b> 79	<b>Category:</b> 3
<b>Assessment Date:</b> 25/10/1996	<b>Last Revision Date:</b> 27/10/2009	
<b>HCWA Number:</b> 13259	<b>Asset ID:</b> MCH126481

<b>Name:</b>	House
<b>Other Names:</b>	7 Conway Street
<b>Type of Place:</b>	House
<b>Address:</b>	7 Conway Street
<b>Suburb:</b>	Beachlands

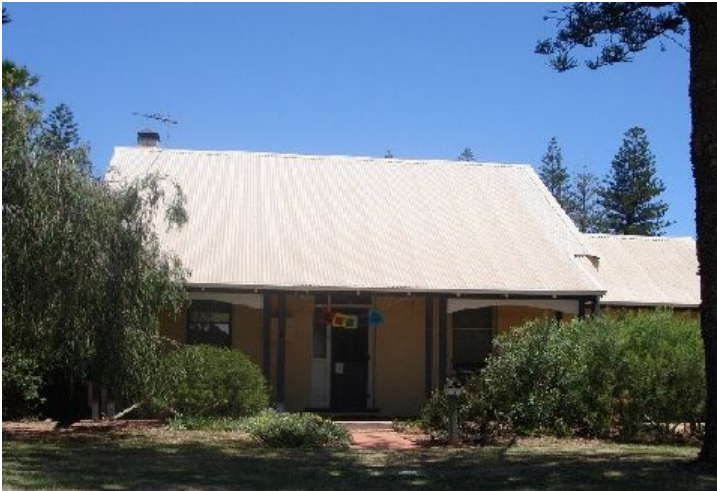
Simple shallow arched valance detail between verandah posts.

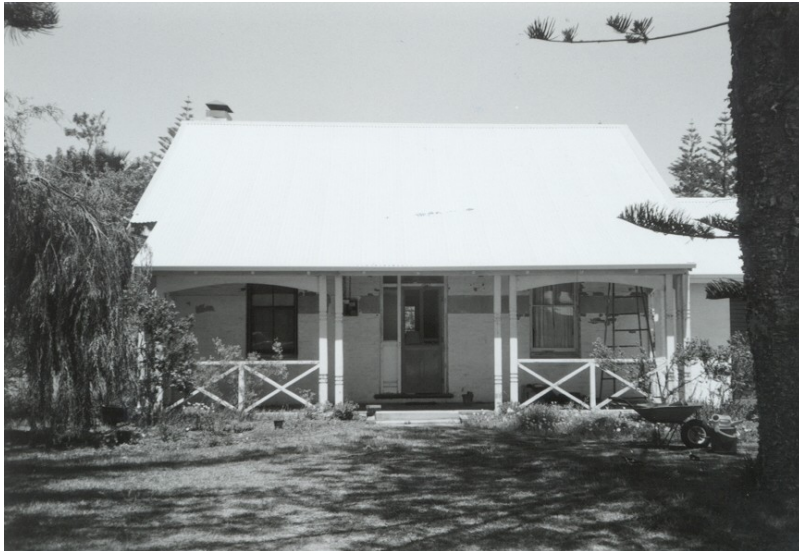
Criss cross balustrade between twin verandah posts.
