# City of Greater Geraldton Municipal Inventory of Heritage Places Place Record

Area: Geraldton Place Number: 87 Category: 3

Name: House

Address: 1 Crowther Street

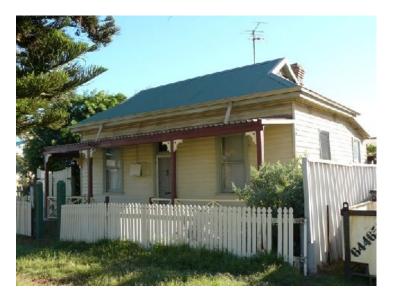
13/04/2008

Weatherboard cottage set behind picket fence.

**Condition:** Good **Integrity:**

**Modifications:** Verandah pitch, cladding and posts

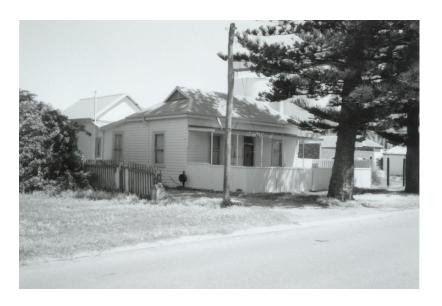
# Photo Description: 25/10/1996

Unsympathetic asbestos fence and metal verandah poles since removed.
