# City of Greater Geraldton Municipal Inventory of Heritage Places Place Record

Area: Geraldton Place Number: 252 Category: 3

Name: House

**Address:** 1 Holland Street

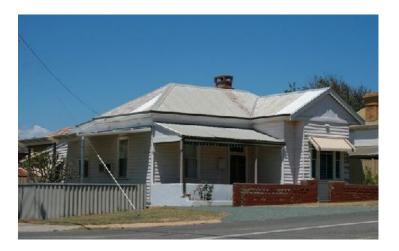
29/10/2007 Rod Milne

View of house from Holland Street.

**Condition:** Good **Integrity:**

**Modifications:** Tall brick wall to property frontage.

**Management**Conservation of the place is recommended. **Recommendation:**Any proposed change to the place should not be placed.

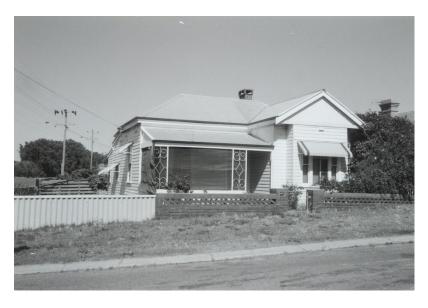
Photo Description: 24/10/1996 Suba & Grundy Metal verandah supports since replaced.
