| Area: Geraldton | Place Number: 310 | Category: 2 |

| Name: | Old Police Well |
| Address: | 283 Marine Terrace |
| Suburb: | Geraldton |

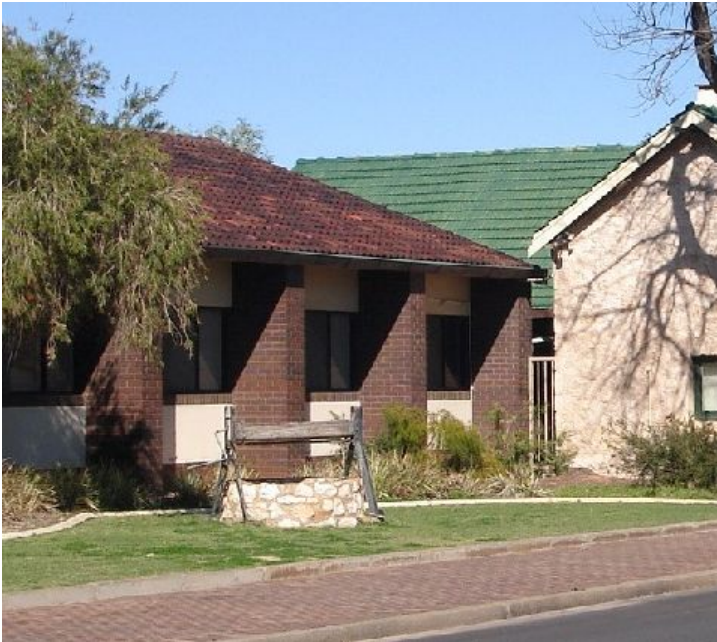
3/08/2007
Rod Milne

Located on grass verge.

| Condition: | Good | Integrity: | |

Sited on the grass verge in front of the Department of Agriculture Buildings, the simple circular well has been filled in and had the stone work restored. A steel frame supports the windless with a small metal bucket attached.

Management Category: 2
Level of Significance: CONSIDERABLE SIGNIFICANCE: Very important to the heritage of the locality.
Management Recommendation: Conservation of the place is highly recommended. Any proposed change should not unduly impact on the heritage values of the place and should retain significant fabric wherever feasible.

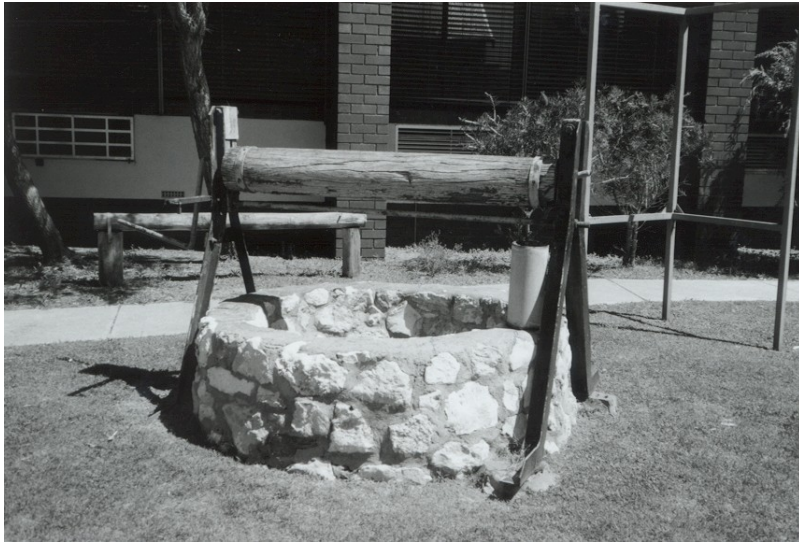
Photo Description:
5/12/1996
Suba & Grundy
Reconstructed well.
