# City of Greater Geraldton Municipal Inventory of Heritage Places Place Record

Area: Geraldton Place Number: 341 Category: 4

Name: House

Address: 2 Ruby Street Suburb: Geraldton

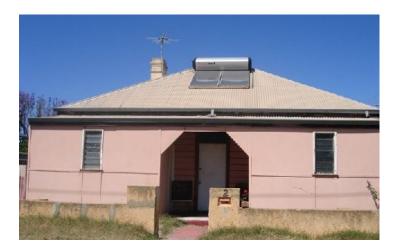
Front verandah enclosed with fibro sheeting.

**Modifications:** Verandah enclosed

This small timber framed house is clad with weatherboard and fibro and has a hipped corrugated iron roof and a separate skillion verandah roof to the rear and front elevations. There is weatherboard cladding to the front facade with fibro to the other walls, including the verandah enclosures. The side windows have metal awnings, and there is a rendered brick chimney to the rear. The street boundary has a low rendered brick wall. The solar hot water system on the north roof is an intrusive element.

Management Recommendation: Conservation of the place is desirable. Any proposed change to the place should be in

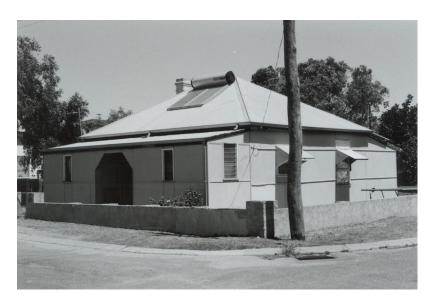
Photo Description: 5/11/1996 Suba & Grundy Corner view of house.
