Area: Geraldton	Place Number: 346	Category: 3
Assessment Date: 24/10/1996	Last Revision Date: 11/03/2010	
HCWA Number: 13738	Asset ID: MCH126830

Name:	House
Other Names:	23 Sanford Street
Type of Place:	House
Address:	23 Sanford Street
Suburb:	Geraldton

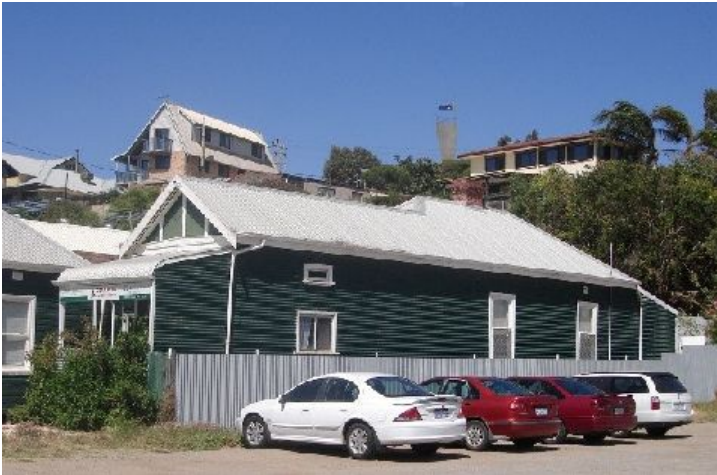
19/11/2007

Narrow building set back from street.

Walls:	Weatherboard/CGI	Roof:	Corrugated Iron
Condition:	Good	Integrity:	
Original fabric:			
Modifications:	Reclad with colorbond

Management Category:	3
Level of Significance:	MODERATE SIGNIFICANCE: Important to the heritage of the locality.
Management Recommendation:	Conservation of the place is recommended. Any proposed change to the place should not unduly impact on the heritage values of the place and should retain significant fabric wherever feasible.

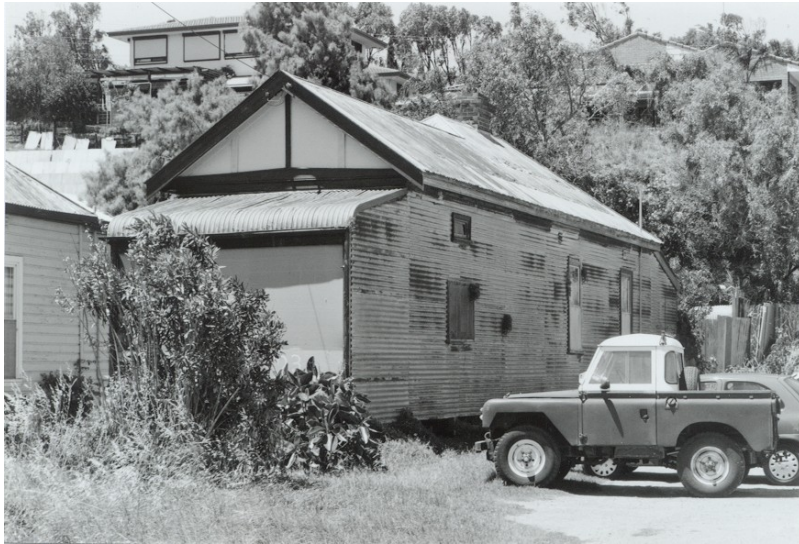
24/10/1996

Corrugated iron wall cladding evident prior to renovation.
