City of Greater Geraldton Municipal Inventory of Heritage Places Place Record

Area:	Geraldton	Place Nur	nber:	352	Cate	egory:	2	
Assess	ment Date:	24/10/1996	Last	Revision	Date:	11/0	3/201	0
HCWA	Number:	13744	Asse	et ID:		MCH	11268	53

Name:	House
Other Names:	94 Sanford Street, cnr Cathedral Avenue
Type of Place:	House
Address:	94 Sanford Street, cnr Cathedral Avenue
Suburb:	Geraldton

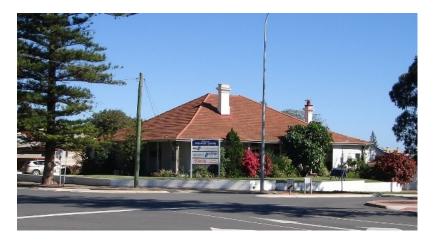
Photo Description: 3/08/2007 Rod Milne

Prior to removal of tiled roof.

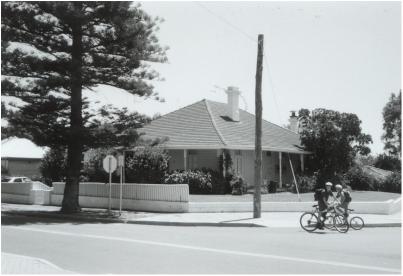
Photo Description: 24/10/1996 Suba & Grundy Tiled roof which was replaced with zincalume in 2009.
