Area: Geraldton	Place Number: 359	Category: 3
Assessment Date: 24/10/1996	Last Revision Date: 11/03/2010	
HCWA Number: 13752	Asset ID: MCH126494

Name:	House
Other Names:	140 Sanford Street
Type of Place:	House
Address:	140 Sanford Street
Suburb:	Geraldton

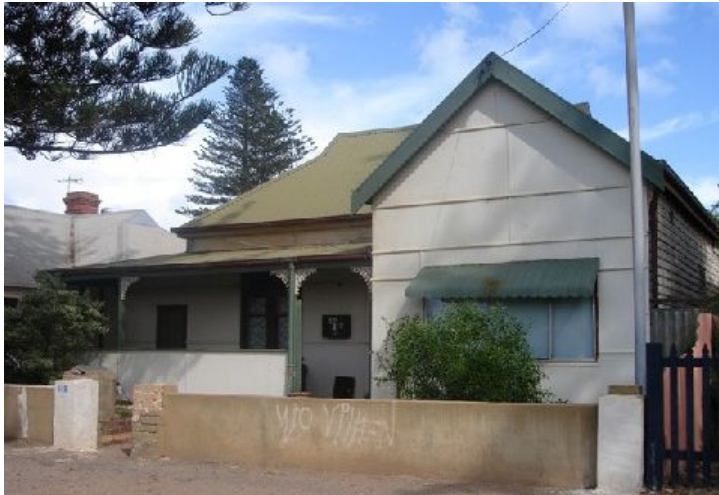
Front facade from Sanford Street.

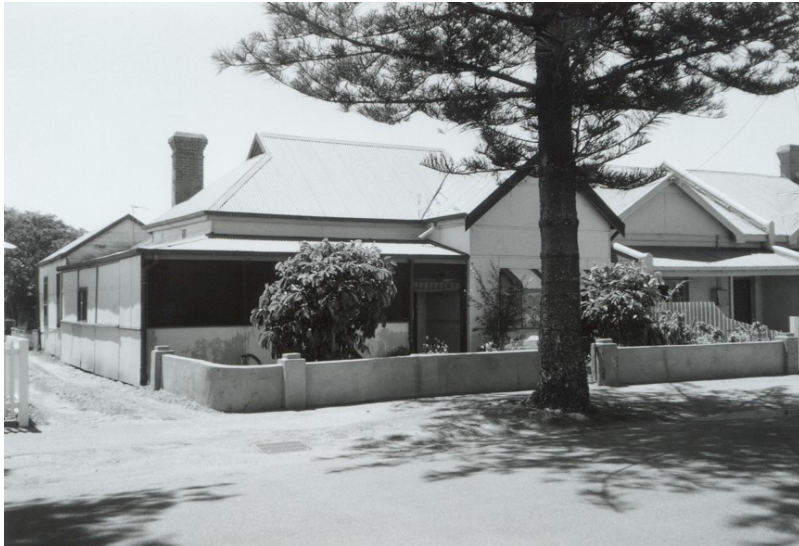
Front facade cladding replaced with fibro.
