Area: Greenough	Place Number: 170	Category: 4
Assessment Date: 09/12/1997	Last Revision Date: 24/02/2015	
HCWA Number: 13936	Asset ID: MCH127005

Name:	Coal Shafts
Other Names:	Eradu North Road
Type of Place:	Mine Shafts
Address:	Eradu North Road
Suburb:	Eradu

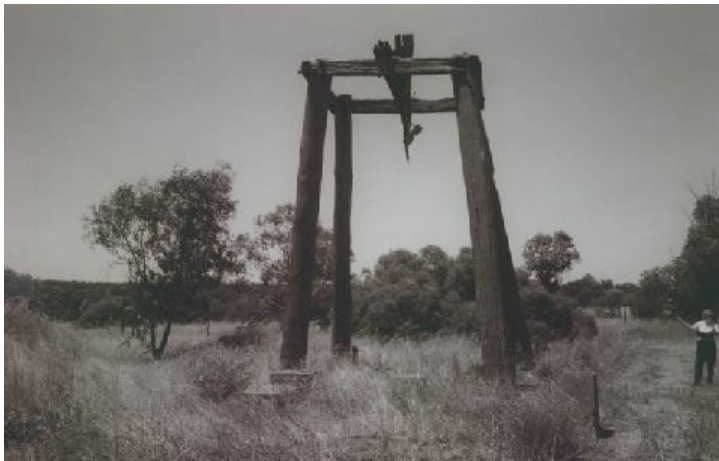
View of mine site

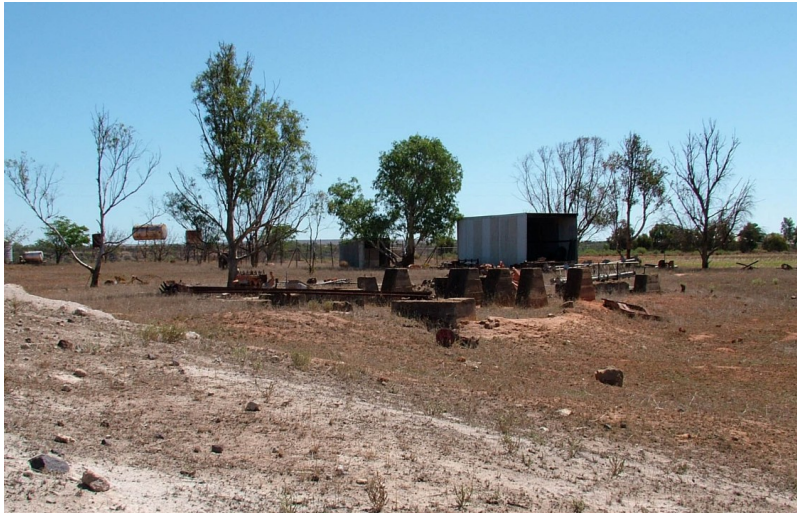
Situated approximately 50 metres north-east of Cream's House are the remnants of two coal mine shafts. One shaft is marked by the remains of a large timber poppet head which sits over a pit now used for rubbish. Immediately to the east are the concrete footings which mark the location of the second shaft.

2004/5 review: The timber poppet head has been removed since the last review.

Timber structure over shaft, now removed

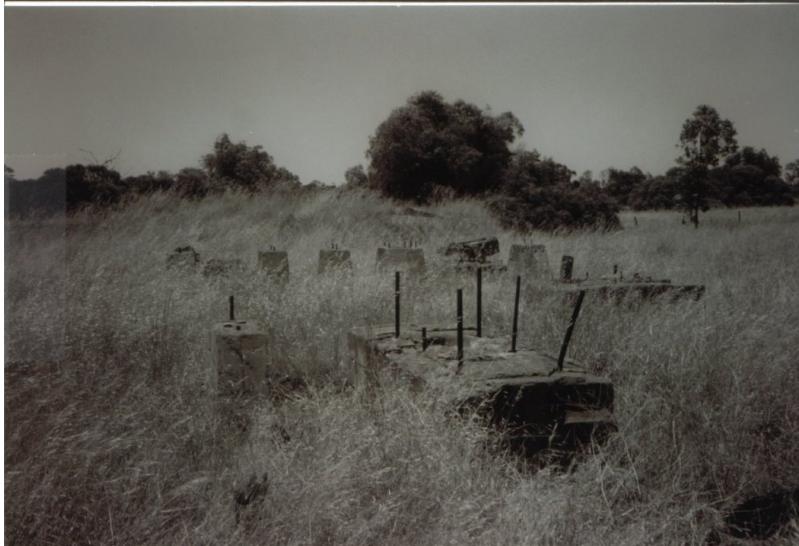
Concrete remains
