RE: TP17/201 LOT 72 (206) CHAPMAN ROAD, BERESFORD

**Condition Report**

**Residence at Lot 72, No. 206 Chapman Road, Beresford**

**17AUG2017**

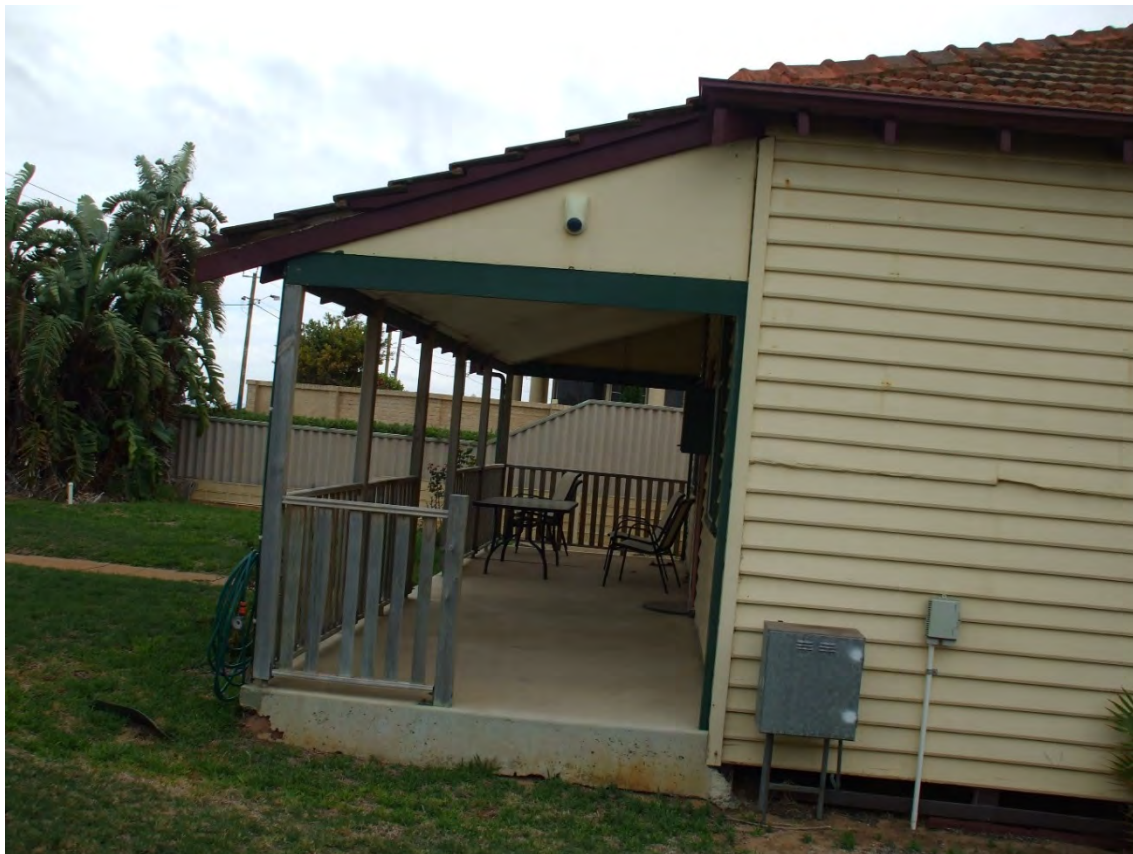
3. Front Verandah view from South

The front verandah has a recent concrete floor and CCA pine balustrade – assumed built at the same time – date of construction unknown.

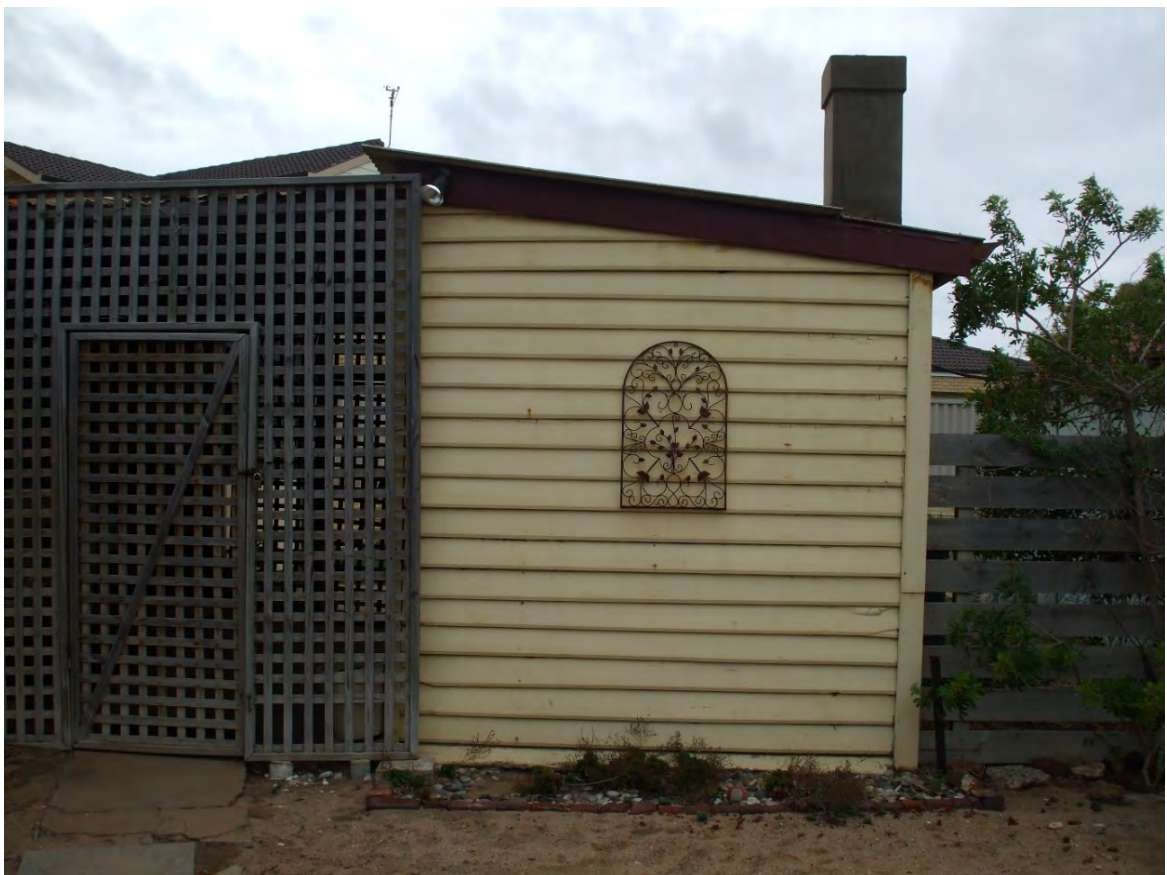
6. Side view Laundry

The laundry located next to the water closet is unenclosed and is constructed of the same timber slats and roof sheeting as per the water closet. Our client would like to have laundry facilities that are located inside of the main dwelling so that any appliances located in the room are protected from the elements.

The next nearest structure to the above is another former outbuilding (the laundry and toilet building) that is now joined to the rear verandah by a flat substandard roof. This building is also of a poor standard with no internal linings, cracked concrete floors, gaps in the laundry where the wall meets the floor and roof and severe subsidence at the north toilet end. This area of roof has been enclosed at some stage in the past with a CCA pine lattice fence and gates to presumably secure the back of the house from intruders.

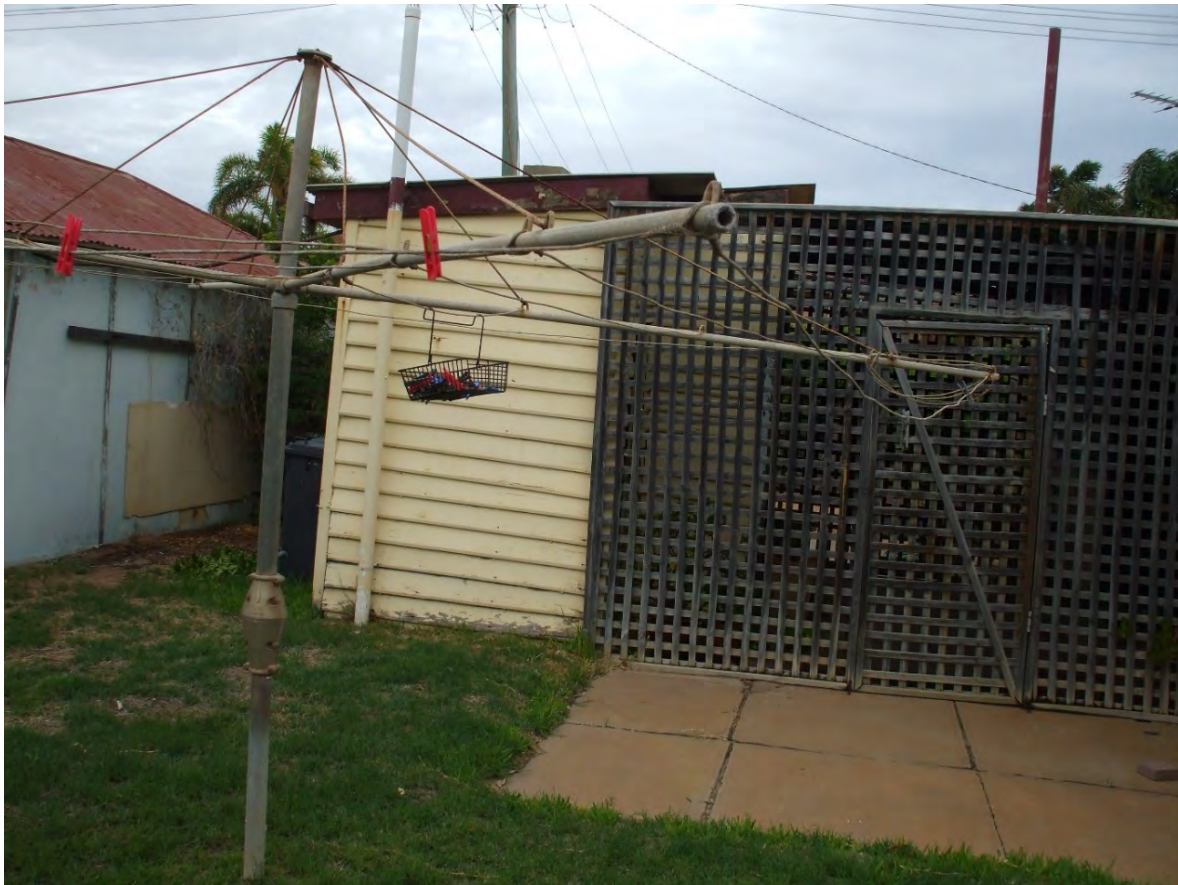
7. Side view Toilet

As can be seen with the floor plan and photos supplied to council, the bathroom and water closet are located outside of the main dwelling. The bathroom is located next to the verandah, and the water closet is detached from the dwelling. To get to it our clients need to descend a couple of steps from the verandah, and then walk through the patio area. The photos supplied shows the water closet as having a single layer of timber slat walls with gaps, allowing rain, wind and sand into the room. The ceiling is corrugated sheeting which is partially rusted. On the whole the water closet is not favourably located and uncomfortable, it is open to the elements and unsafe for use late at night.

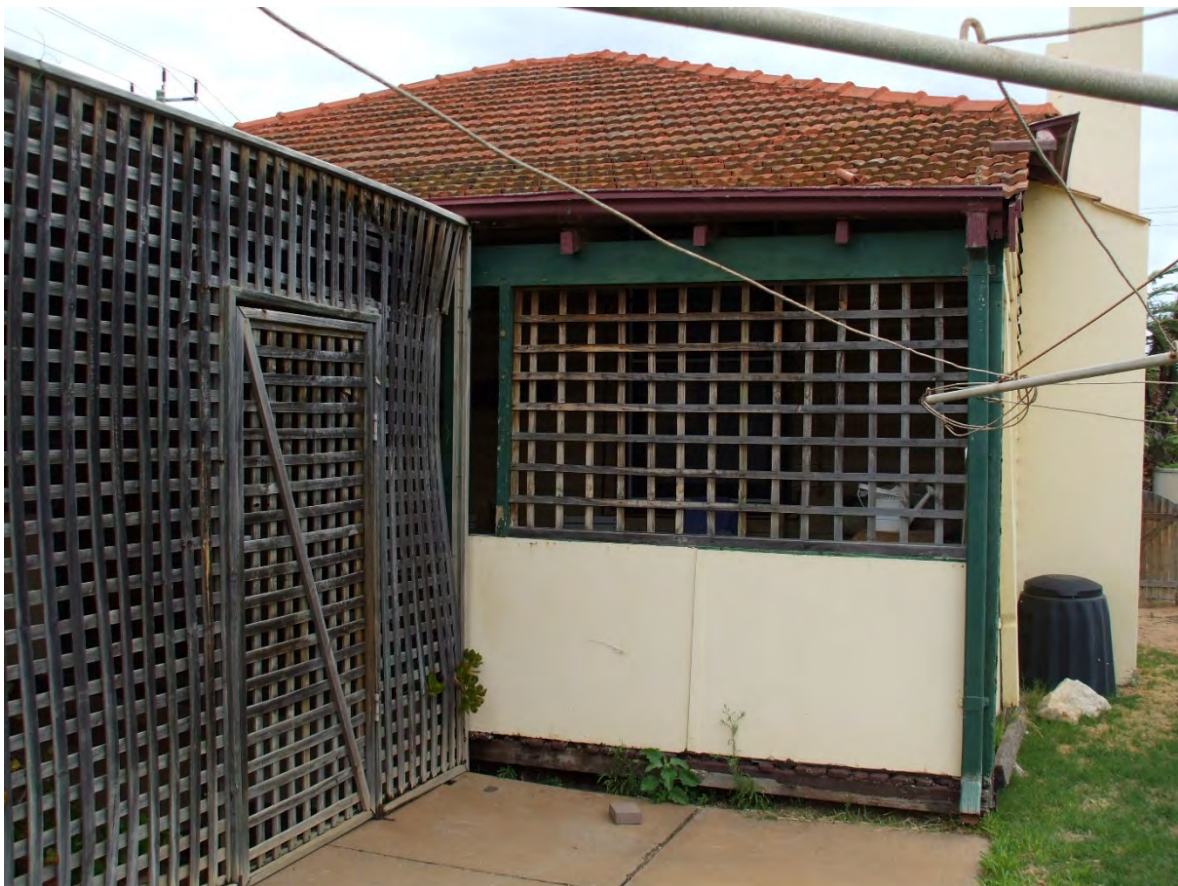
8. View of rear verandah

The rear of the main house is next with a semi enclosed verandah structure that has a bathroom in its south end. The north end of the verandah is enclosed by an old fibro wall that is badly cracked from subsidence of the verandah support structure in the north east corner. There is no lining to the underside of the tile roof. At the south end the bathroom is in poor condition, though usable, with water damage and peeling paint evident internally.

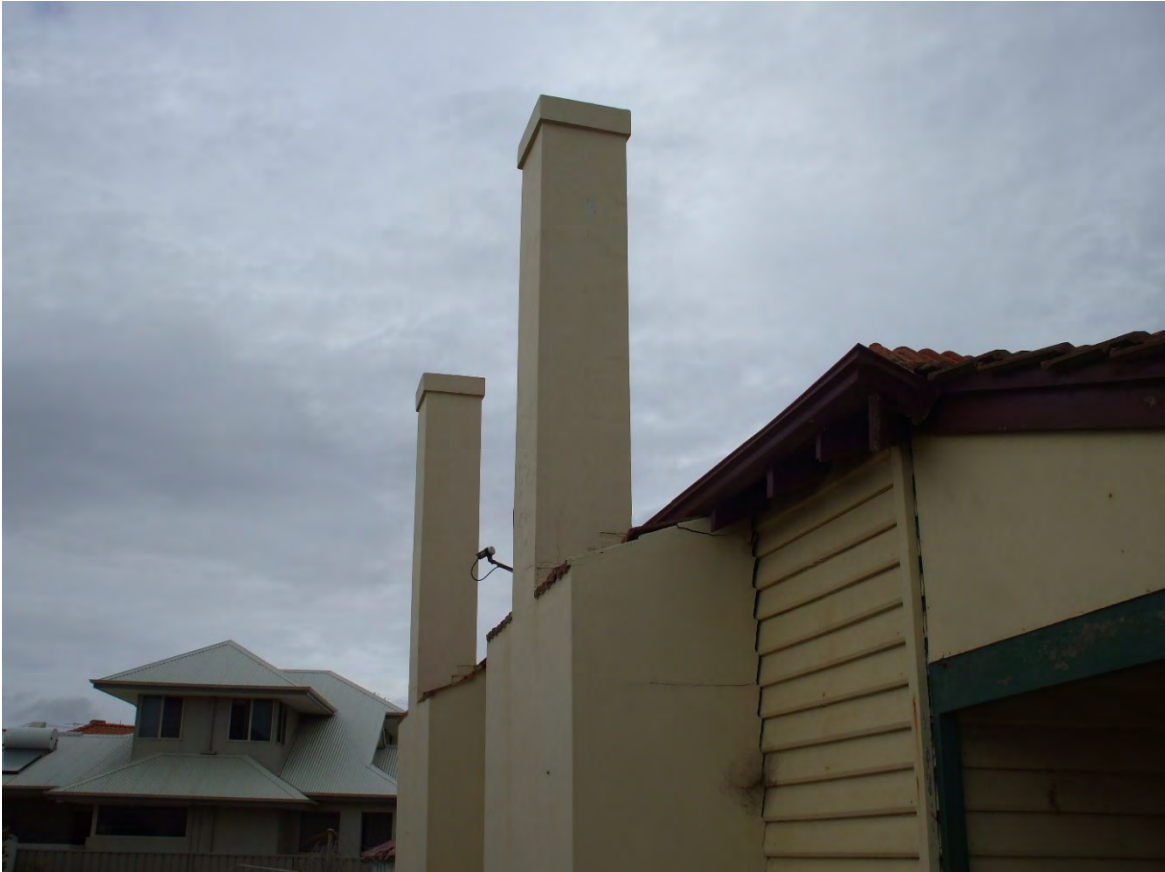
9. Chimneys on Nth side

The two chimney structures on the north side of the house are imposing but plain structures on what is a modest size house. Both have evidence of cracking through their rendered finishes with the major concern being the cracking where the tall narrow chimney stack sits on the supporting brick fireplace wall – I deem both of these as unsafe constructions as there was generally no historic reinforcing of chimney structures and this unsafe assessment is accentuated by the square shouldered design of the support wall with the tall narrow stacks above. It was more common to buttress the chimney stacks by building up angled masonry side walls from the top of the supporting wall.

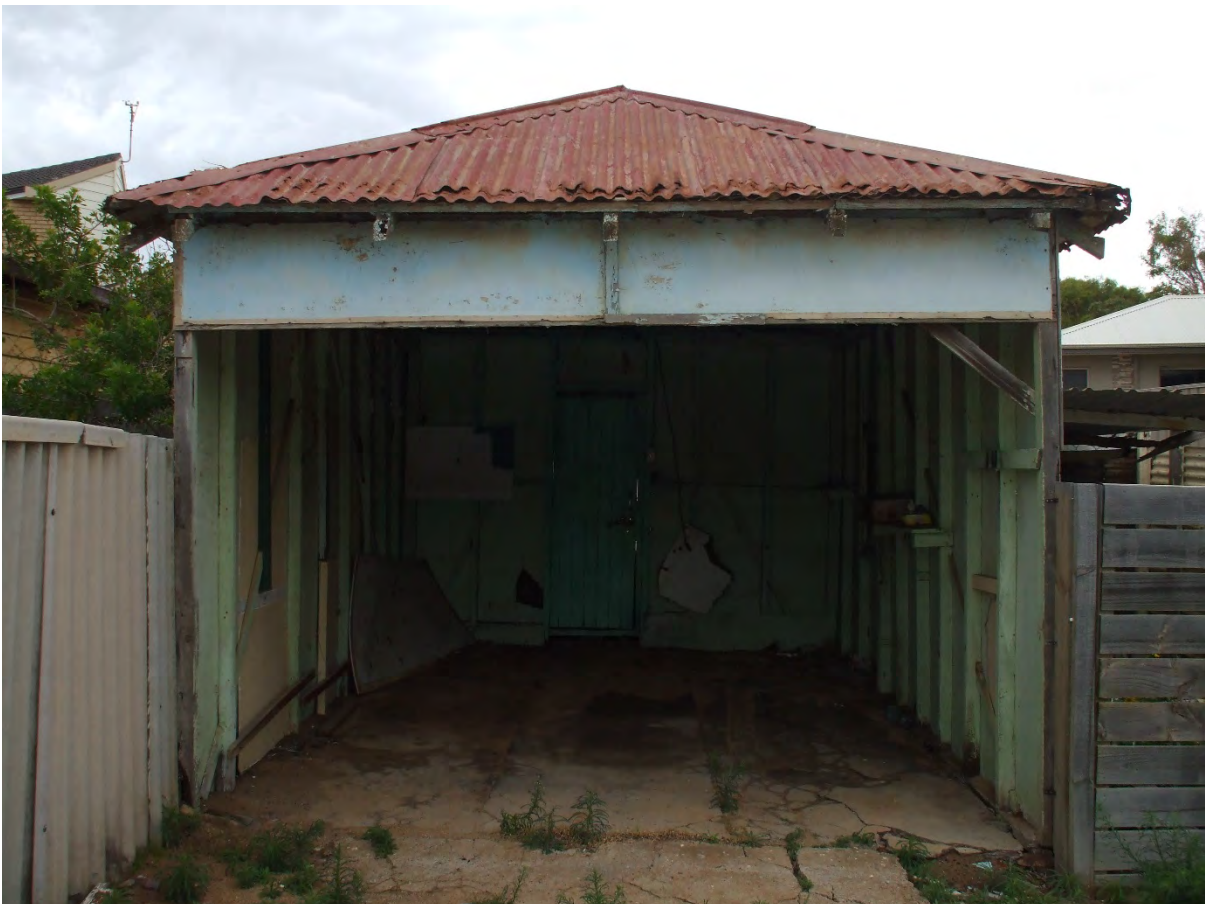
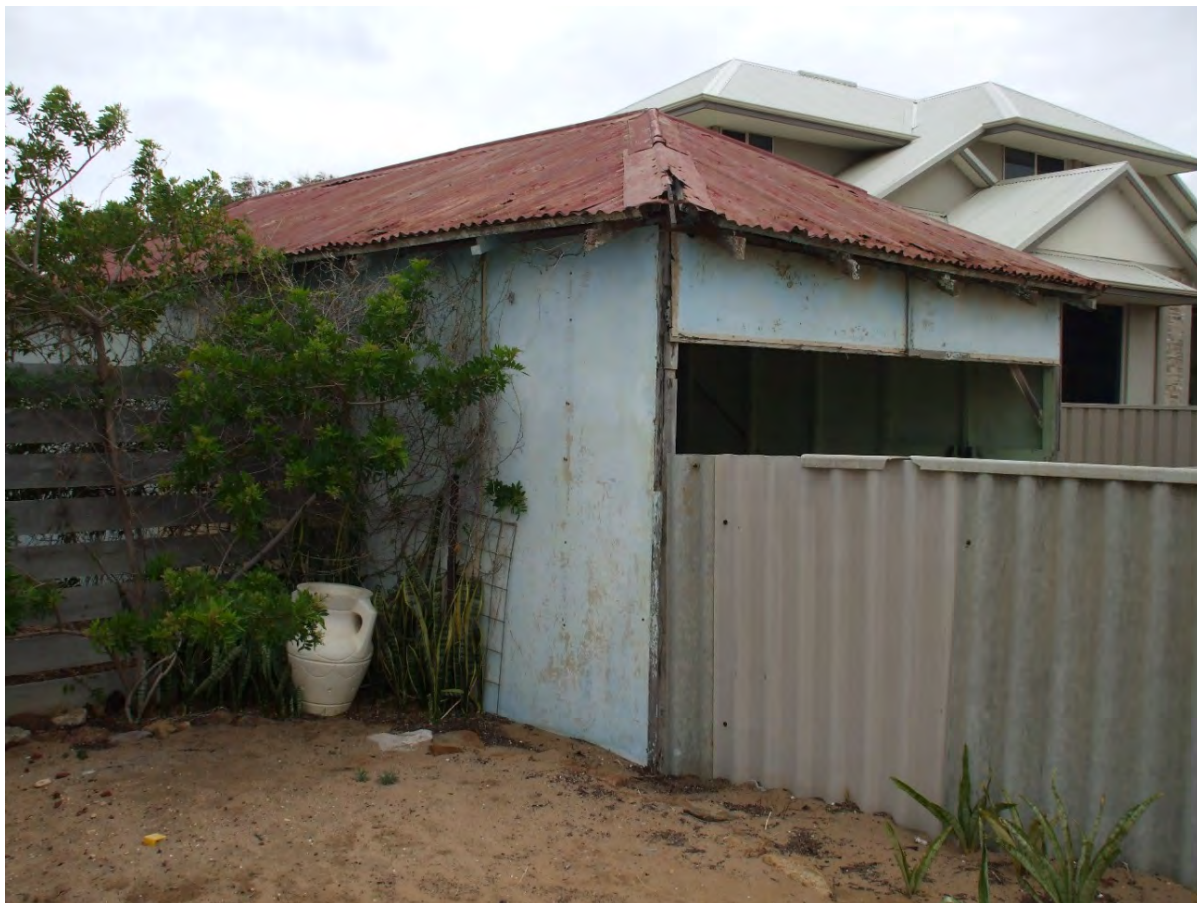
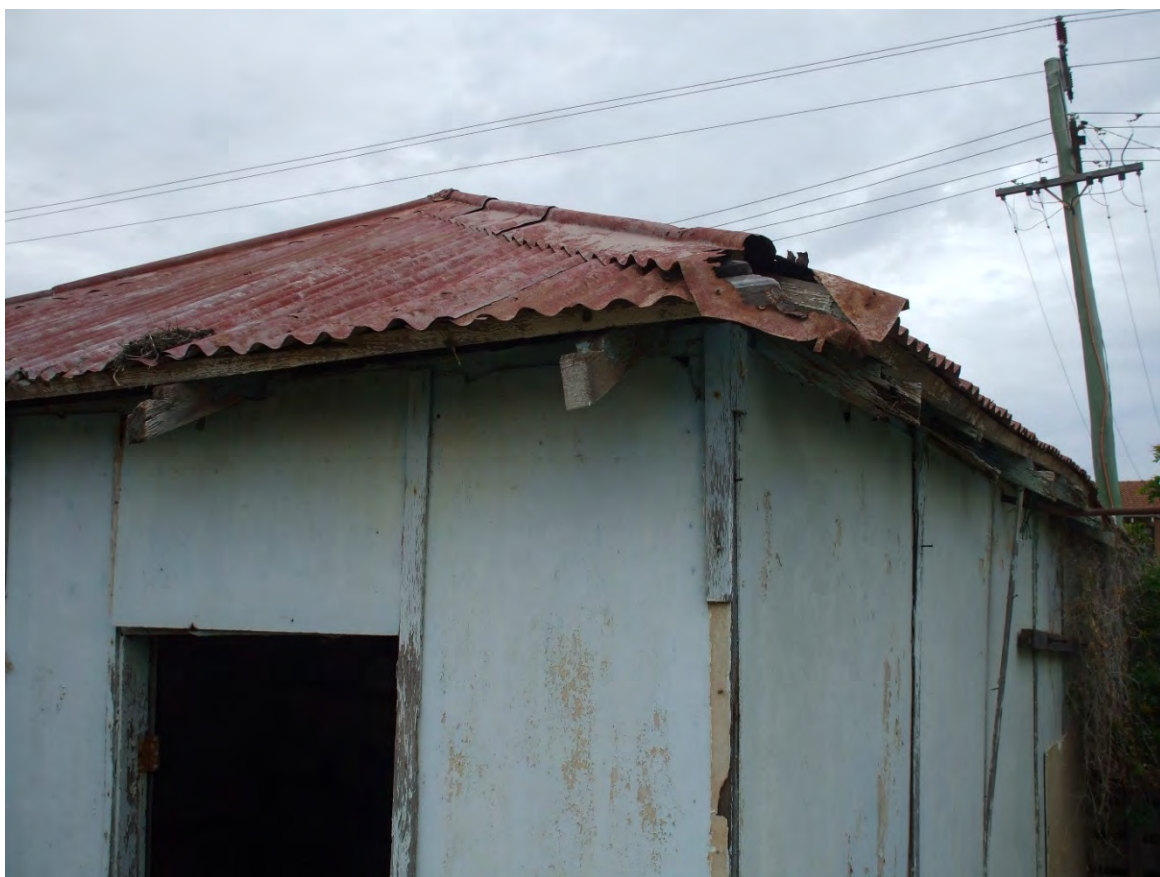
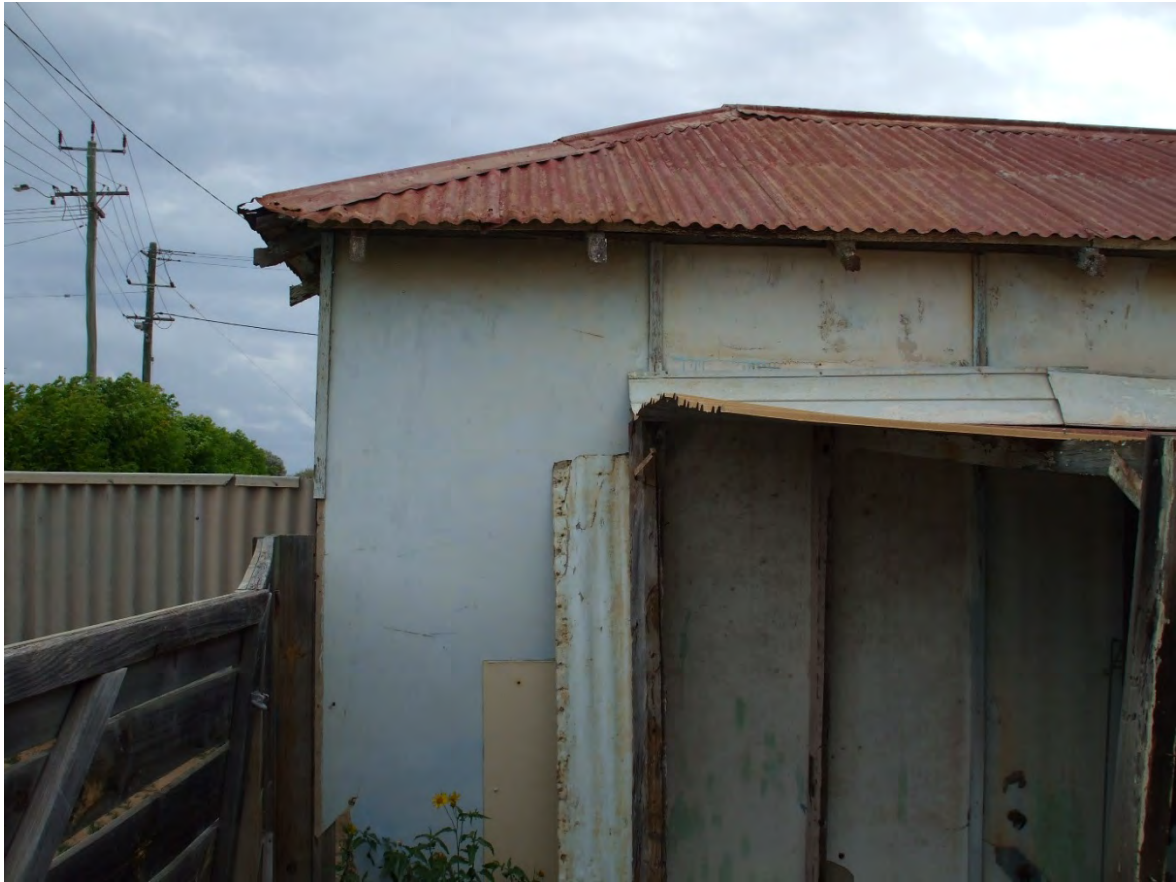
The outbuildings of the current dwelling are quite dilapidated with unstable walls that contain asbestos making the area quite unsafe. There is no door to the garage, the concrete floor is severely cracked and lifting and the roof sheeting rusted. Mr and Mrs King are currently unable to use the garage to lock away their vehicles neither are they able to use the area for storage. The proposed new dwelling will have a double garage attached to the house with a separate storage area.

The rear outbuildings as shown on the site plan consist of a single garage with a storage area to its north end and a lean to shed on its east side - all in a poor state of repair. The roof of this structure is painted, rusted CGI with old fibro cladding to the timber framed walls. Many of the fibro panels are broken or missing with some of the damage caused by two large Cape Lilac trees (now visible stumps) that were allowed to grow by a previous owner at too close a distance to the structure. This structure is generally not used.
