<b>Area:</b> Geraldton	<b>Place Number:</b> 105	<b>Category:</b> 3
<b>Assessment Date:</b> 24/10/1996	<b>Last Revision Date:</b> 28/10/2009	
<b>HCWA Number:</b> 13357	<b>Asset ID:</b> MCH126565

<b>Name:</b>	House
<b>Other Names:</b>	61 Durlacher Street
<b>Type of Place:</b>	House
<b>Address:</b>	61 Durlacher Street
<b>Suburb:</b>	Geraldton

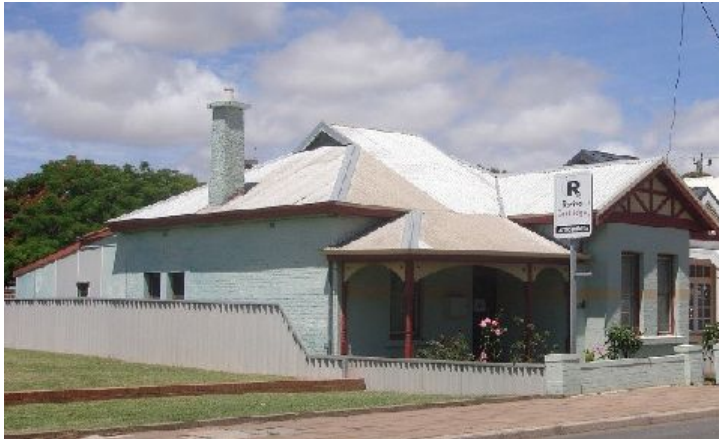
18/12/2007

Brickwork painted light blue.

<b>Walls:</b>	Brick	<b>Roof:</b>	Corrugated Iron
<b>Condition:</b>	Good	<b>Integrity:</b>	
<b>Original fabric:</b>	Pediment detailing		
<b>Modifications:</b>	Brickwork painted

<b>Management Category:</b>	3
<b>Level of Significance:</b>	MODERATE SIGNIFICANCE: Important to the heritage of the locality.
<b>Management Recommendation:</b>	Conservation of the place is recommended. Any proposed change to the place should not unduly impact on the heritage values of the place and should retain significant fabric wherever feasible.

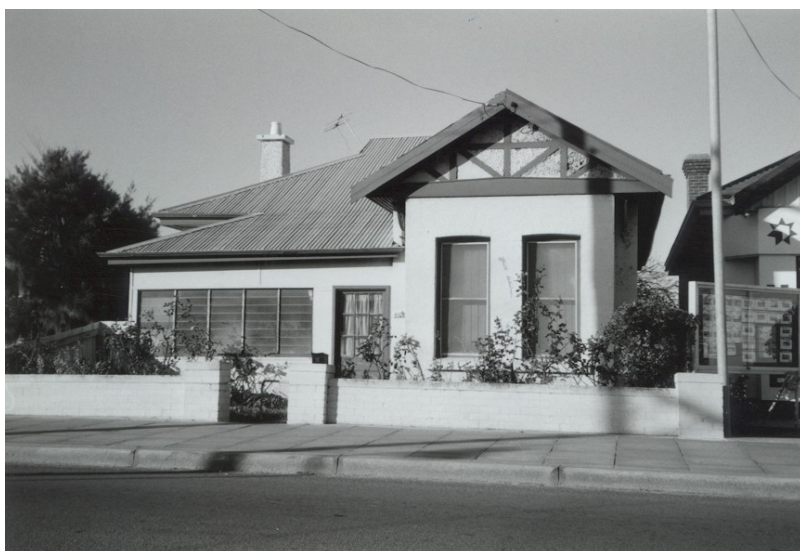
24/10/1996

Verandah enclosures since removed.
