Area: Geraldton	Place Number: 184	Category: 2
Assessment Date: 14/10/1996	Last Revision Date: 19/11/2009	
HCWA Number: 13281	Asset ID: MCH126884

Name:	Corner Store Fmr
Other Names:	147 Augustus Street
Type of Place:	Shop/House
Address:	147 Augustus Street
Suburb:	Geraldton

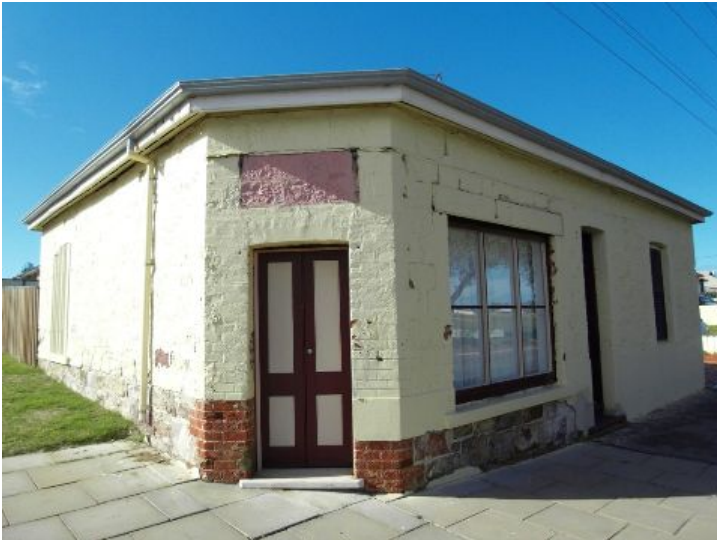
Former shop now in use as a residence.

Walls:	Stone	Roof:	Corrugated Iron
Condition:	Good	Integrity:	
Original fabric:			
Modifications:

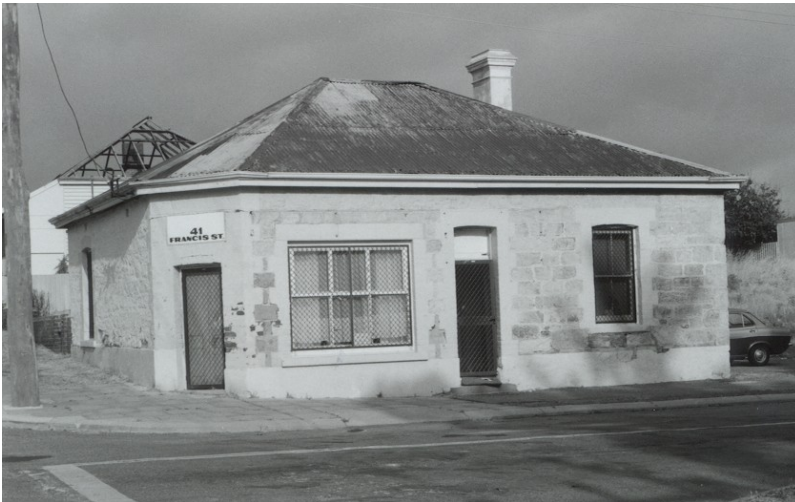
Building prior to re-roofing.
