Area: Geraldton	Place Number: 81	Category: 3
Assessment Date: 25/10/1996	Last Revision Date: 27/10/2009	
HCWA Number: 13336	Asset ID: MCH126482

Name:	House
Other Names:	9 Conway Street
Type of Place:	House
Address:	9 Conway Street
Suburb:	Beachlands

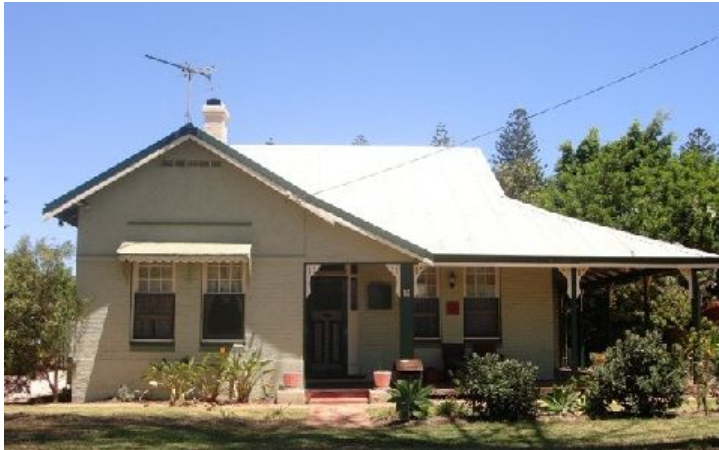
Wrap around verandah to corner of house.

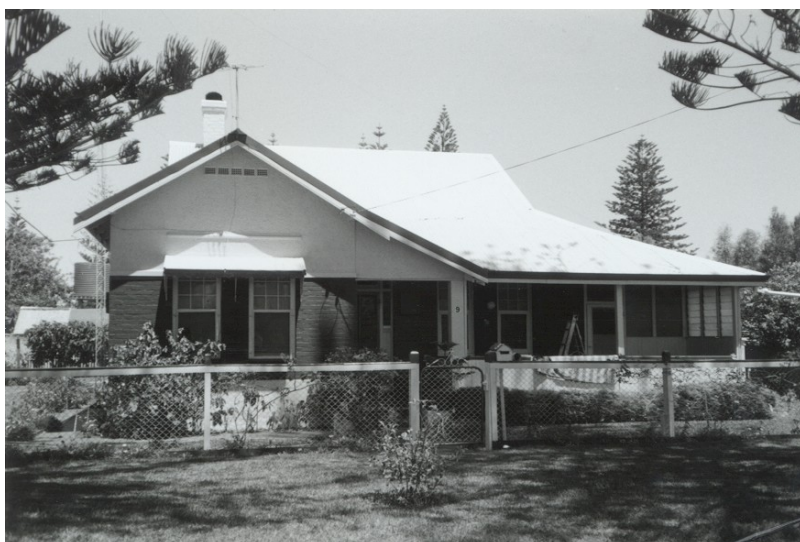
View from Conway Street showing verandah enclosures and front fence.
