| Area: Geraldton | Place Number: 83 | Category: 4 |

| Name: | House |
| Address: | 13 Conway Street |
| Suburb: | Beachlands |

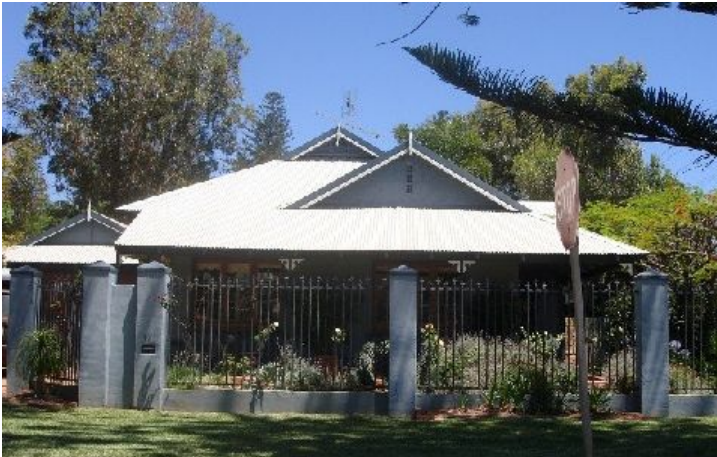
20/11/2007
Rod Milne
Corner location.

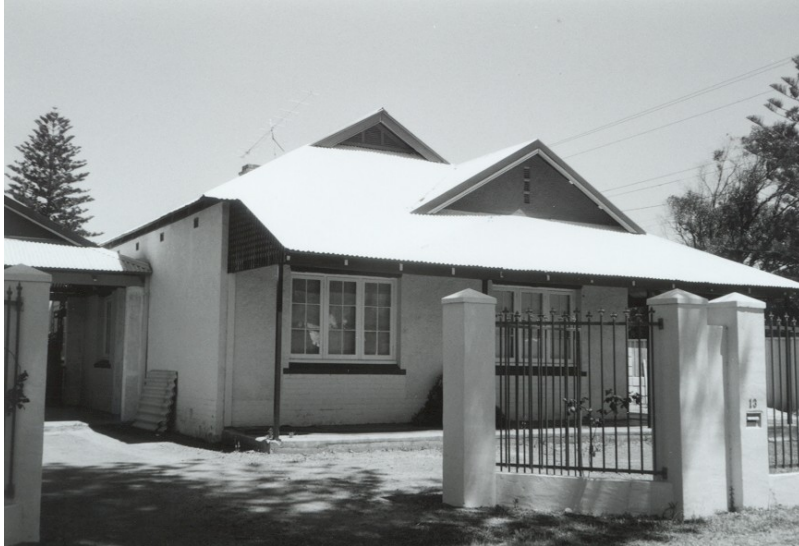
Roof gablets and small window panes a feature.
