Area: Geraldton	Place Number: 347	Category: 3
Assessment Date: 24/10/1996	Last Revision Date: 11/03/2010	
HCWA Number: 13739	Asset ID: MCH126833

Name:	House
Other Names:	26 Sanford Street
Type of Place:	House
Address:	26 Sanford Street
Suburb:	Geraldton

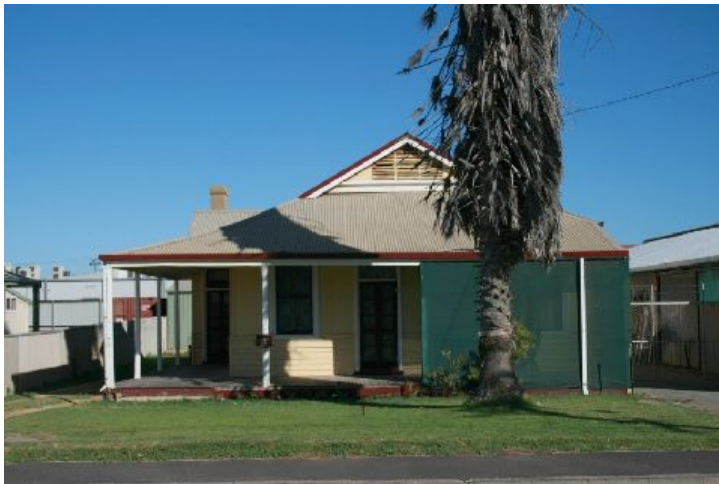
22/10/2007

One of a matching pair of adjacent houses.

Walls:	Weatherboard/Fibro	Roof:	Corrugated Iron
Condition:	Fair	Integrity:	
Original fabric:			
Modifications:

Management Category: 3
Level of Significance: MODERATE SIGNIFICANCE: Important to the heritage of the locality.
Management Recommendation: Conservation of the place is recommended. Any proposed change to the place should not unduly impact on the heritage values of the place and should retain significant fabric wherever feasible.

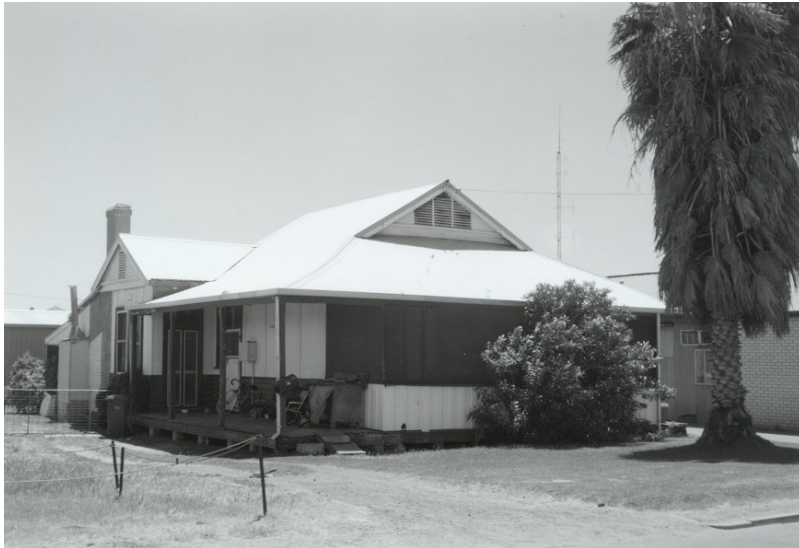
24/10/1996

Tall palm tree to front garden.
