| Area: Geraldton | Place Number: 348 | Category: 3 |

| Name: | House |
| Address: | 28 Sanford Street |
| Suburb: | Geraldton |

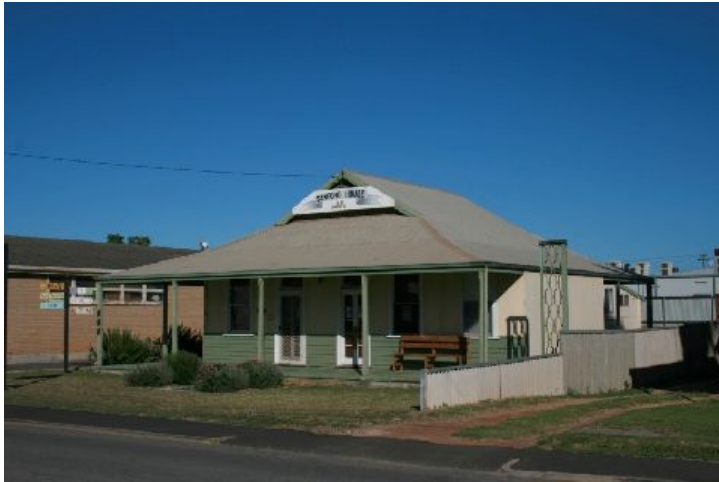
French doors are a feature of the house.

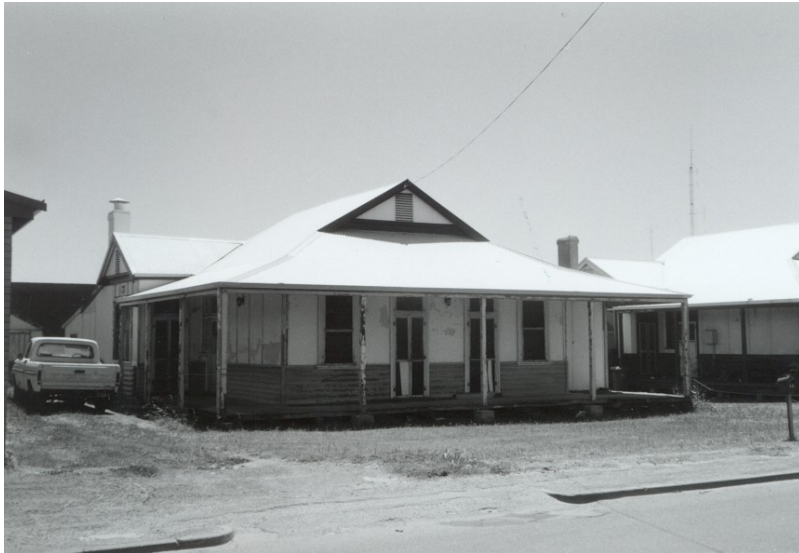
Prominent spreading verandah a feature.
