Area: Geraldton	Place Number: 349	Category: 3
Assessment Date: 24/10/1996	Last Revision Date: 11/03/2010	
HCWA Number: 13741	Asset ID: MCH126841

Name:	House
Other Names:	52 Sanford Street
Type of Place:	House
Address:	52 Sanford Street
Suburb:	Geraldton

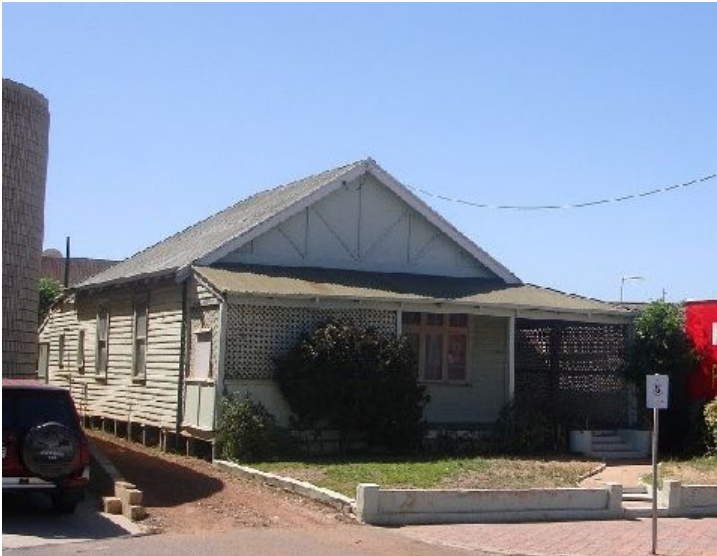
Large gable addresses the street facade.

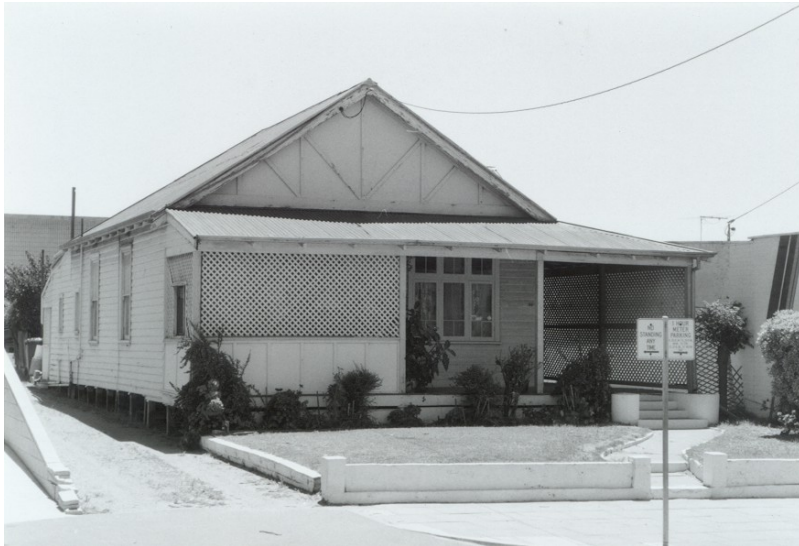
Weatherboard wall cladding.
