<b>Area:</b> Geraldton	<b>Place Number:</b> 405	<b>Category:</b> 3
<b>Assessment Date:</b> 24/10/1996	<b>Last Revision Date:</b> 09/03/2012	
<b>HCWA Number:</b> 13798	<b>Asset ID:</b> MCH127130

<b>Name:</b>	House
<b>Other Names:</b>	138 Shenton Street
<b>Type of Place:</b>	House
<b>Address:</b>	138 Shenton Street
<b>Suburb:</b>	Beachlands

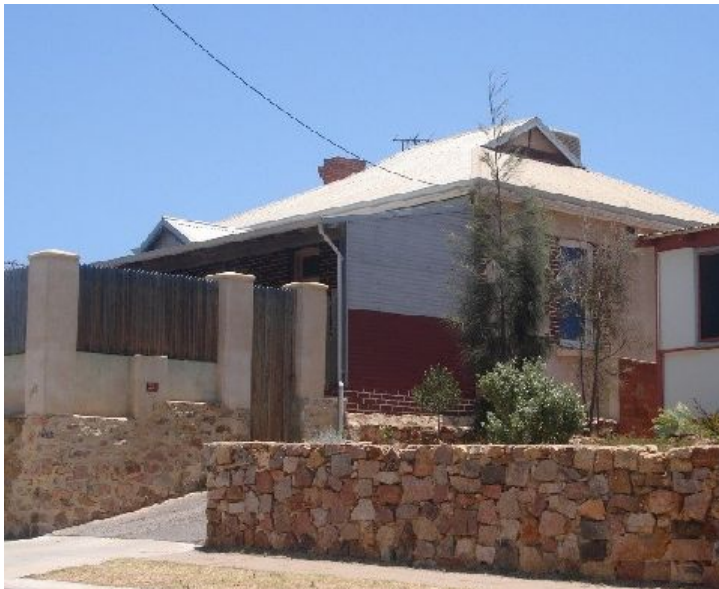
15/01/2008  
Rod Milne  
Elevated position.

<b>Walls:</b>	Brick	<b>Roof:</b>	Corrugated Iron
<b>Condition:</b>	Good	<b>Integrity:</b>	
<b>Original fabric:</b>	Largely intact		
<b>Modifications:</b>

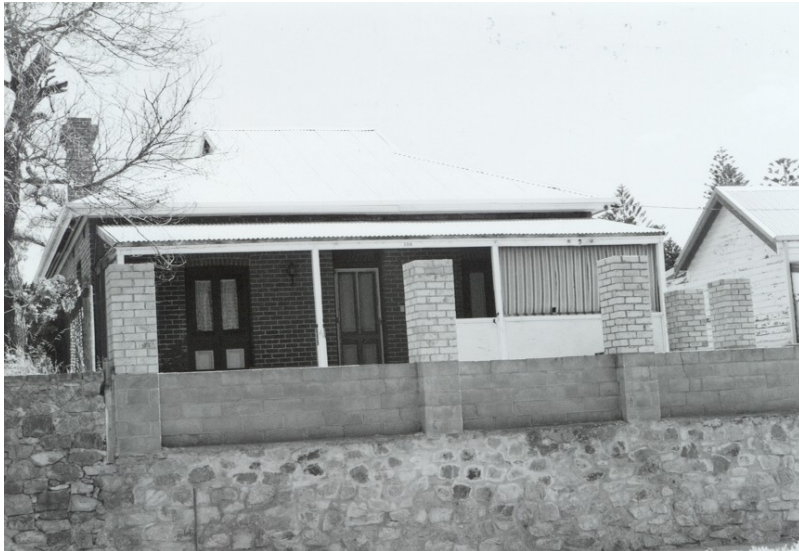
24/10/1996

Elevated position.
