**SINGLE HOUSE  
262 CHAPMAN ROAD,  
BERESFORD, GERALDTON**

**Development Application  
Report**

**Heritage Impact Assessment**

February 2019

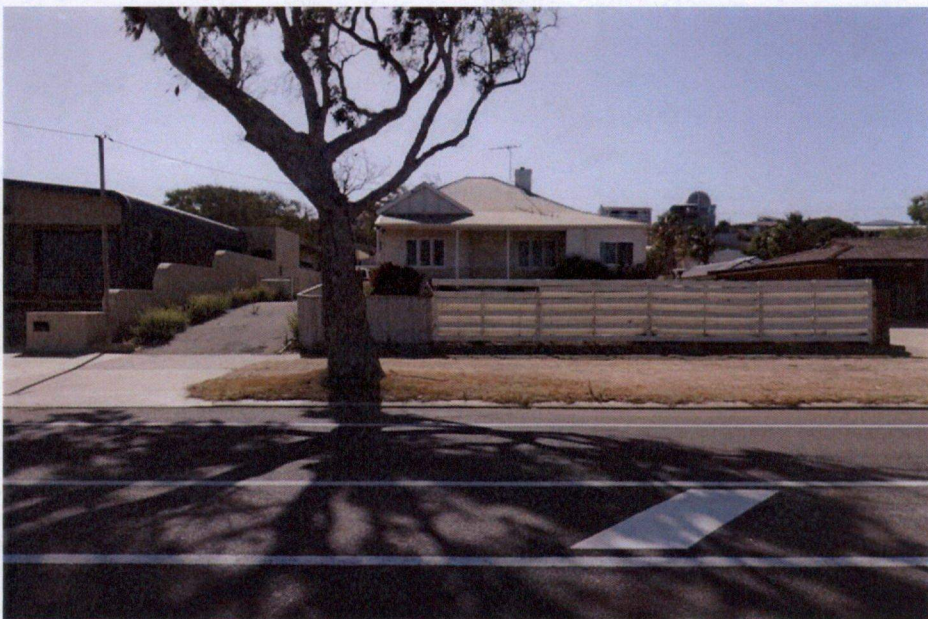
262 Chapman Road with its Tuart verge tree. The ranch style fencing dates from the late 1960s or early 1970s

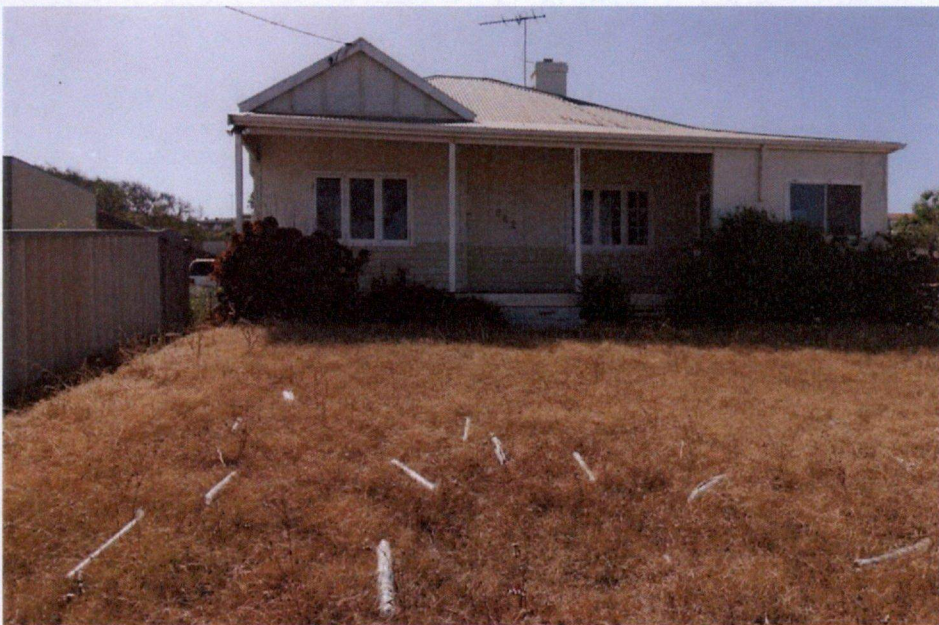
The house was built with a full width and return skillion roofed verandah, but the southern end of the west verandah and the whole of the south verandah has been filled in. The verandah now has reeded timber decking boards and 4" square posts which are notched indicating that there was originally a balustrade. Concrete steps replace the original timber steps.

Front of 262 Chapman Road, note the front door was removed and the west and south verandahs filled in. The verandah posts are original and scars on the posts indicate a balustrade.

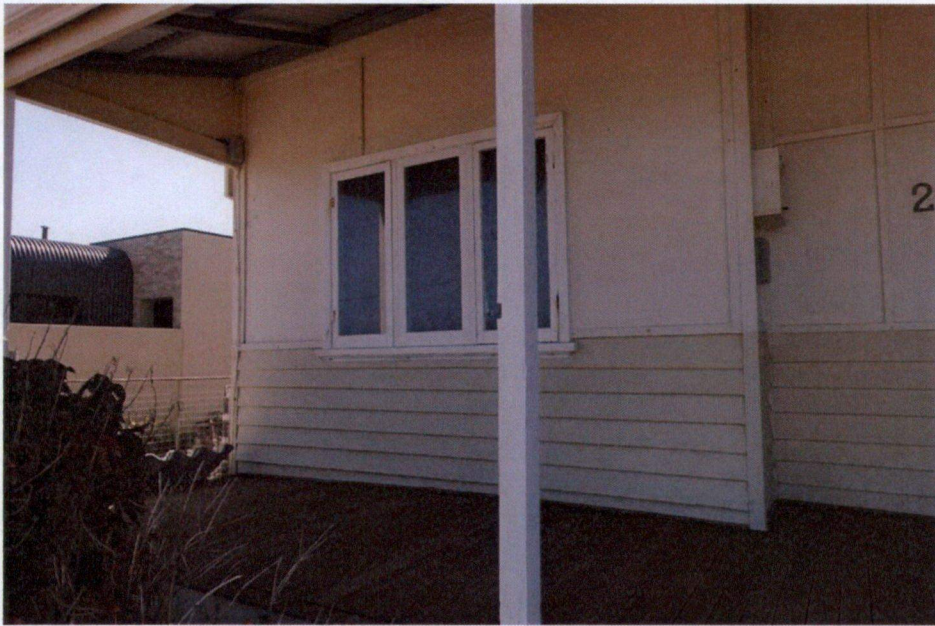
The roof is hipped with a gable over the thrust bay to the north-west room (Room 1), with an asbestos and batten infill to the gable. There is a single brick chimney extending through the roof which served the original kitchen (Room 3) and living room (Room 6). The front door was located to the centre of the west elevation, south of the thrust bay, but this has been filled in and the door moved to the infilled southern verandah.

Thrust bay to main bedroom (Room 1) and blocked in front door to the right.

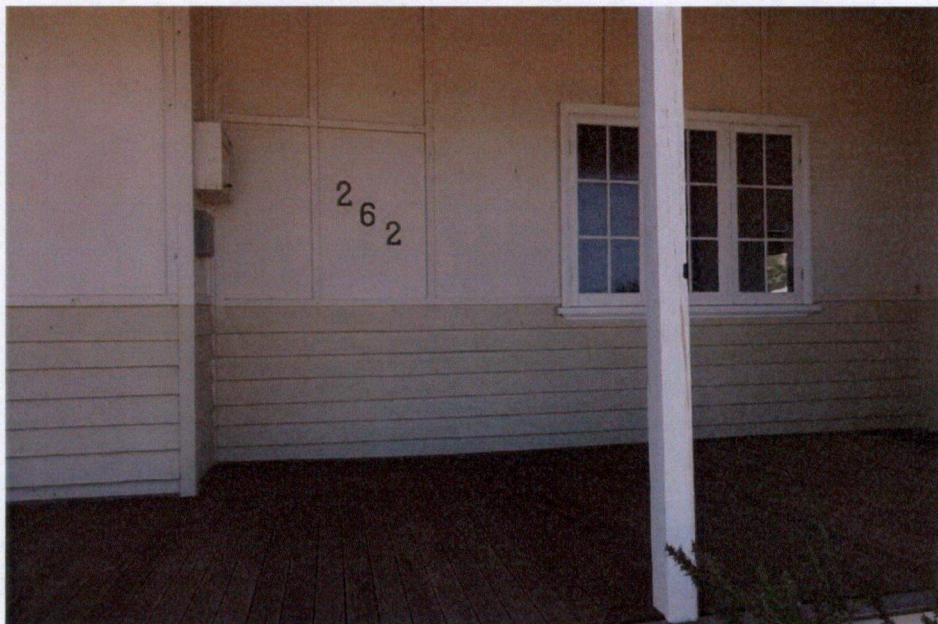
There are two sets of casement windows in the front elevation, one set of single pane and one set of 6 pane casements. One or the other is a replacement set, most likely the single pane set. The front door is a flush door a product of the 1960s or later.

The old front door location and the set of windows that are most likely original.

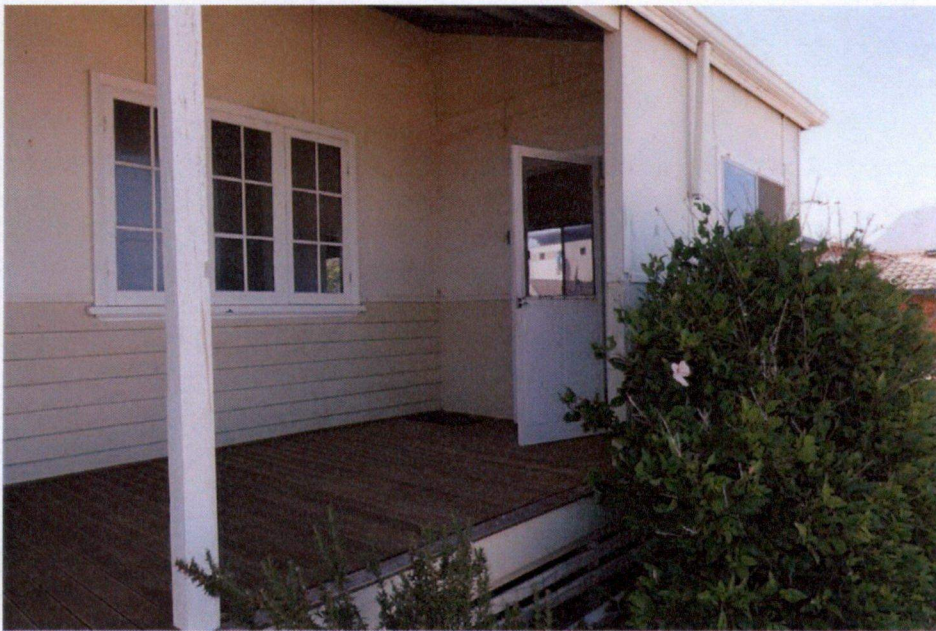
The current front door in the verandah infill.

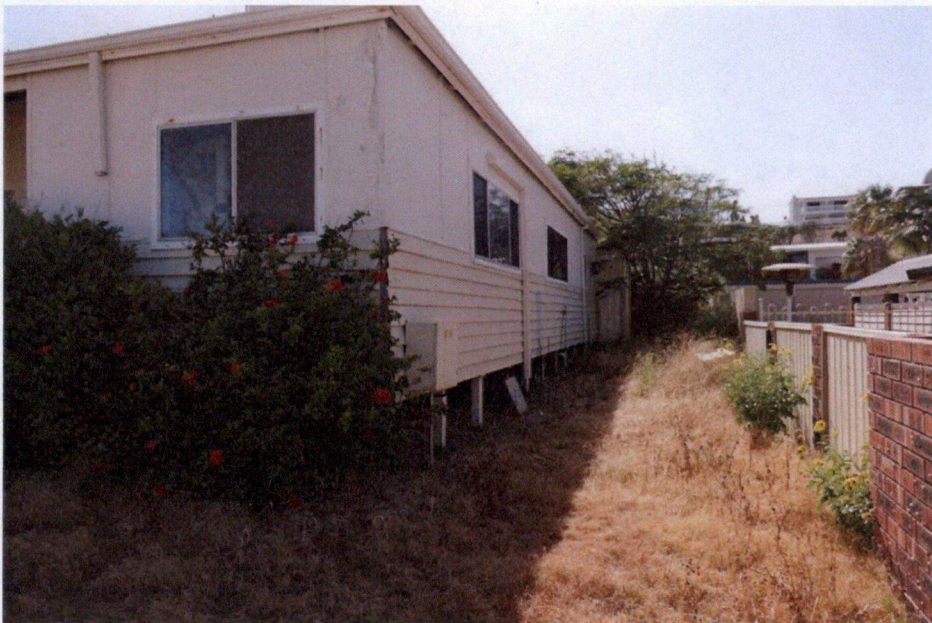
The north elevation follows the same pattern as the front elevation, with a single double hung sash window (Room 2) and aluminium windows (Room 4). The south elevation is all the product of filling in a verandah which was done using the same materials and the original house, though all windows on this side of the house are aluminium sliding sashes.

The south elevation, a filled in verandah with aluminium windows. The tree in the distance is a Cape Lilac.

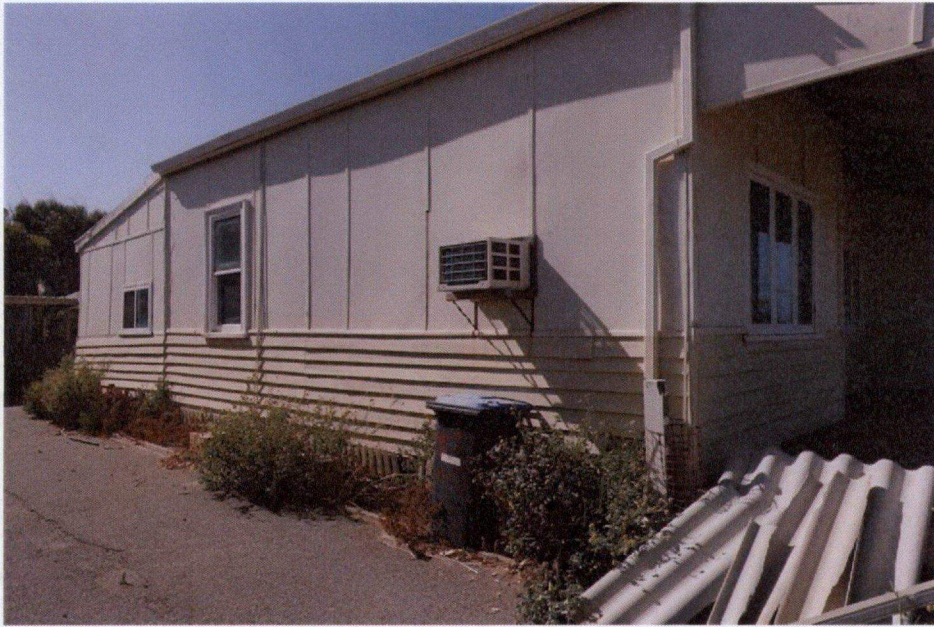
North elevation which is largely original fabric, aside from the window in the skillion.

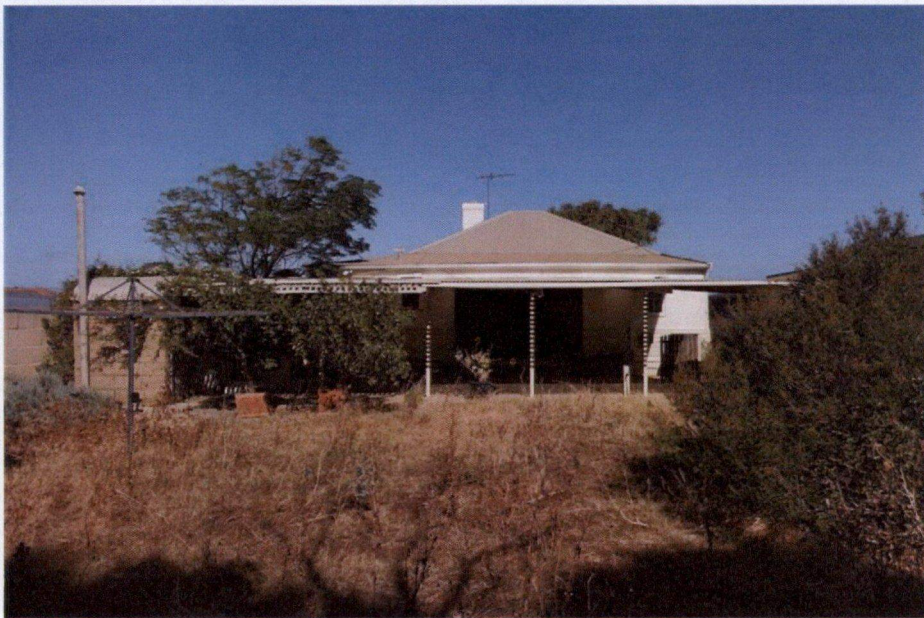
The rear elevation is a patchwork comprising the exterior of the original bathroom to the north (Room 5), a verandah filled in with aluminium sliding doors, and a laundry and bathroom with sash and louvred windows. The area is shaded by a large steel framed patio shade structure of recent vintage, together with a concrete floor.

Rear of the house, with the concrete block construction water closet to the left.

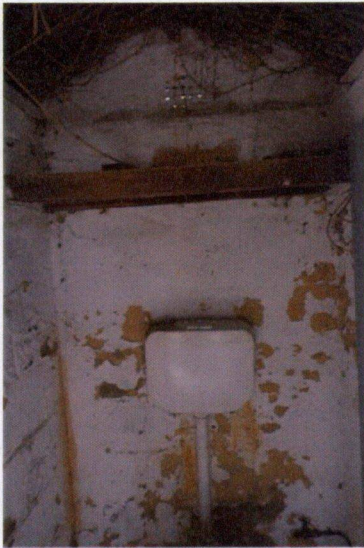
The water closet is constructed in handmade concrete blocks and would appear to be contemporaneous with the house. There is a contemporary pan and cistern in the toilet and the brackets for the wash down pan cistern is still in place. The toilet is listing to the east.

Interior of the water closet and washdown cistern brackets.

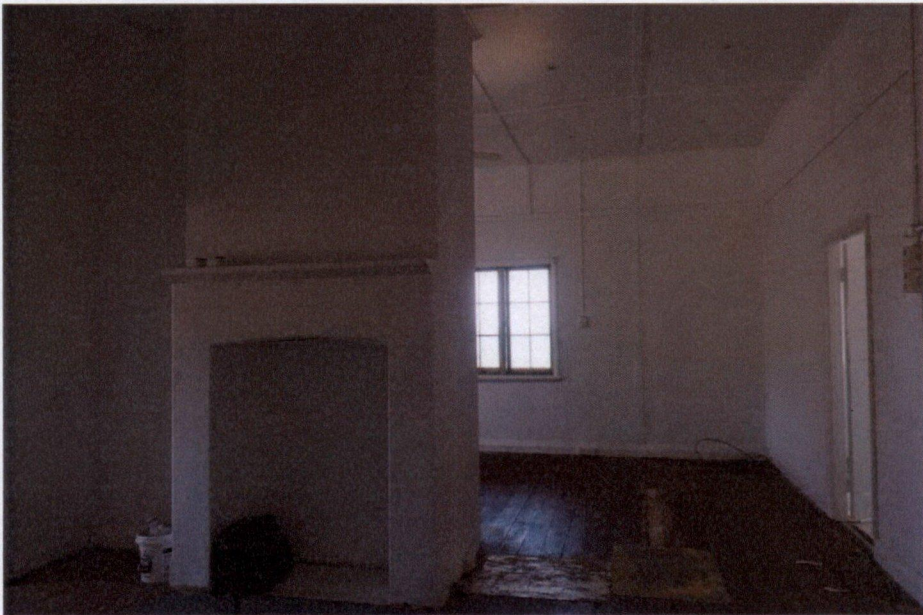
The original house comprised four main rooms and a hall, then a rear bedroom, bathroom and verandah. The southern wall that created the original central corridor has been removed, and the southern walls that separated room 3 and 6 from the verandah have been removed also.

Kitchen looking west (Room 3). The line of the corridor can be seen in the floor.

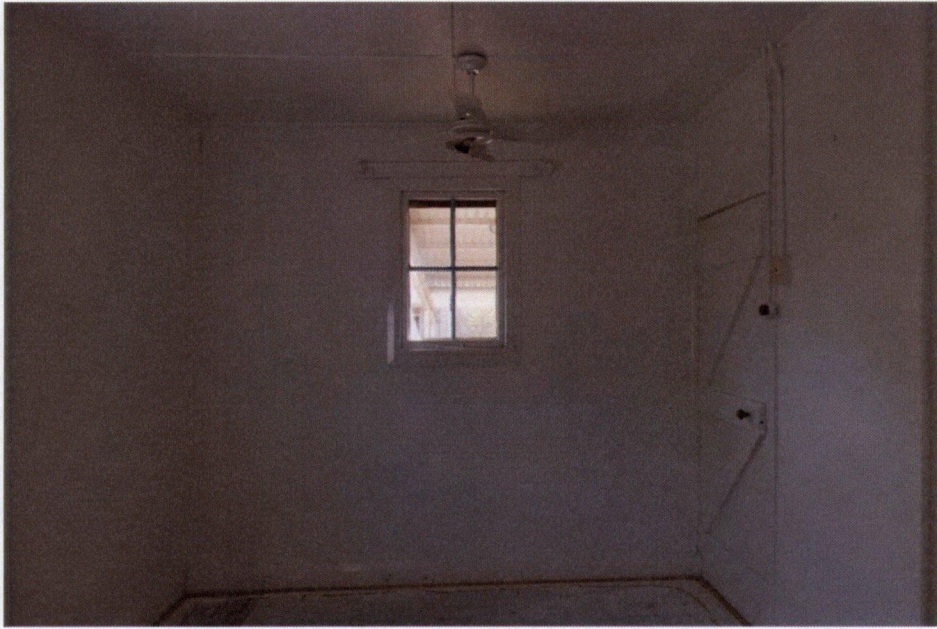
In Rooms 4 and 5, where the rear bedroom and bathroom and have been joined together, the same details that were noted in the original rooms of the house continue in this area, except that Room 4 has a flush door and Room 5 has a ledge and braced T&G faced door. Both rooms have a skillion soffit.

A combined bedroom and bathroom (Rooms 4 and 5). The line of the dividing wall can be seen in the floor.

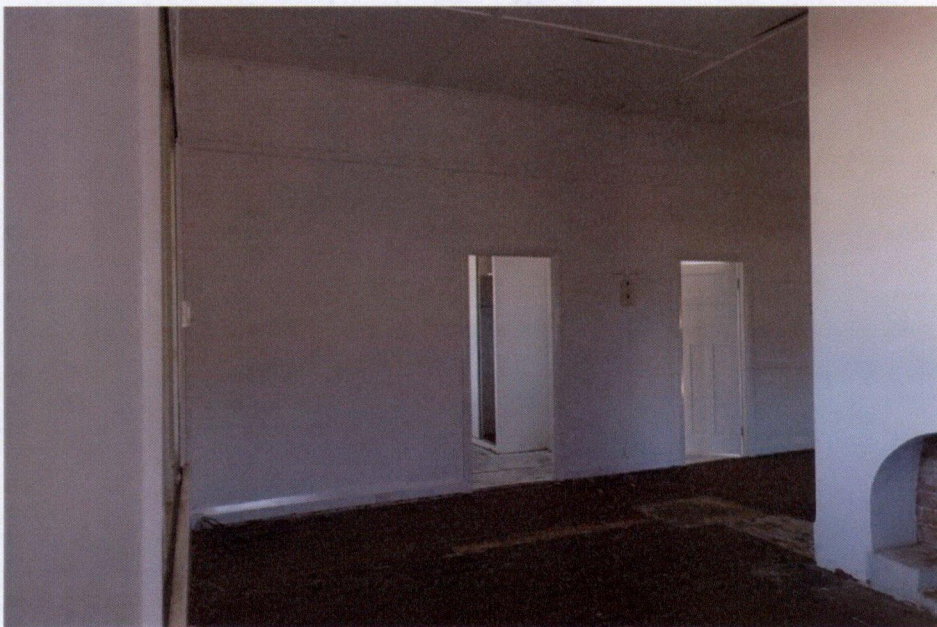
Combined living room and passage (Room 6), with bedrooms beyond.

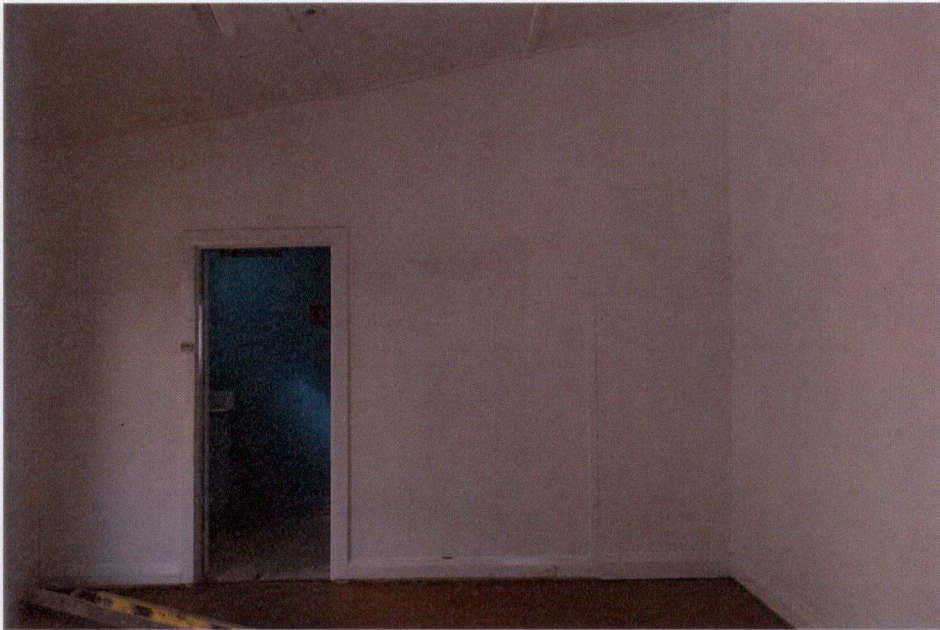
Room 11 is a filled in verandah, with aluminium sliding sashes to complete the filling in. This space is part of the original construction and is also under a skillion roof. The floor in this area is falling away steeply.

Infilled rear verandah looking south (Room 11) to the laundry.

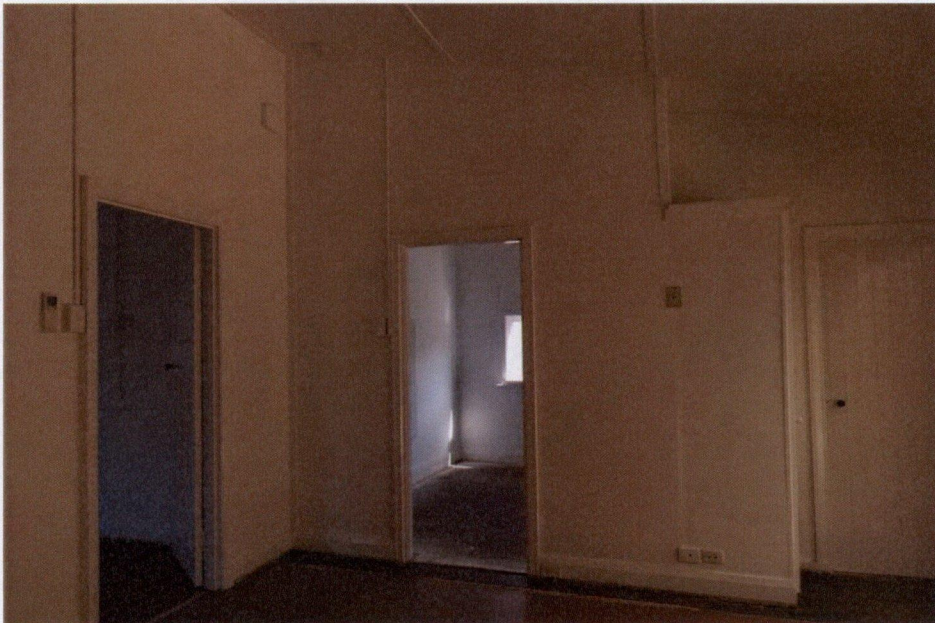
Infilled verandah looking north (Room 11). The former bathroom door is to the right.
