Area: Geraldton	Place Number: 153	Category: 3
Assessment Date: 15/10/1996	Last Revision Date: 04/11/2009	
HCWA Number: 13403	Asset ID: MCH126703

Name:	House
Other Names:	116 Fitzgerald Street
Type of Place:	House
Address:	116 Fitzgerald Street
Suburb:	Beachlands

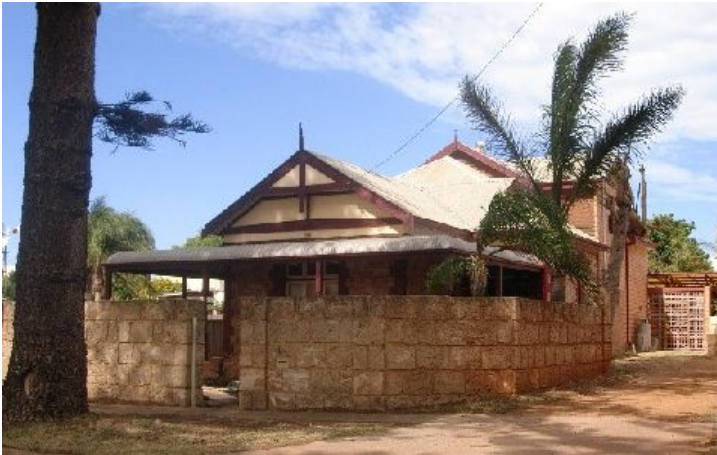
3/12/2007

Large brick extension to rear.

The original front section of this stone and brick house has a gambrel roof with a central flying gable to the street (east) facade with a finial and pendant. Surrounding the gable, a bullnose verandah is supported on turned timber posts. The stone work to the original section is finely pointed with red brick quoining and arches to the openings and matching brick quoining to the corners. Windows to the front section are timber framed and casement style with a transom light. A tall brick chimney is situated to the south of the front section. To the rear, a large brick extension has a gable roof with a finial and weatherboard infill to the gable end. The house is separated from the street by a tall limestone block wall.

Management Category: 3
Level of Significance: MODERATE SIGNIFICANCE: Important to the heritage of the locality.
Management Recommendation: Conservation of the place is recommended. Any proposed change to the place should not unduly impact on the heritage values of the place and should retain significant fabric wherever feasible.

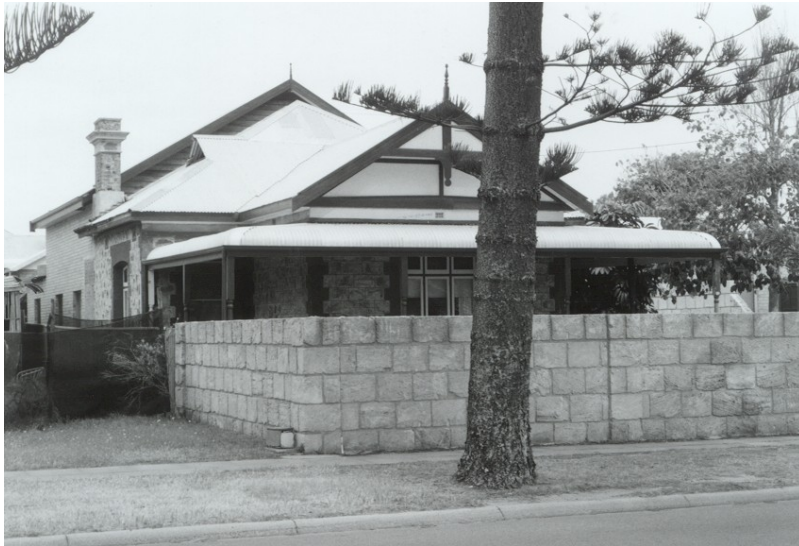
15/10/1996

House set behind tall limestone block wall.
