City of Greater Geraldton Municipal Inventory of Heritage Places Place Record

Area: Geraldton Place Number: 157 Category: 4

Name: House

Address: 136 Fitzgerald Street

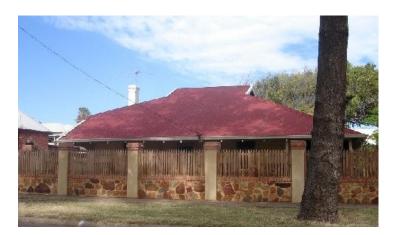
Front facade from Fitzgerald Street.

Condition: Good Integrity:

The corrugated iron gambrel roof of this timber framed house extends to cover the surrounding verandahs to the north and east which are supported on timber posts. The walls of the house are clad with weatherboard to half height with fibro above. Windows are double hung and timber framed. There is a corbelled brick chimney to the south. A masonry wall with rendered piers and timber picket infill forms the property frontage.

Management Conservation of the place is desirable. Any **Recommendation:** proposed change to the place should be in

sympathy with the heritage values of the place.

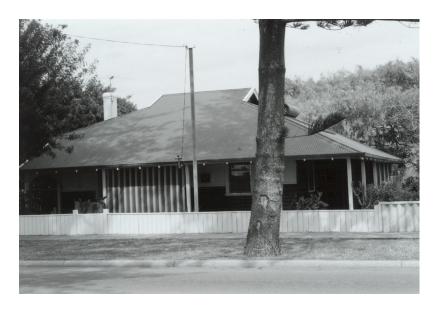
Photo Description: 15/10/1996 Suba & Grundy Low fence since replaced.
