City of Greater Geraldton Municipal Inventory of Heritage Places Place Record

Area: Geraldton Place Number: 176 Category: 2

Name: House

Address: 14 Francis Street

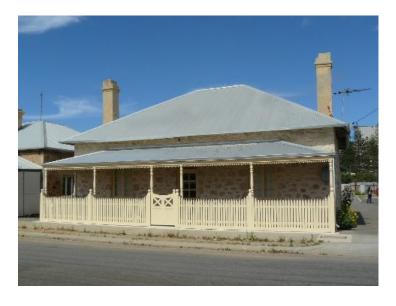
Photo Description:

14/12/2009 Tanya Henkel Stone house restored

This stone house has a hipped corrugated iron roof punctuated by two tall rendered masonry chimneys to the north and south. There is a lean-to roof to the rear which covers a fibro clad extension. Windows are small paned and casement style to the front facade. A low rendered masonry wall forms the street boundary of the place.

Considerable work has been carried out to the house in recent years including removing the unsympathetic render from the stone walls and the art-deco style flat concrete awning to the front facade. There are plans to reinstate a verandah to the frontage. The building was also reroofed.

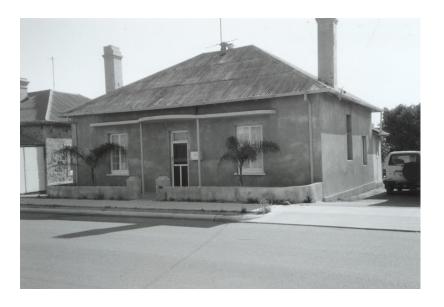
Photo Description:

14/10/1996 Suba & Grundy

Rendered walls and flat roofed awning to front facade since removed.
