Area: Geraldton	Place Number: 60	Category: 3
Assessment Date: 05/12/1996	Last Revision Date: 06/10/2009	
HCWA Number: 13244	Asset ID: MCH126792

Name:	House
Other Names:	206 Chapman Road
Type of Place:	House
Address:	206 Chapman Road
Suburb:	Beresford

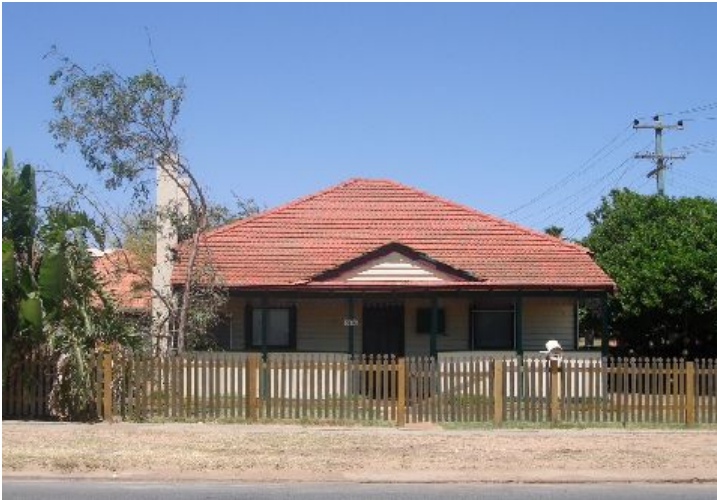
10/01/2008

The front (west) elevation of the house with picket fence.

This building is a timber framed weatherboard clad house with a hipped tiled roof which extends broken-back to cover the front verandah. There is a separate small gable with weatherboard to the gable end above the verandah which enhances the main entrance. The verandah is supported on timber posts with fibro infill below the handrail. There are two rendered chimneys to the north. There is a weatherboard clad lean-to at the rear. The property has a timber picket fence to the Chapman Road frontage.

Management Category:	3
Level of Significance:	MODERATE SIGNIFICANCE: Important to the heritage of the locality.
Management Recommendation:	Conservation of the place is recommended. Any proposed change to the place should not unduly impact on the heritage values of the place and should retain significant fabric wherever feasible.

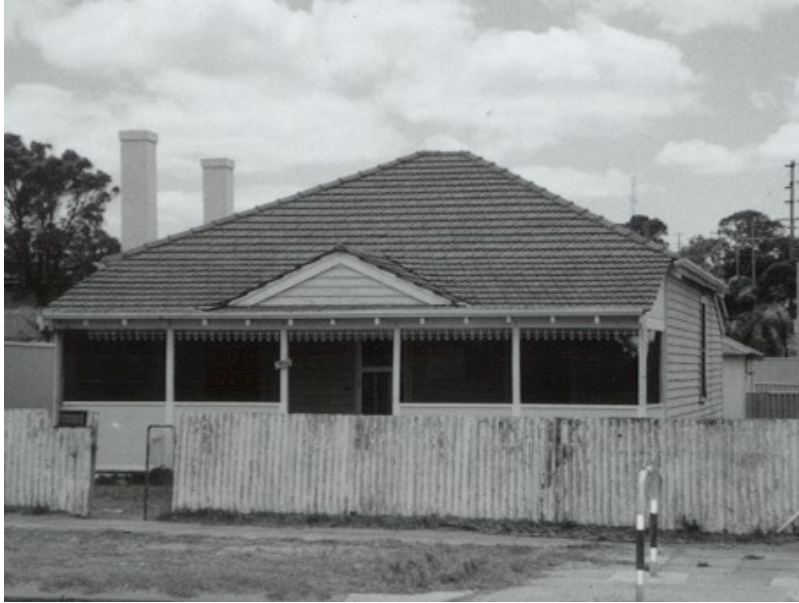
5/12/1996

This house has considerable streetscape appeal given its simple style, small scale and relatively high integrity. The aesthetic charm of the house is enhanced by the twin tall chimneys, the small entry gable and the use of weatherboard cladding.

Two tall rendered chimneys punctuate the roofscape.
