# City of Greater Geraldton Municipal Inventory of Heritage Places Place Record

Name: House/Shop

Address: 32 Gregory Street

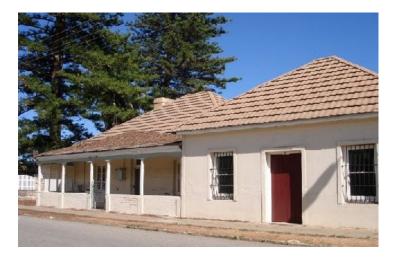
The former shop with adjoining residence.

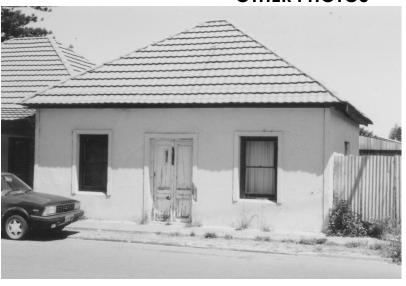
FORMER SHOP: This small square rendered stone building fronts directly on to the street and has a steeply pitched aluminium tiled hipped roof. The front facade has double timber entry doors with double hung windows each side. Decorative wrought iron security grilles have been installed to the windows. Openings are enhanced with additional rendering.

14/10/1996 Suba & Grundy The front facade of the former shop

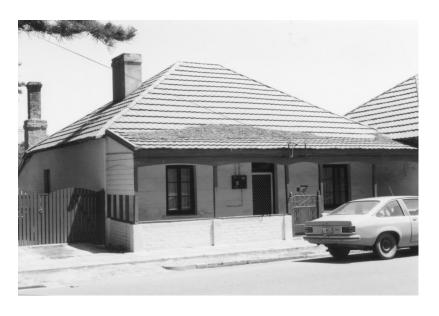
RESIDENCE: This ashlar rendered stone building's verandah fronts directly onto the street. The main roof is hipped aluminium tile and it extends with a shallower pitch to cover the front verandah. The verandah is supported on half timber posts on brick piers with a brick balustrade. Between the verandah posts there is an arched timber frieze and the south end of the verandah has some weatherboard infill. There are rendered masonry chimneys to the south and south west, the latter has had a tall brick extension added. Windows are timber framed casement style.

14/10/1996
Suba, Callow & Grundy
The adjoining residence has two chimneys.
