City of Greater Geraldton Municipal Inventory of Heritage Places Place Record

Area: Geraldton Place Number: 215 Category: 2

Name: House

Address: 49-51 Gregory Street

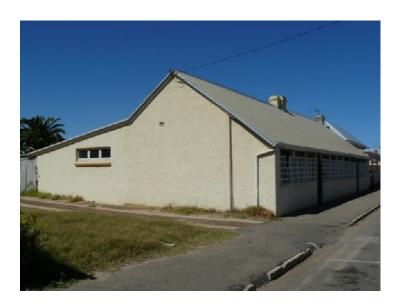
Photo Description:

13/04/2008 Tanya Henkel View showing steeply pitched roof.

This long limestone rubble building fronts directly on to the street. There is a steeply pitched corrugated iron gable roof which extends to the front (west) to cover the verandah and also extends as a shallow pitch skillion roof to the rear. The stone has been rendered to the front and north facades. The verandahs are supported on half timber posts and enclosed with lattice above a masonry balustrade. There are two separate wrought iron entry gates to the street. Windows are timber framed and double hung, 18 pane. A single chimney is centrally placed to the apex of the gable.

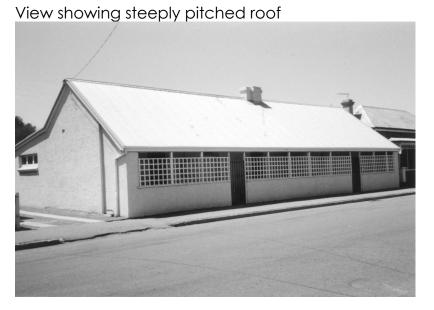
Photo Description:

14/10/1996
Suba & Grundy
Building fronts directly onto footpath.
