Area: Geraldton	Place Number: 256	Category: 4
Assessment Date: 25/10/1996	Last Revision Date: 27/11/2009	
HCWA Number: 13426	Asset ID: MCH126629

Name:	House
Other Names:	9 Jose Street
Type of Place:	House
Address:	9 Jose Street
Suburb:	Beachlands

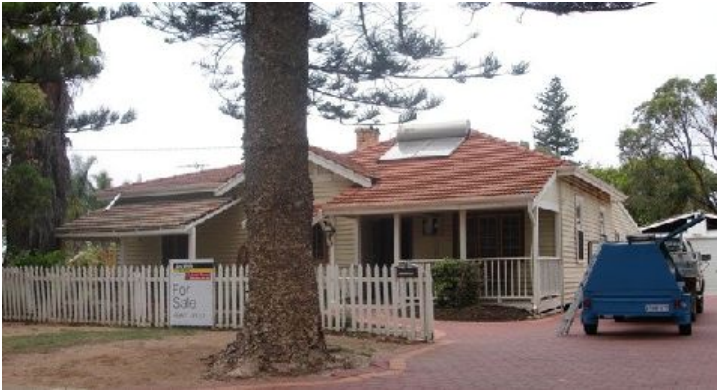
Weatherboard house set behind picket fence.

Walls:	Weatherboard	Roof:	Tile
Condition:	Fair	Integrity:	
Original fabric:			
Modifications:	Numerous changes over time

This timber framed weatherboard clad house has a tiled hipped roof with a separate gable roof to the front (main) room. The roof extends to cover the verandah which is supported on timber posts with a simple timber balustrade. The gable end has fibro and timber batten infill and below it a tiled awning covers the window to the main room. Windows are eight paned timber framed casement style. The street boundary has a Gothic style timber picket fence and the street verge features two large Norfolk Island Pines (*Araucaria heterophylla*).

Management Category:	4
Level of Significance:	SOME SIGNIFICANCE: Contributes to the heritage and/or historical development of the locality.
Management Recommendation:	Conservation of the place is desirable. Any proposed change to the place should be in sympathy with the heritage values of the place.

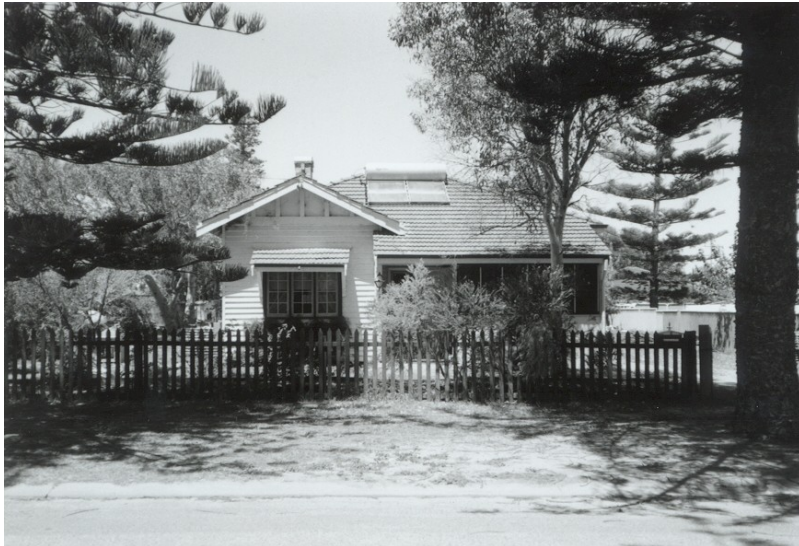
Timber batten infill to gable end.
