Area: Geraldton	Place Number: 325	Category: 2
Assessment Date: 06/11/1996	Last Revision Date: 10/03/2010	
HCWA Number: 13719	Asset ID: MCH126701

Name:	1st Bluff Point Scouts Hall, Fmr
Other Names:	8 Morris Street
Type of Place:	Hall
Address:	8 Morris Street
Suburb:	Bluff Point

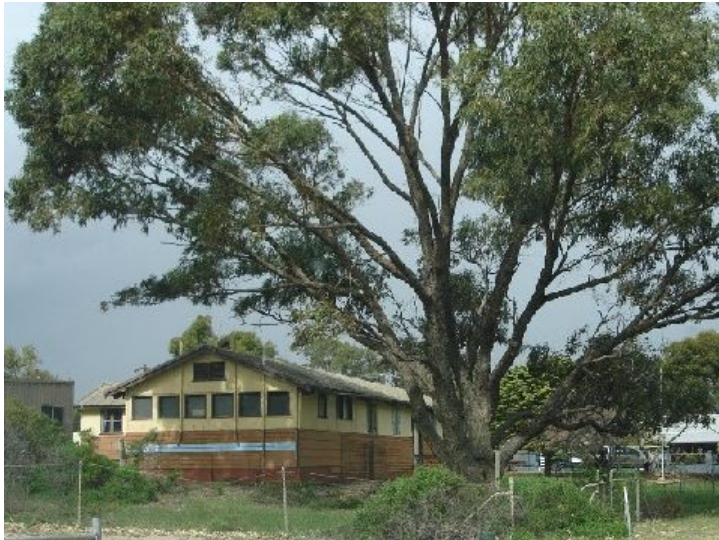
Simple timber framed halls.

Walls:	Weatherboard/Fibro	Roof:	Asbestos
Condition:	Fair	Integrity:	
Original fabric:			
Modifications:	Original roofing replaced

There are two timber framed fibro clad buildings set at right angles to each other with the larger building running north-south. Both buildings have a gable fibro roof with fibro cladding to the upper half of the walls and weatherboard below. The larger building has aluminium framed windows, the smaller has timber framed casement windows.

Management Category:	2
Level of Significance:	CONSIDERABLE SIGNIFICANCE: Very important to the heritage of the locality.
Management Recommendation:	Conservation of the place is highly recommended. Any proposed change should not unduly impact on the heritage values of the place and should retain significant fabric wherever feasible.

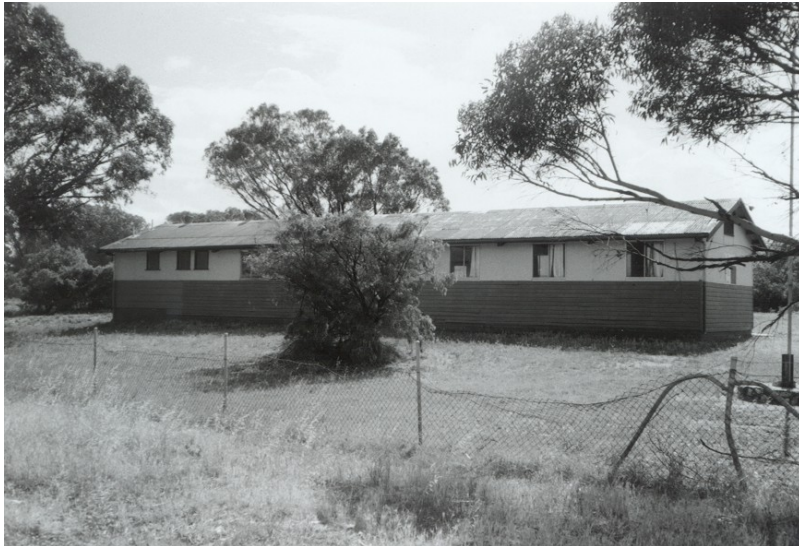
One of two halls on site.
