City of Greater Geraldton Municipal Inventory of Heritage Places Place Record

Name: House

Address: 6 Nichols Street

Suburb: Beresford

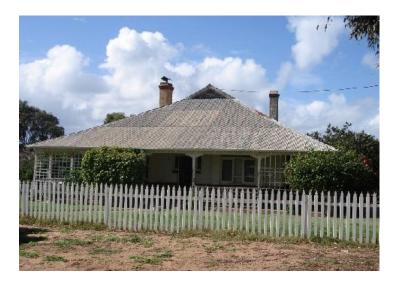
Front facade from Nichols Street.

This brick house has a corrugated iron gambrel roof with a separate gable roof to the north. The main roof extends to cover the surrounding verandahs which are supported on timber posts with brackets to the verandah beam. The verandah to the south west corner is partly enclosed with trellis. The walls are stucco rendered above window ledge height with red face tuckpointed brick below. Windows are timber framed and casement style. To the rear there are two tall stucco rendered brick chimneys. A picket fence forms the front boundary while a corrugated iron clad garage is sited to the north west corner of the block. (See also 4 Nichols Street.)

Management Conservation of the place is highly

Recommendation: recommended. Any proposed change should

not unduly impact on the heritage values of the

place and should retain significant fabric

wherever feasible.

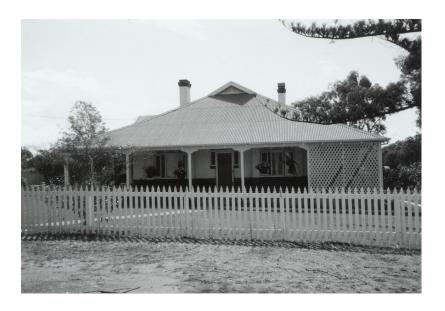
6/11/1996 Suba & Grundy Tall chimneys punctuate the roofscape.
