# City of Greater Geraldton Municipal Inventory of Heritage Places Place Record

Area: Geraldton Place Number: 355 Category: 2

Name: House

Address: 106 Sanford Street

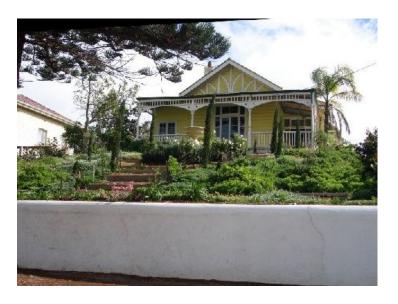
1/08/2007 Rod Milne

Elevated position and decorative verandah details.

**Condition:** Poor **Integrity:**

Set high above the street this timber framed weatherboard clad house has a gambrel roof with a large separate gable roof to the street which covers the main room. The gable end is enclosed with roughcast and decorative timber battens. The main room has a hipped verandah to three sides which is supported on turned timber posts with a decorative frieze. There are french doors to the verandah. A small rendered masonry retaining wall forms the street boundary of the property.

**Management** Conservation of the place is highly

**Recommendation:** recommended. Any proposed change should

not unduly impact on the heritage values of the

place and should retain significant fabric

wherever feasible.

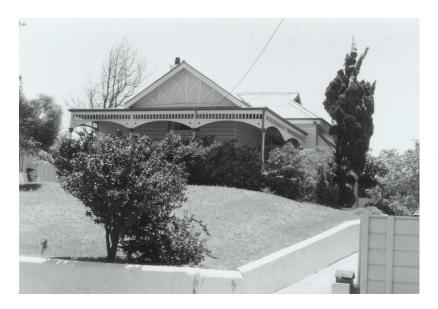
Photo Description: 24/10/1996 Suba & Grundy Gable end batten work a feature.
