<b>Area:</b> Geraldton	<b>Place Number:</b> 370	<b>Category:</b> 4
<b>Assessment Date:</b> 24/10/1996	<b>Last Revision Date:</b> 12/03/2010	
<b>HCWA Number:</b> 13764	<b>Asset ID:</b> MCH126542

<b>Name:</b>	House
<b>Other Names:</b>	145 Shenton Street
<b>Type of Place:</b>	House
<b>Address:</b>	145 Shenton Street
<b>Suburb:</b>	Beachlands

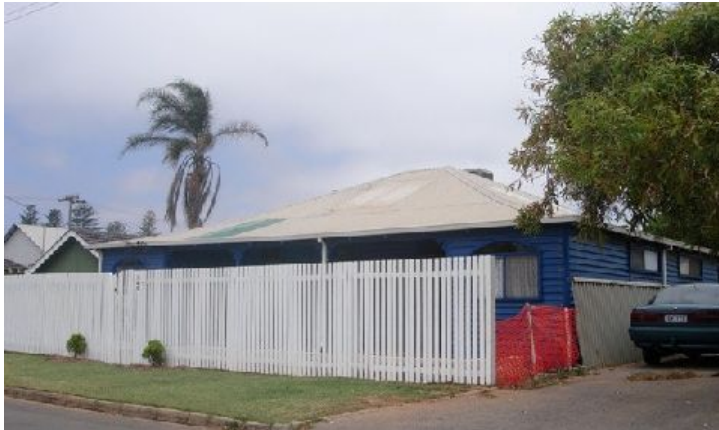
20/11/2007

Hidden behind tall fence.

Set behind a tall picket fence, this timber framed weatherboard clad house has a hipped corrugated iron roof with a separate hipped roof to the main room which extends to cover the front verandah and a lean-to roof to the rear. The verandah is supported on timber posts with decorative brackets to the verandah beam. Windows are a mixture of timber and aluminium frames.

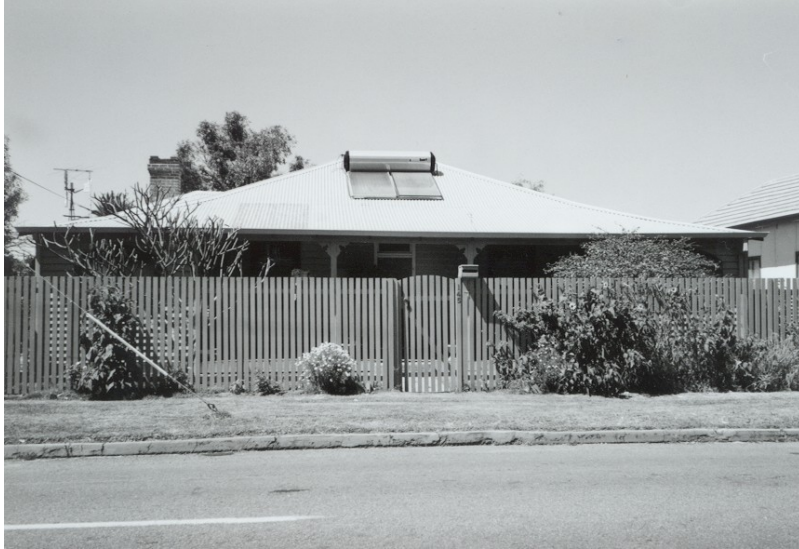
24/10/1996

Solar hot water system since removed.
