City of Greater Geraldton Municipal Inventory of Heritage Places Place Record

Name:	House
Other Names:	151 Shenton Street
Type of Place:	House
Address:	151 Shenton Street
Suburb:	Beachlands
Suburb:	Beachlands

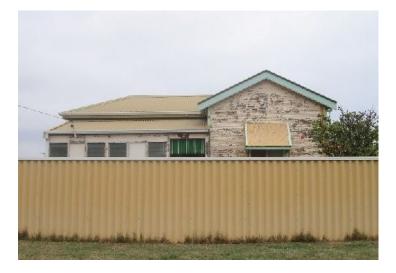
Photo Description: 30/11/2007 Rod Milne Corrugated iron cladding a feature.

Walls: Condition:	Corrugated Iron Fair	Roof: Integrity:	Corrugated Iron
Original fabric Modifications		n infill	
 This timber fra	med house is clad wi	th painted cor	rugated iron to the sides

Inis timber tramed house is clad with painted corrugated iron to the sides with ripple iron to the front main room. The roof is hipped corrugated iron with a separate gable to the front and a skillion roof to the rear with a lean-to roof beyond which covers a weatherboard clad extension. The front verandah has a separate roof which is supported on timber posts with fibro and louvre window infill to the front and side. An awning to the side window is made of corrugated iron and ripple iron to the front room. There is a tall corrugated fibro fence to the street boundary.

Management Category:	3
Level of Significance:	MODERATE SIGNIFICANCE: Important to the heritage of the locality.
Management Recommendation:	Conservation of the place is recommended. Any proposed change to the place should not unduly impact on the heritage values of the place and should retain significant fabric wherever feasible.

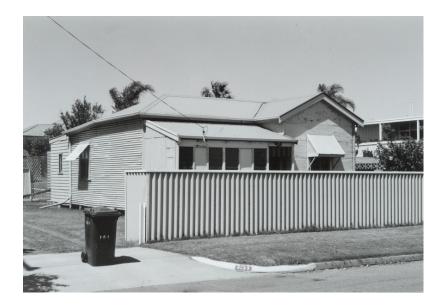
Photo Description: 24/10/1996 Suba & Grundy Enclosures to the front verandah.
