City of Greater Geraldton Municipal Inventory of Heritage Places Place Record

Name: House

Other Names: 9 Snowdon Street

Address: 9 Snowdon Street

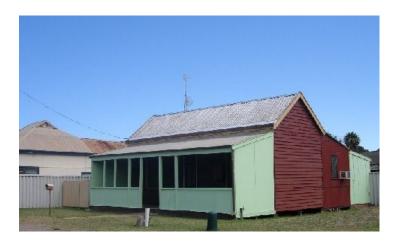
11/12/2007 Rod Milne Small weatherboard cottage.

This small timber framed weatherboard clad cottage has a steeply pitched corrugated iron gable roof and a colorbond clad lean-to to the rear with a fibro clad extension beyond. The front verandah has a separate roof and is partly enclosed on the verandah ends and beneath the balustrade with fibro sheeting. There is a brick chimney to the west elevation.

Condition: Good **Integrity:**

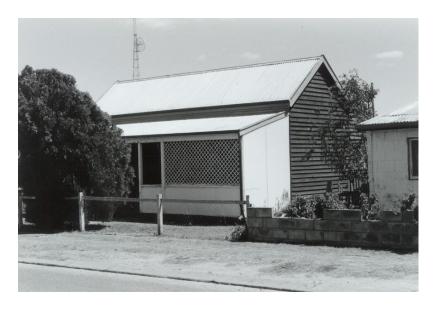
Photo Description: 3/12/1996 Suba & Grundy Lattice verandah infill since removed.
