<b>Area:</b> Greenough	<b>Place Number:</b> 120	<b>Category:</b> 1
<b>Assessment Date:</b> 22/09/1997	<b>Last Revision Date:</b> 29/03/2005	
<b>HCWA Number:</b> 13900	<b>Asset ID:</b> MCH127088

<b>Name:</b>	Belay
<b>Other Names:</b>	Evans Road (east side)
<b>Type of Place:</b>	Homestead
<b>Address:</b>	Evans Road (east side)
<b>Suburb:</b>	Walkaway

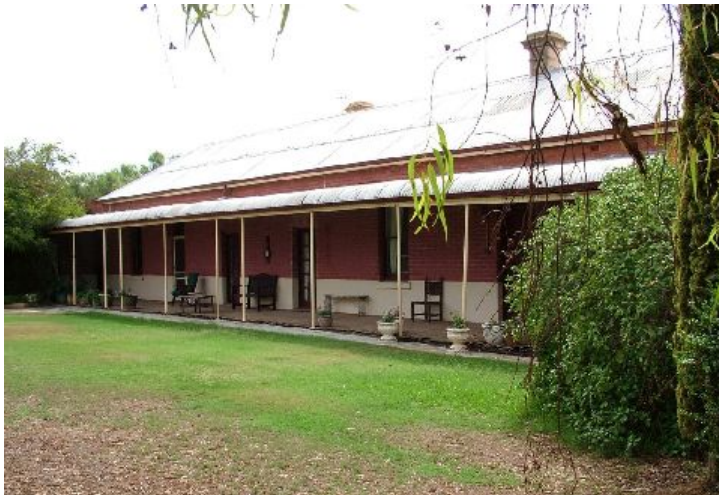
Belay Homestead, west facade

Overall the condition of the place is fair but there is deterioration of some fabric such as the fretting brickwork. In other areas, well intentioned but inappropriate conservation techniques have occurred and need reversing such as removal of concrete verandahs and the cement render to lower sections of external walls. The integrity and authenticity are very high as a result of the continued occupation and care of the place overall.

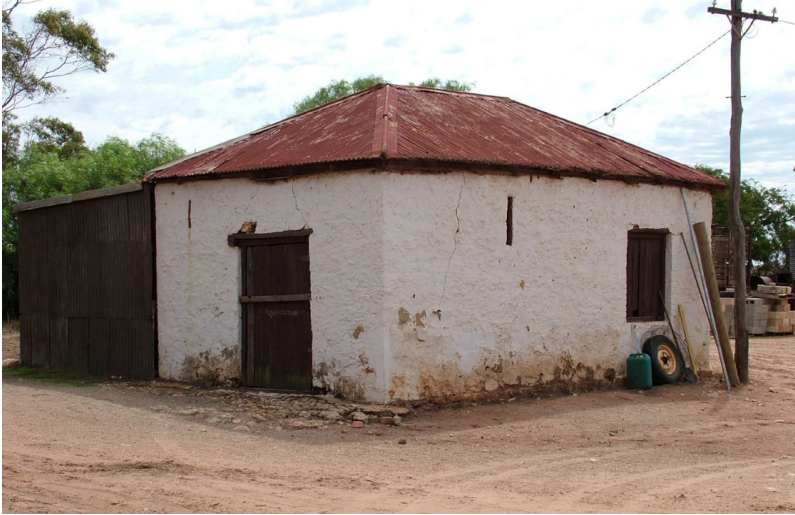
Daemeon & Martin  
view of dairy

The out buildings are of equal significance, in reasonable condition and generally still in use although often not for their original purpose. Nevertheless the solid barn, mill and shearing sheds are impressive and cover a substantial area. The small, former dairy building near the house has been painted white.

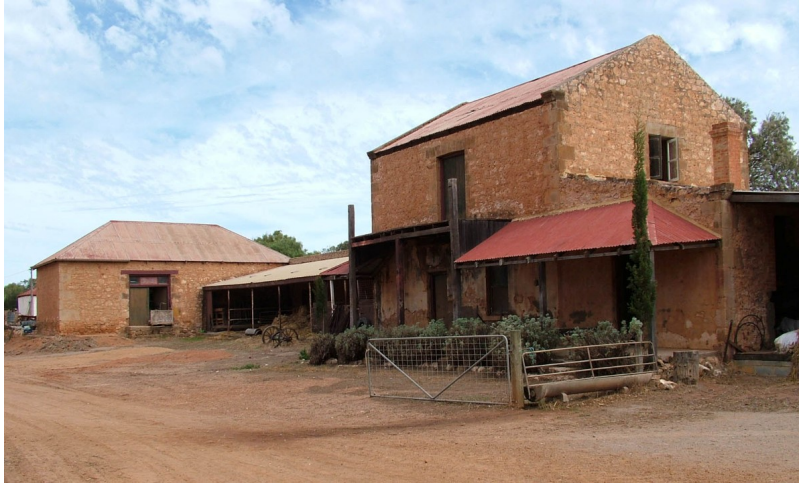
**Photo Description:**  
29/03/2005  
Daemeon & Martin  
view of barn and flour mill

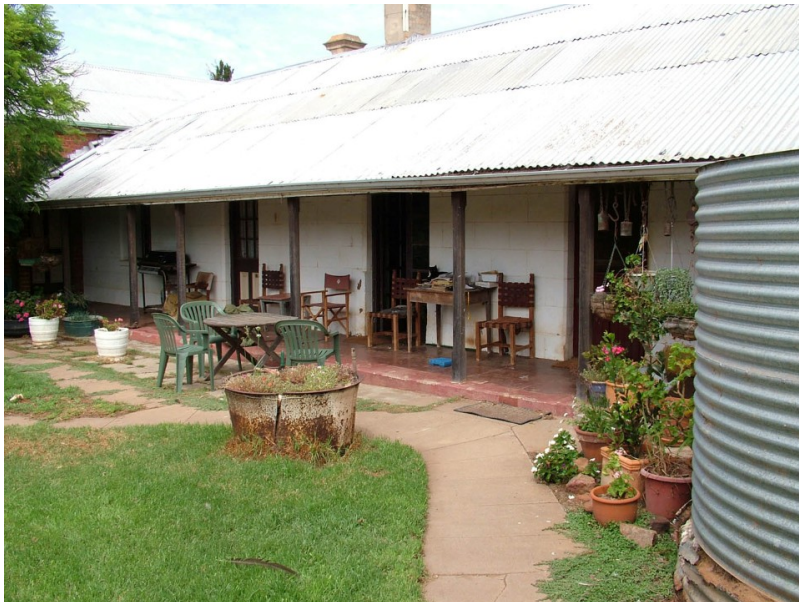
**Photo Description:**  
29/03/2005  
Daemeon & Martin  
Belay homestead, east façade

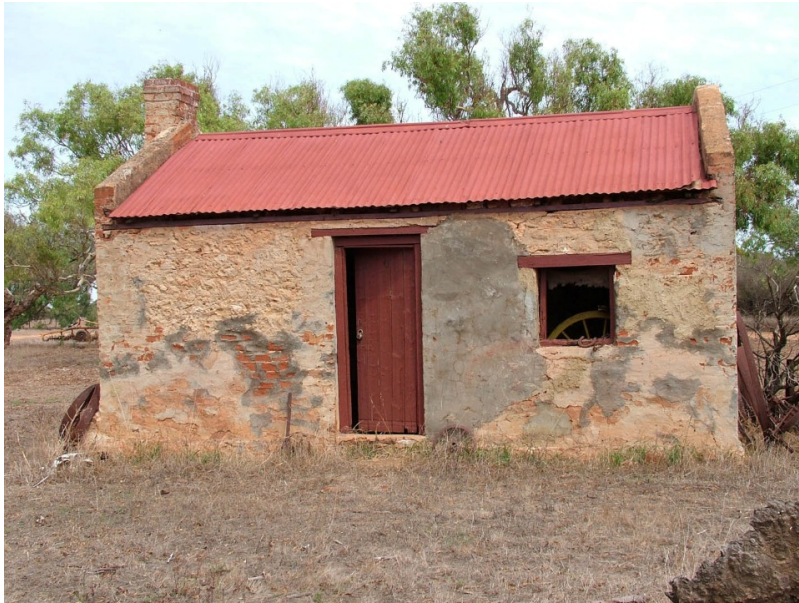
view of Shepherd's Cottage

2004/05 Review: To the east of the homestead is a stone one room cottage with a corrugated iron roof. This is the former Shepherd's Cottage. To the west is a single room stone rendered building with a corrugated iron roof, large door to the south and slit windows on the other 3 sides. This building was used as a dairy. To the north is a large complex of stone walled buildings with corrugated iron roofs. These include a barn, groom's room, stallion room, 2 storey flour mill, and blacksmith's shop. These buildings have undergone modifications and extensions to cater for modern farming practices.
