Area: Greenough	Place Number: 39	Category: 1
Assessment Date: 23/09/1997	Last Revision Date: 19/04/2005	
HCWA Number: 1156	Asset ID: MCH126854

Name:	Central Greenough School
Other Names:	Central Greenough State School, Miss Duncan's School
Type of Place:	School
Address:	Gregory Road (East side) (formerly called Clinch Place)
Suburb:	Greenough

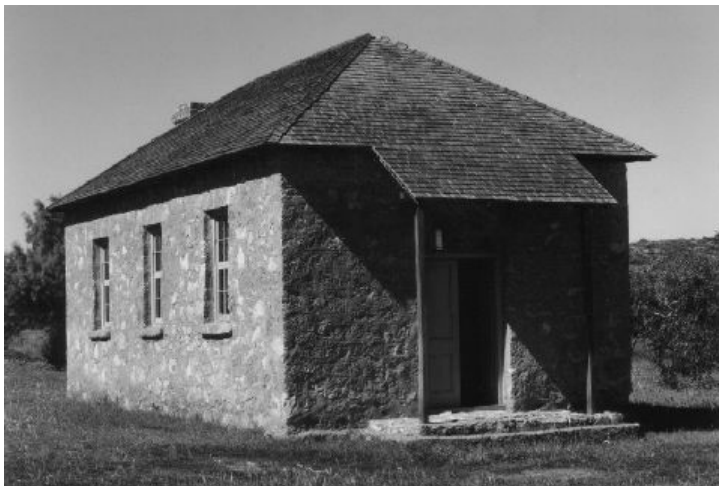
West and north elevations of school

Walls:	Limestone	Roof:	Shingle
Condition:	Poor	Integrity:	
Original fabric:			
Modifications:

Located on the east side of Clinch Place, this simple rectangular random rubble limestone structure is built in Victorian Georgian style. It has a hipped roof which extends to the west to form a porch which covers the front entry and is supported on two tall timber posts. A stone corbelled chimney is set in the east roof of the building. The front entry has double timber doors with an arched transom light above. There are three windows to the sides of the building which are six pane pivot style above and fixed below.

Management Category:	1
Level of Significance:	EXCEPTIONAL SIGNIFICANCE: Essential to the heritage of the locality.
Management Recommendation:	Conservation of the place is considered essential. Any proposed change should not unduly impact on the significance of the place and be in accordance with either a Conservation Plan or Heritage Impact Statement.

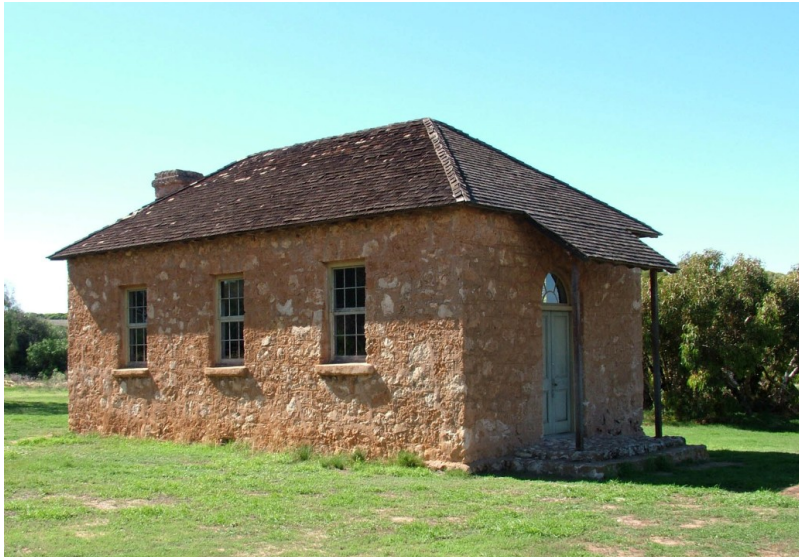
West and north elevations of school
