City of Greater Geraldton Municipal Inventory of Heritage Places Place Record

Area: Mullewa Place Number: 20 Category: 2

Name: Shop

Other Names: 5 Jose Street
Type of Place: Shop/Office?
Address: 5 Jose Street
Suburb: Mullewa

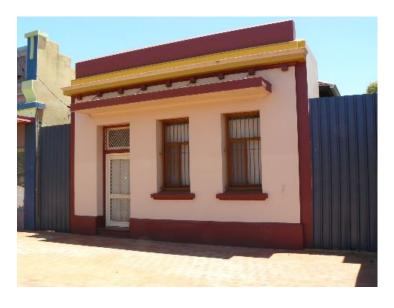
Simple awning over entry and window openings.

Walls: Brick (Rendered) Roof: Zincalume

Condition: Not applicable Integrity:

Original fabric: Parapet detailing Modifications: Windows replaced

This small single storey commerical premise is of rendered brick construction with a hipped zincalume roof hidden behind a low, simple parapet. The front façade addressing Jose Street has a side entry door and two windows, above which is a flat awning. The original timber framed windows have been replaced with aluminium framed alternatives, with metal grilles in front. The building is painted predominently cream with a Federation Red highlight colour.

Management Conservation of the place is highly

Recommendation: recommended. Any proposed change should

not unduly impact on the heritage values of the

place and should retain significant fabric

wherever feasible.
