Area: Mullewa	Place Number: 22	Category: 2
Assessment Date: 10/02/1995	Last Revision Date: 28/02/2012	
HCWA Number: 1660	Asset ID: MCH126544

Name:	Bank of NSW Fmr
Other Names:	29a Jose Street
Type of Place:	Fmr Bank
Address:	29a Jose Street
Suburb:	Mullewa

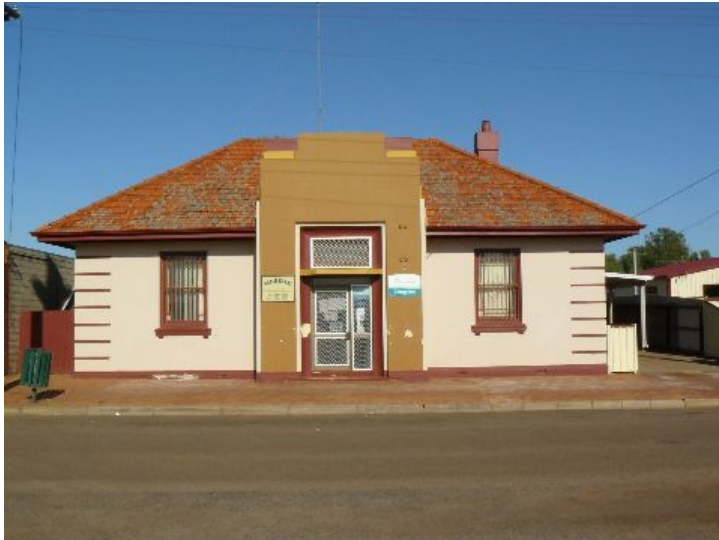
Symmetrical façade featuring a stepped parapet to the central entry portico.

Walls:	Brick (Rendered)	Roof:	Tiles
Condition:	Good	Integrity:	
Original fabric:	Highly intact		
Modifications:	New entry door

The former Bank of NSW is a rendered brick building with a hipped tiled roof. The building fronts directly onto the footpath and has a symmetrical façade with a window set either side of a central entrance. The entrance is enhanced by a protruding rendered wall in a contrast colour with a stepped parapet which extends approximately 2 metres above the door highlight window. While the windows remain original as timber framed and double hung, the door has been replaced with an aluminium framed modern alternative. The windows have metal bars while the door has security grilles. A rendered chimney punctuated the northern roofscape. The corners to the front facade feature a striped detailing reminiscent of the Art Deco style.

Management Category: 2
Level of Significance: CONSIDERABLE SIGNIFICANCE: Very important to the heritage of the locality.
Management Recommendation: Conservation of the place is highly recommended. Any proposed change should not unduly impact on the heritage values of the place and should retain significant fabric wherever feasible.
