Area: Geraldton	Place Number: 139	Category: 3
Assessment Date: 15/10/1996	Last Revision Date: 03/11/2009	
HCWA Number: 13389	Asset ID: MCH127092

Name:	House
Other Names:	76 Fitzgerald Street
Type of Place:	House
Address:	76 Fitzgerald Street
Suburb:	Geraldton

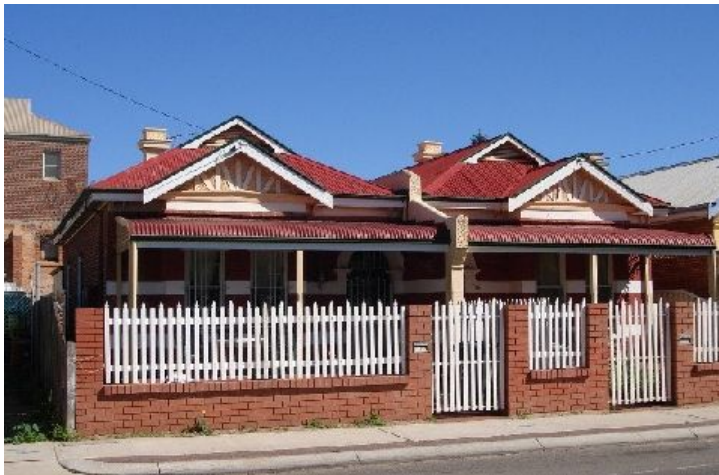
Photo Description:
15/01/2008
Rod Milne
Two semi detached houses.

This property has two identical semi detached brick buildings. Each building is separated by a parapet wall and has a corrugated iron gambrel roof punctuated by a corbelled rendered masonry chimney to the rear with a separate gable roof to the front. The gable end has roughcast and timber infill. Below the gable a separate bull nose verandah roof joins to the central parapet wall. The verandah is supported on timber posts. Recessed entry doors are situated each side of the parapet wall and have a rendered masonry arch above which extends to form a band at central window height along the front facade. Windows are narrow, timber framed and double hung. The street boundary has a low brick parapet and columns with a timber picket fence and gates set between. (See also 76 Fitzgerald Street).

Management Category:	3
Level of Significance:	MODERATE SIGNIFICANCE: Important to the heritage of the locality.
Management Recommendation:	Conservation of the place is recommended. Any proposed change to the place should not unduly impact on the heritage values of the place and should retain significant fabric wherever feasible.

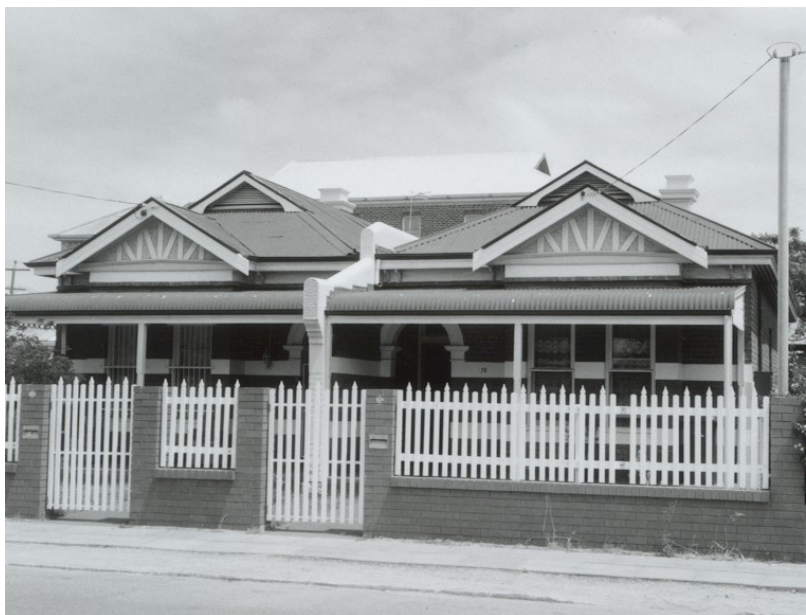
View from Fitzgerald Street.
