Area: Geraldton	Place Number: 151	Category: 3
Assessment Date: 15/10/1996	Last Revision Date: 04/11/2009	
HCWA Number: 13401	Asset ID: MCH126700

Name:	House
Other Names:	111 Fitzgerald Street
Type of Place:	House
Address:	111 Fitzgerald Street
Suburb:	Geraldton

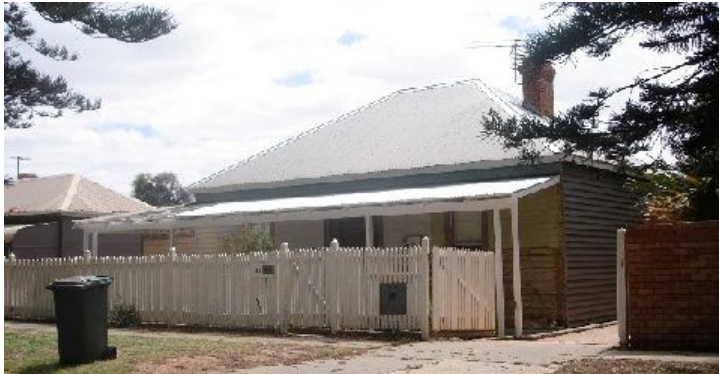
View from Fitzgerald Street.

Walls:	Weatherboard	Roof:	Corrugated Iron
Condition:	Good	Integrity:	
Original fabric:			
Modifications:	Verandah enclosure to north.

This weatherboard house has a steeply pitched hipped corrugated iron roof with a lean-to roof to the rear. A separate hipped verandah roof runs along the street (west) and north sides, supported on timber posts. There is a brick chimney to the south east. The rear yard has a privy with a curved corrugated iron roof. A timber picket fence forms the front property boundary.

Management Category:	3
Level of Significance:	MODERATE SIGNIFICANCE: Important to the heritage of the locality.
Management Recommendation:	Conservation of the place is recommended. Any proposed change to the place should not unduly impact on the heritage values of the place and should retain significant fabric wherever feasible.

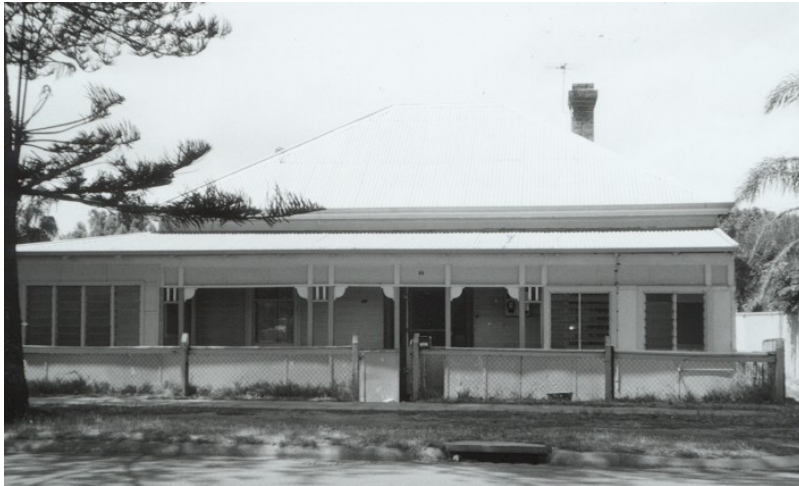
Verandah partly enclosed.
