<b>Area:</b> Geraldton	<b>Place Number:</b> 156	<b>Category:</b> 2
<b>Assessment Date:</b> 15/10/1996	<b>Last Revision Date:</b> 04/11/2009	
<b>HCWA Number:</b> 13406	<b>Asset ID:</b> MCH127014

<b>Name:</b>	House
<b>Other Names:</b>	124 Fitzgerald Street
<b>Type of Place:</b>	House
<b>Address:</b>	124 Fitzgerald Street
<b>Suburb:</b>	Beachlands

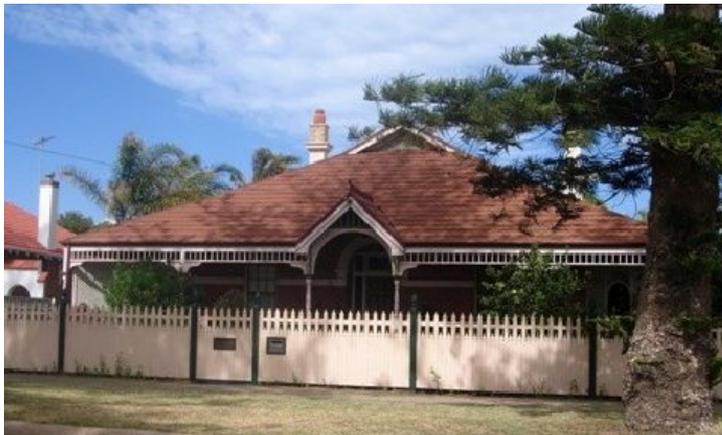
Decorative verandah posts, braces and frieze.

This large house has an aluminium tiled gambrel roof which extends to cover verandahs on three sides. The verandahs are supported on turned timber posts with timber brackets to a small baluster frieze. A small gable to the front verandah enhances the entrance. The face red brick is tuckpointed and has a rendered band at half window height which extends to form an arch above the recessed entry. Windows are timber framed and double hung. There are three rendered corbelled chimneys, two also have terracotta chimney pots. A timber picket fence forms the street boundary of the property.

**Management Category:** 2  
**Level of Significance:** CONSIDERABLE SIGNIFICANCE: Very important to the heritage of the locality.  
**Management Recommendation:** Conservation of the place is highly recommended. Any proposed change should not unduly impact on the heritage values of the place and should retain significant fabric wherever feasible.

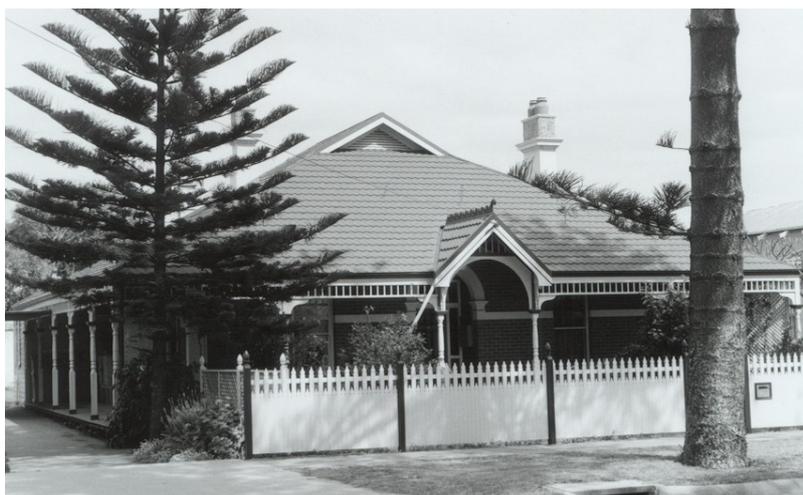
Entry enhanced by roof gable.
