Area: Geraldton	Place Number: 64	Category: 4
Assessment Date: 05/12/1996	Last Revision Date: 06/10/2009	
HCWA Number: 13248	Asset ID: MCH126817

Name:	House
Other Names:	262 Chapman Road
Type of Place:	House
Address:	262 Chapman Road
Suburb:	Beresford

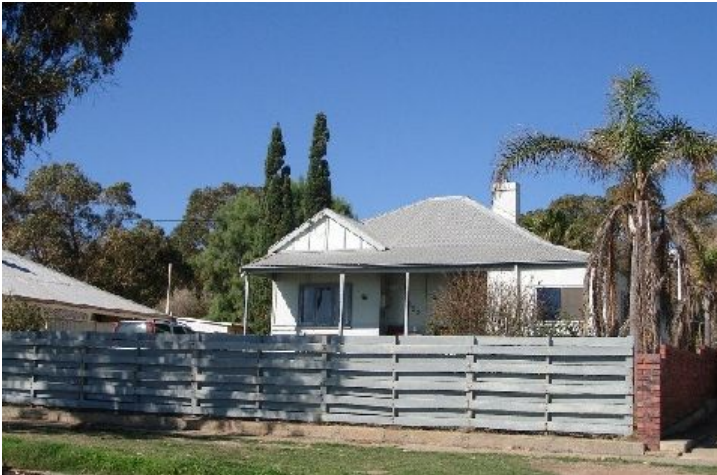
28/08/2007

House set behind timber fence.

This timber framed house is clad with weatherboard to window sill height and fibro above. A hipped corrugated iron roof extends to cover the verandahs to the west and south whilst a separate gable covers the main room to the north west. The gable end has fibro infill with vertical timber slats. The front verandah is supported on timber posts with fibro sheet and aluminium infill to the verandahs to the southwest and south. The windows are timber framed casement style and there is a brick chimney to the south. There is a timber fence to the property frontage.

Management Category:	4
Level of Significance:	SOME SIGNIFICANCE: Contributes to the heritage and/or historical development of the locality.
Management Recommendation:	Conservation of the place is desirable. Any proposed change to the place should be in sympathy with the heritage values of the place.

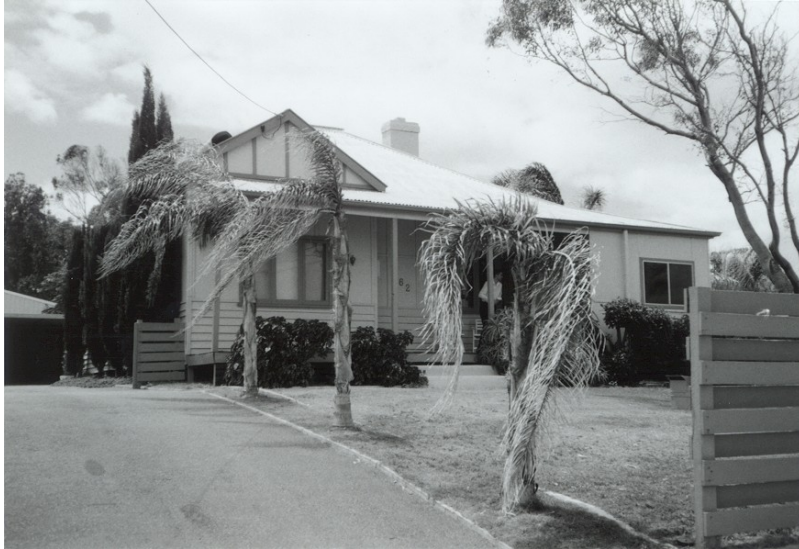
5/12/1996

View of house from Chapman Road.
