Area: Geraldton	Place Number: 202	Category: 4
Assessment Date: 24/10/1996	Last Revision Date: 24/11/2009	
HCWA Number: 13299	Asset ID: MCH126952

Name:	House
Other Names:	93 Gertrude Street
Type of Place:	House
Address:	93 Gertrude Street
Suburb:	Geraldton

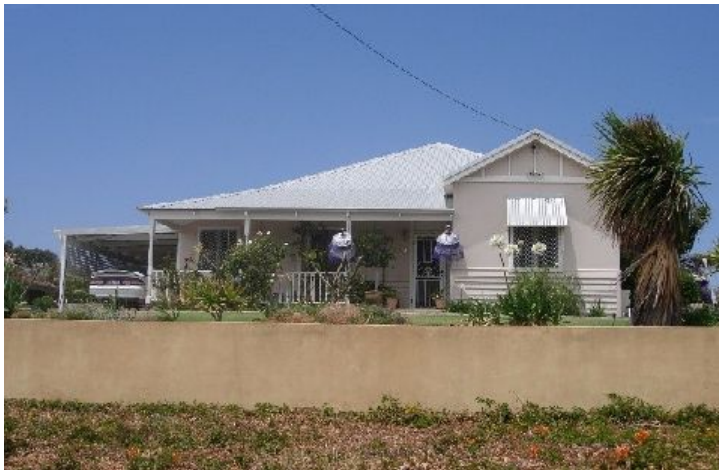
Set above the street level.

Walls:	Weatherboard/Fibro	Roof:	Zincalume
Condition:	Good	Integrity:	
Original fabric:			
Modifications:

This timber framed house has a hipped zincalume roof with broken back extensions which cover the verandahs to the front (west) and north. To the rear there is a lean-to roof and to the south west a separate gable roof covers the main room. The house is clad with weatherboard to window sill height with fibro above and fibro and timber batten to the gable end. The front verandah is supported on timber posts with a timber balustrade between. The north verandah is enclosed with weatherboard below and windows above. The windows to the gable and south side have corrugated iron awnings. There is a small brick chimney to the north east and a carport with a lean-to roof is attached to the north side.

Management Category:	4
Level of Significance:	SOME SIGNIFICANCE: Contributes to the heritage and/or historical development of the locality.
Management Recommendation:	Conservation of the place is desirable. Any proposed change to the place should be in sympathy with the heritage values of the place.

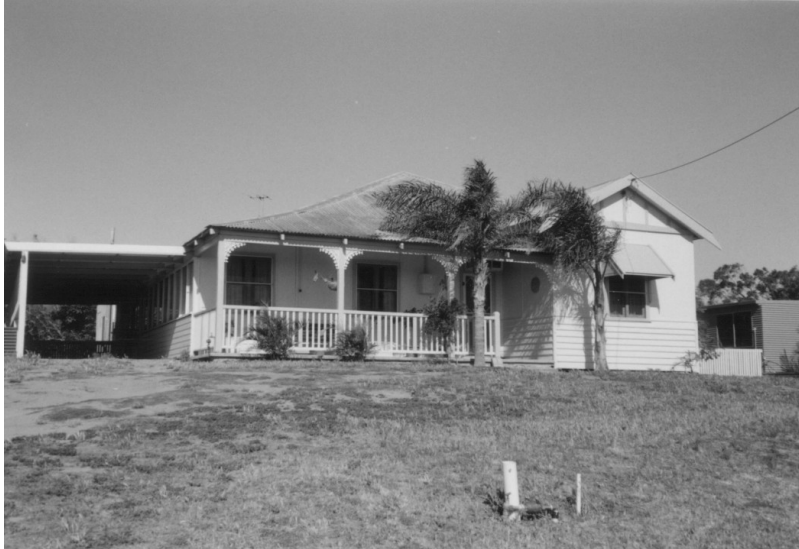
Asbestos roof since replaced.
